Technical Service Bulletin

46 Brake noise analysis and handling

46 14 64 2034181/4 January 2, 2014. Supersedes Technical Service Bulletin Group 46 number 13-63 dated December 5, 2013 for reasons listed below.

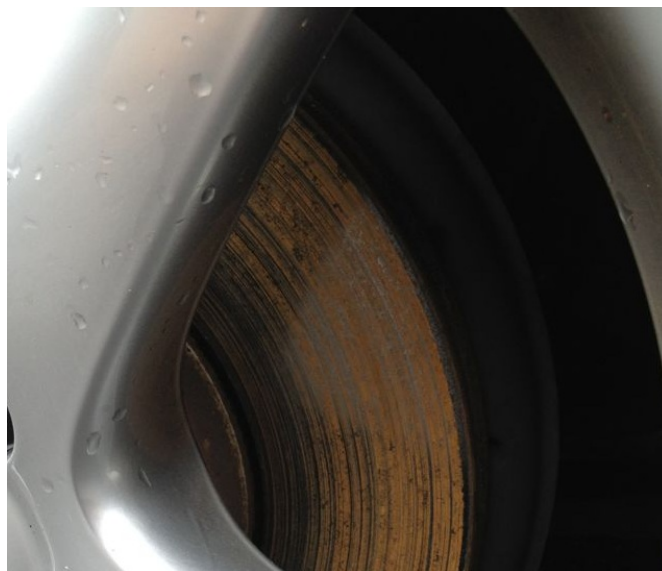
1. Brake discs or brake pads are close to or below their wear limit.
2. Aftermarket pads or discs have been installed.
3. There is debris (such as small stones, grit, road salt, or sand) between brake disc and brake pad.
4. Discs are covered with rust. Rust can form when the vehicle has not been driven for a long period of time (Figure 1).

Figure 1. Disc covered with rust.

- Fill out as much information as possible in the questionnaire. Some fields are mandatory.
4. Clean the brake pads and discs:
 1. With careful consideration of the traffic situation, perform between 2 and 5 ABS stops from speeds above 50 mph. Between each ABS stop, allow the brake components to cool by driving the vehicle for more than one minute at speeds greater than 50 mph.

2. Let vehicle sit for two hours to cool down.
 3. Test drive again. If the noise was not eliminated after completion of steps 1 and 2 please contact the Audi Technical Assistance Center (TAC) before replacing any parts. This will assist us in diagnosing any potential issues with the condition noted above.

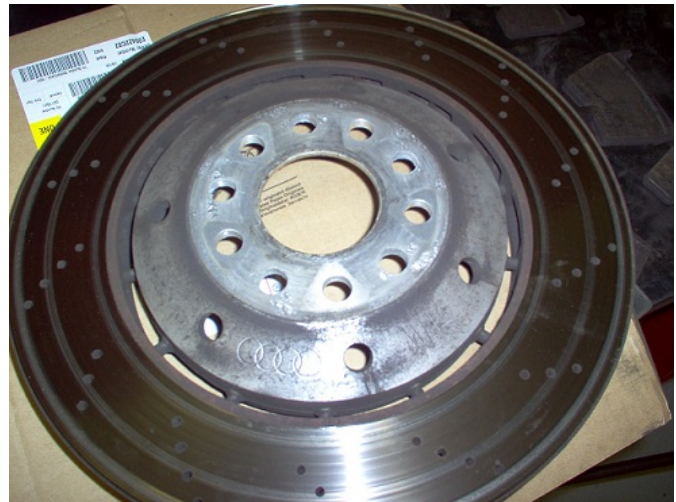
5. Discs are grooved (Figure 2).

Figure 2. Grooved disc.

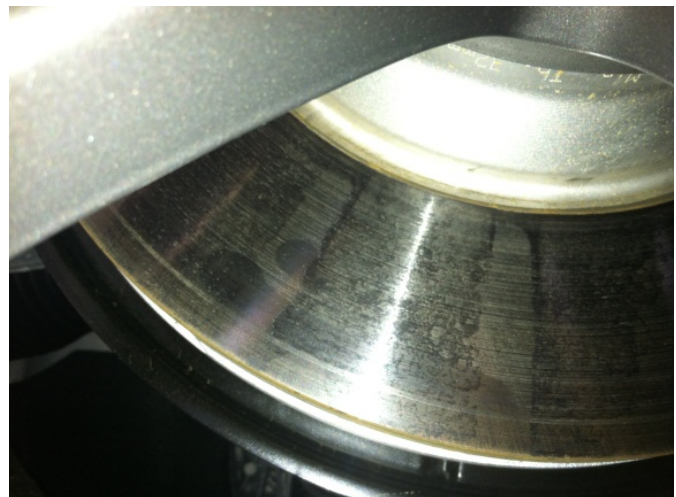
6. There is chemical contamination on the braking surface of the brake disc due to wheel or tire cleaner being sprayed directly onto the brake disc (Figure 3 and Figure 4).

Figure 3. Discoloration on the brake disc due to chemical contamination from cleaner that was sprayed directly onto the disc.

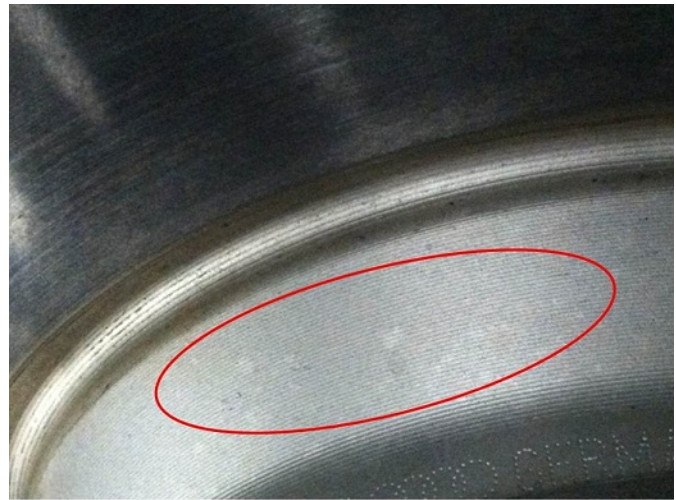
Figure 4. Small spots and discoloration due to chemical contamination from cleaner that was sprayed directly onto the disc.

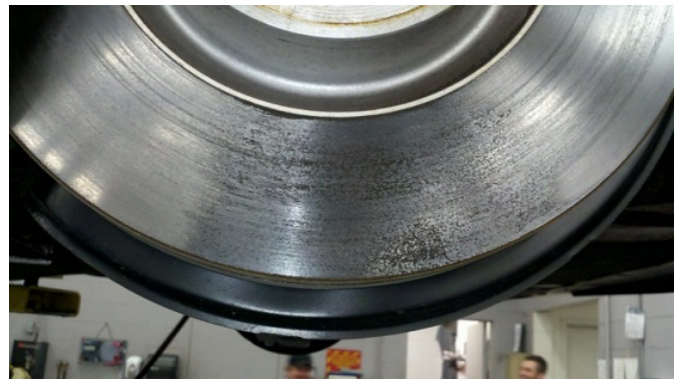
7. There are “pad marks” on the brake disc as a result of brake pad material transferring to the discs (Figure 5). Pad marks can occur when a vehicle has been parked for long periods of time in a wet or snowy environment.

Figure 5. Brake pad material has transferred to the discs.
