# Technical Service Bulletin

## 91 Microphone testing tips

91 14 19 2026895/3 January 3, 2014. Supersedes Technical Service Bulletin Group 91 number 11-16 dated October 5, 2011 for reasons listed below.

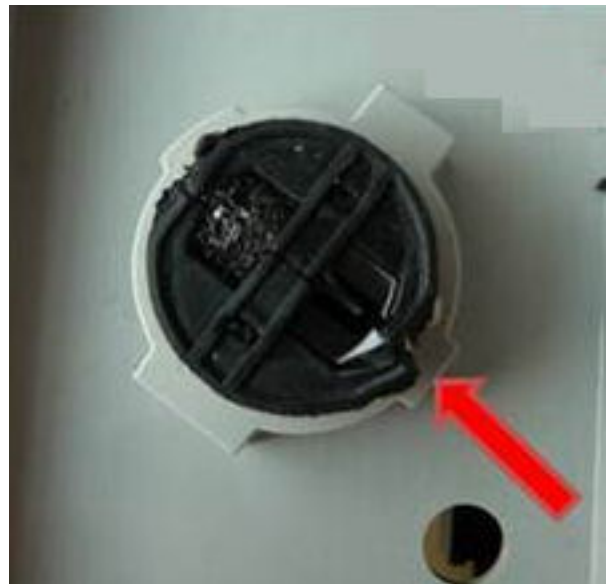
**Figure 1.** Damaged rubber seal.

1. Remove the roof module and press on the microphones to verify that they are securely seated in the roof module.
2. If the vehicle is a 2012 or newer C7 or D4, remove the microphones and inspect the rubber seal around the edge for tears or breaks in the seal (Figure 1).
  - If the seal is damaged, replace the microphone.
  - If the seal is not damaged, reinstall the microphones into the roof module and re-test.

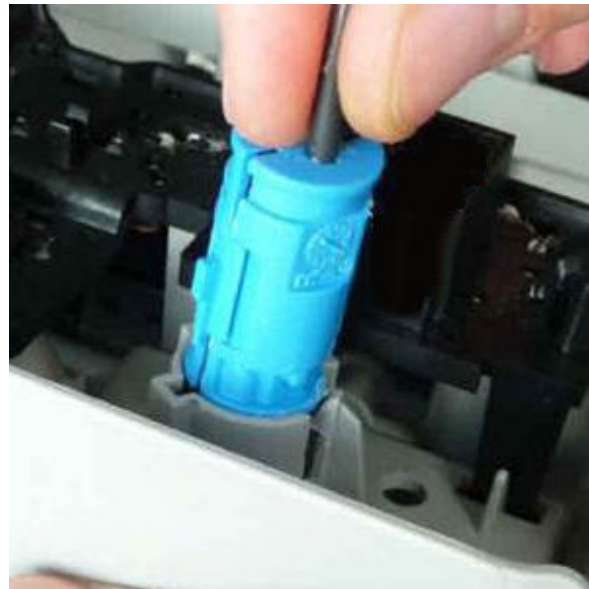
**Figure 2.** Correct installation angle of microphones.

When installing microphones back into the roof module, make sure that the microphones are installed straight into the cavity (Figure 2). Installing them at any other angle can cause damage to the microphone and/or seal.
