Technical Bulletin

85 14 01 January 22, 2014 2012432 Supersedes Technical Bulletin 85-07-01 dated May 24, 2007 to include additional models in which the replacement part will repair correctly, and switch bulletin to information only. Warranty has expired.

HVAC, Temperature Output Control Cannot Be Adjusted

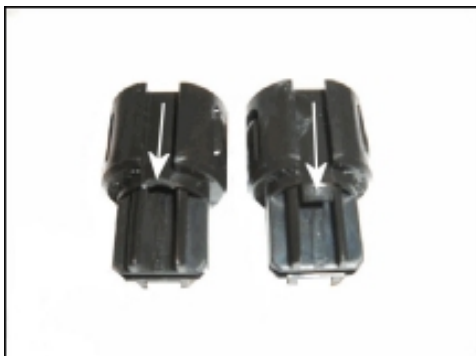
The blend door control lever moves freely, but the blend door does not operate.

A bushing that fits on the lever may have a broken tab/clip, -arrows-, as shown.

This tab/clip may cause the bushing to fall out of the fresh air housing which can result in the door becoming inoperative and result in undesired air temperature.

In the past the entire fresh air housing was replaced because the bushing was not available as a separate part. The bushing is now available as a separate part.

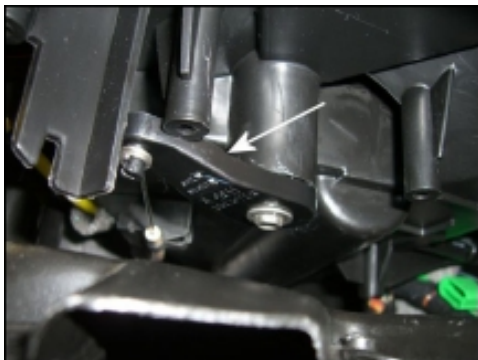
- This will expose the location of the control lever, -arrow-, as shown.

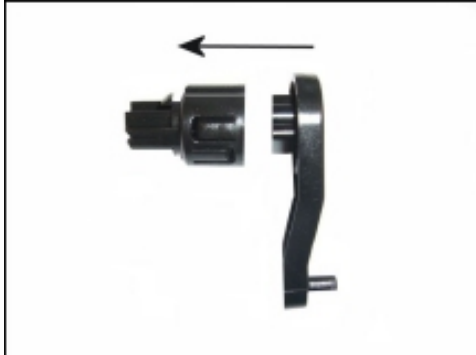
- Re-bolt a new bushing onto the lever, -arrow-, as shown.

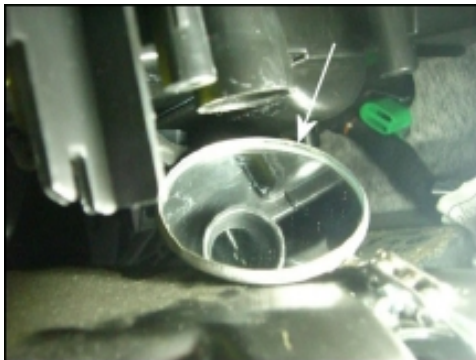
- Re-insert the bushing with lever onto the blend door until it is firmly secured in the housing.

A mirror can be used to aid in identifying the orientation of the blend door when re-securing the bushing in the fresh air housing, -arrow-, as shown.
