Technical Service Bulletin

01 MIL on, rough running, no start (DTCs P0087, P0088, P0191)

01 14 69 2036668/1 March 6, 2014.

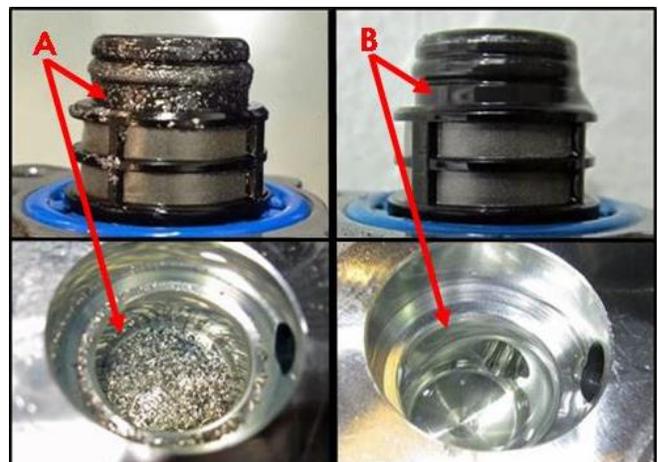
1. Remove the N290 fuel metering valve and inspect the valve and valve bore for the presence of metallic particles (Figure 2). Proceed with the appropriate section below.

Figure 2. Fuel metering valve and valve bore with metallic particles (A), and without metallic particles (B).

If metallic particles are found on the N290 fuel metering valve or in the valve bore:

If metallic particles *are not* found on the N290 fuel metering valve or in the valve bore:

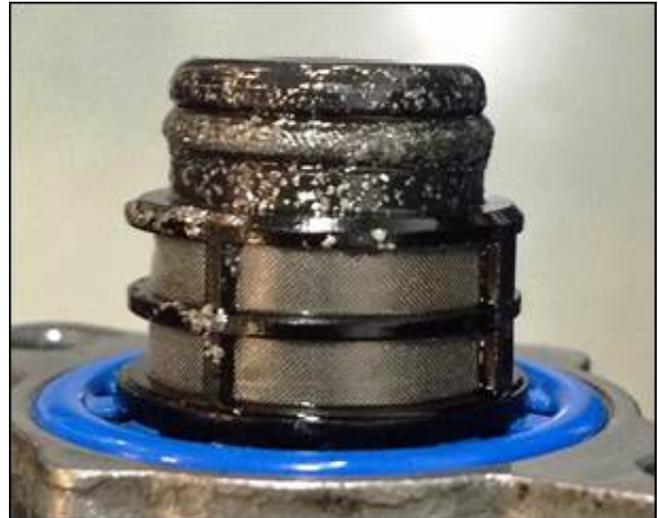
Figure 3. Example of a clear picture showing the metallic particles in the N290 fuel metering valve.

1. Contact the Audi Technical Assistance Center (TAC) and open a TAC ticket before continuing with the repair. Before contacting TAC, attach the following to the TAC ticket:
 - GFF diagnostic log
 - Clear pictures showing the metallic particles in the N290 fuel metering valve and bore (Figure 3 and Figure 4).

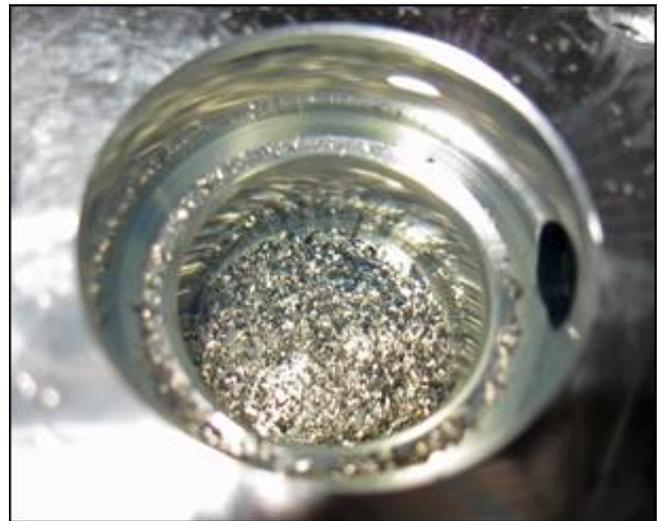
Figure 4. Example of a clear picture showing the metallic particles in the valve bore.
