Technical Service Bulletin

85 Side air vents inoperative and/or noisy during operation

85 14 21 2037052/1 April 17, 2014.

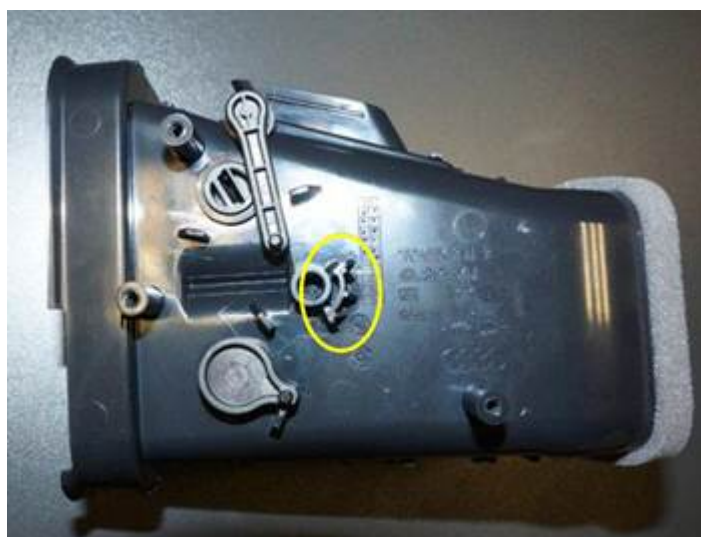
The mechanical stop for vent linkage (Figure 1 and Figure 2) is broken, allowing for the linkage to extend past intended range of operation.

Figure 1. Good, non-broken component.

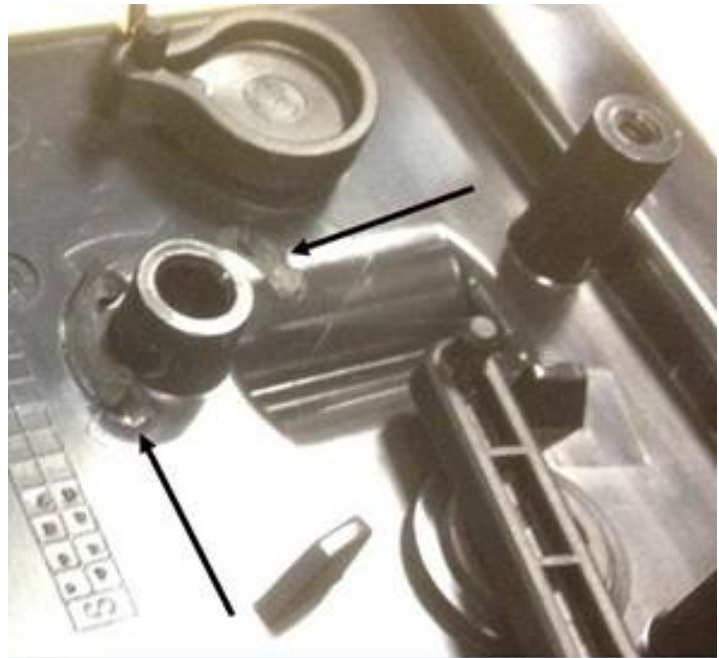
Figure 2. Broken component.

Air distribution housing linkage stop includes more ribbing for increased strength.

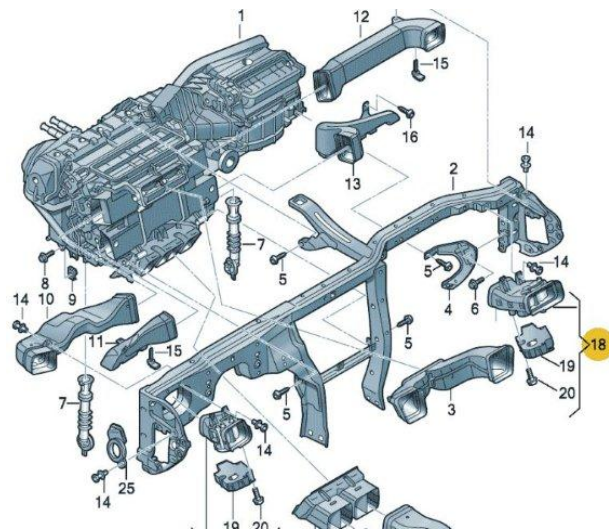
Figure 3. Air distribution housing.

Inspect the air distribution housing (Figure 3) and replace if broken. Follow instructions in Elsa repair manual.
