# Technical Service Bulletin

## 74 Front seat backrest cover damaged

74 14 19 2036572/2 May 9, 2014. Supersedes Technical Service Bulletin Group 74 number 14-18 dated February 26, 2014 for reasons listed below.

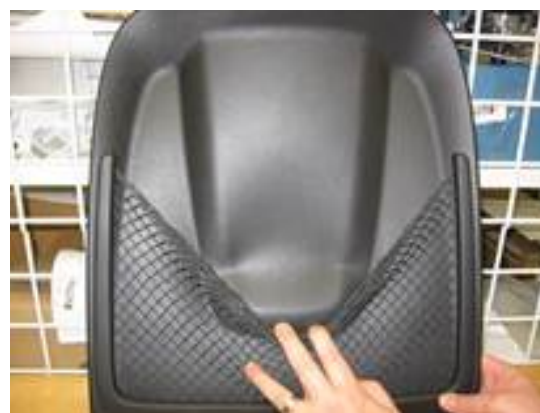
- The panel on the back of the front seat is warped or dented (Figure 1).
- The headrest on the rear seatback may also be damaged.

*Figure 1. Damaged front seatback panel.*

- When the rear seat seatbacks are folded down, the rear seat headrests must be removed to accommodate the front seats (Figure 4).
- With the rear seat headrests removed, there is adequate clearance to accommodate the front seats even if they are adjusted as far back as possible (Figure 5).
- When the rear seats are folded back up and locked, the headrests must be reinstalled. The procedure for removal and reinstallation of the rear seat back headrests can be found in the Owner's Manual.

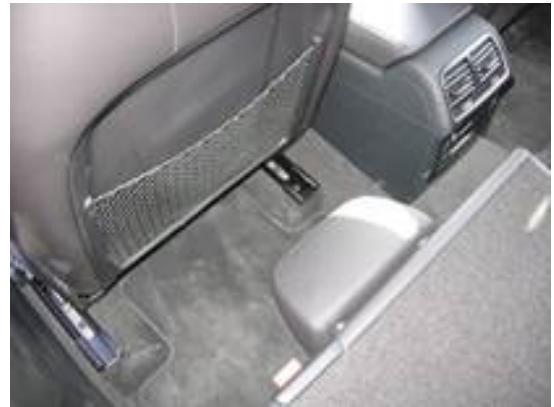
The damage is caused when the headrest of the rear seat backrest comes in contact with the back of the front seat.

This occurs when the rear seat is folded down with the headrests installed (Figure 2), and the front seat is moved back far enough to make contact with the rear seat headrest (Figure 3).

**Figure 2:** *Folded-down rear seat backrest with headrest installed.*

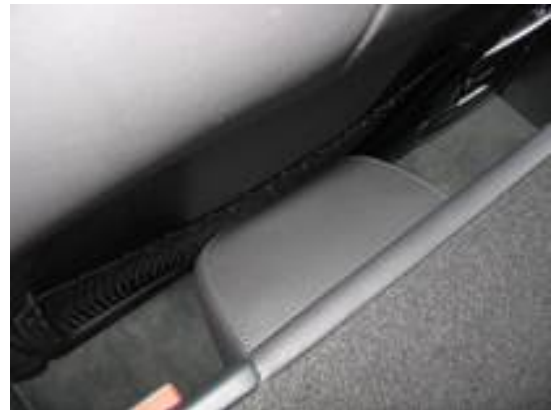
**Figure 3:** *Front seat moved back far enough to make contact with rear seat headrest.*

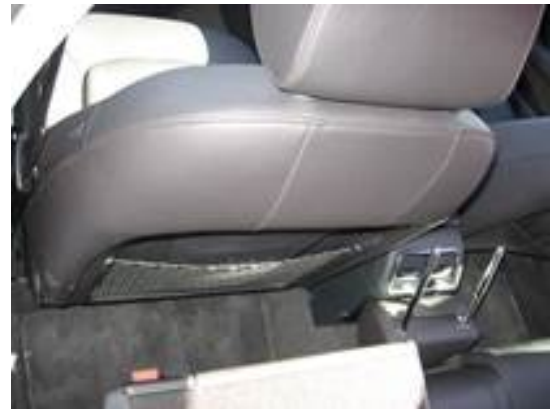
**Figure 4:** Rear seat backrest folded down with headrest removed.

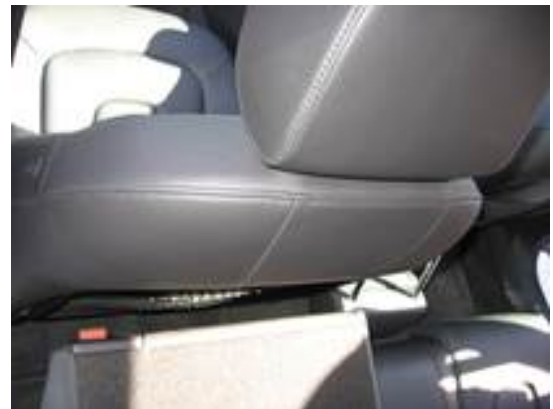
**Figure 5:** Front seat adjusted as far back as possible.
