# Technical Service Bulletin

## 94 Headlight lens has small crack

94 14 41 2037164/1 May 7, 2014.

Model(s)	Year	VIN Range	Vehicle-Specific Equipment
A3	2015 - 2016	All	Not Applicable

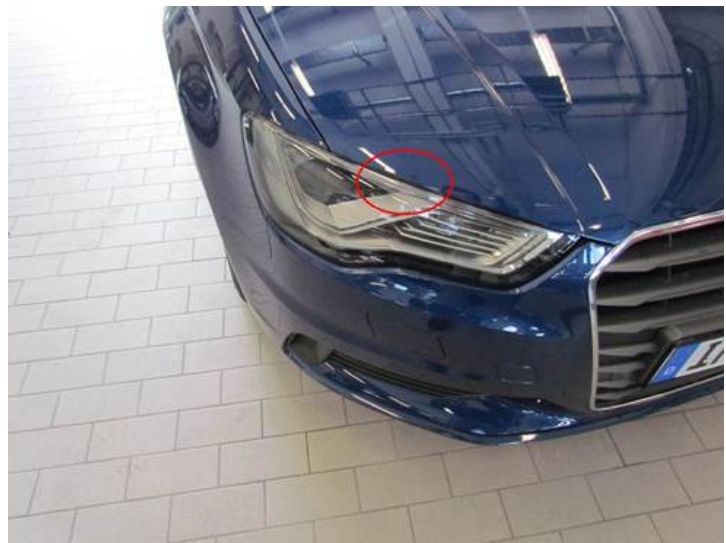
There are small crack lines in the top area of the headlight lens (the area covered by the lower edge of the hood) (Figure 1 and Figure 2).

*Figure 1. Top area of headlight lens.*

1. Feel the area with your fingernail to verify that the mark is below the surface of the plastic lens.
2. Ensure that the mark cannot be seen when the hood is closed.
3. Show the customer that the mark is underneath the surface of the plastic lens, and explain the *Technical Background* to the customer.

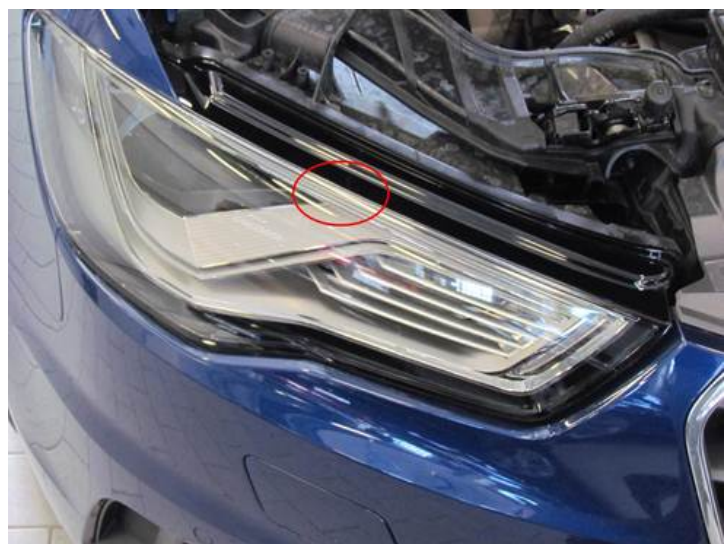
*Figure 2. Closer view of area.*

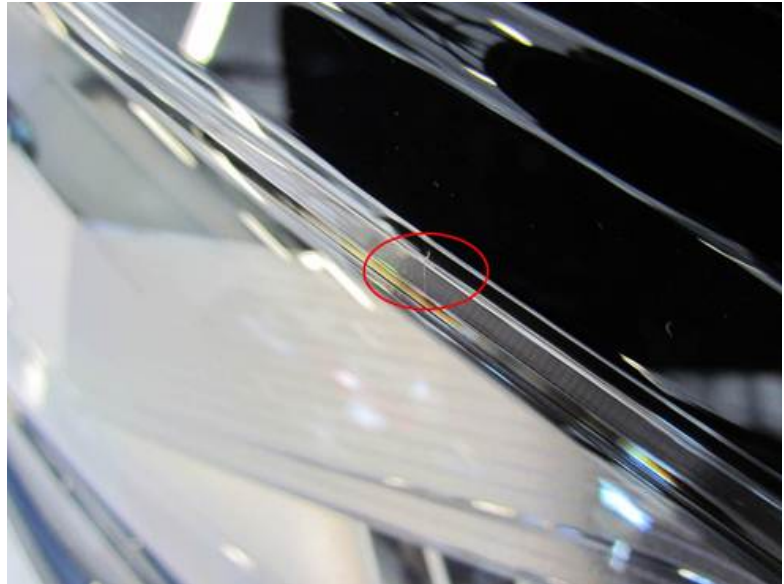
A separation mark (Figure 3) is created inside of the plastic when the lens is removed from the tool during manufacturing of the headlight. This separation mark is normal, and it is not a defect of the part.

**Figure 3.** Close-up view of separation mark.
