Technical Service Bulletin

26 Rattling noises from underneath vehicle

26 14 23 2037812/1 July 21, 2014.

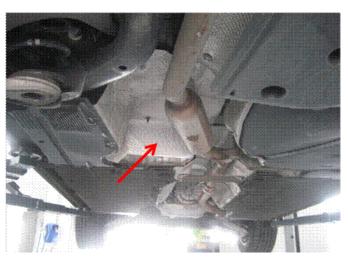
These noises may be a result of contact between an exhaust heat shield and the body of the vehicle.

Figure 1. Heat shield for center resonator.

1. Pull the lower portion of the heat shield for the center resonator (Figure 1) away from the body, just enough so that this area of the body can be cleaned.

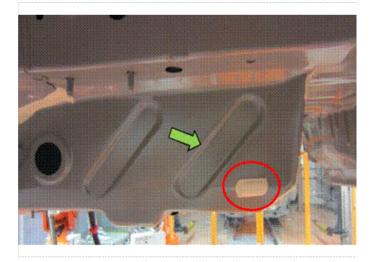
Figure 3. Specific location of PVC sealer application.

Using adhesive sealant D 511500A2 (with the VAG 1628 cartridge gun) apply a pad of the sealant 40mm x 40mm x 5mm thick (Figure 2 and Figure 3).

3. Move the heat shield back into position so that a bond is made between the heat shield and the body.
