Technical Service Bulletin

46 Brake noise analysis and handling

46 14 91 2034181/8 July 22, 2014. Supersedes Technical Service Bulletin Group 46 number 14-76 dated March 25, 2014 for reasons listed below.

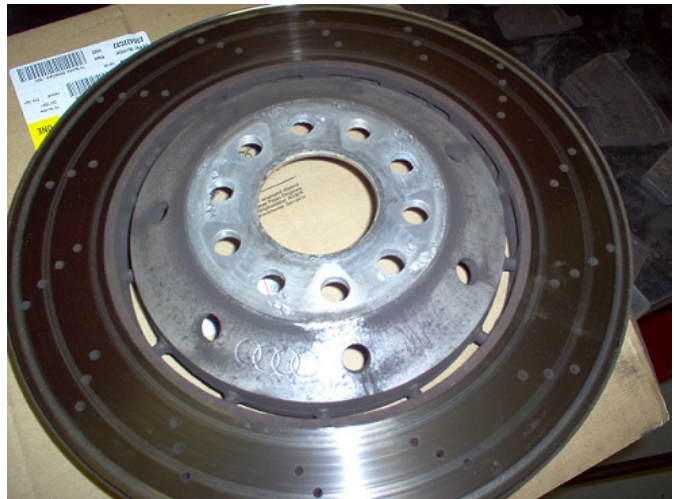
- Discs are grooved (Figure 2).

Figure 2. Grooved disc.

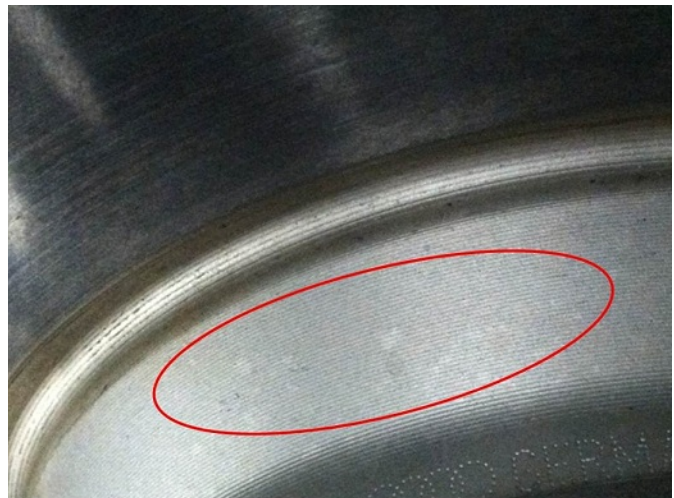
6. There is chemical contamination on the braking surface of the brake disc due to wheel or tire cleaner being sprayed directly onto the brake disc (Figure 3 and Figure 4).

Figure 4. Small spots and discoloration due to chemical contamination from cleaner that was sprayed directly onto the disc.

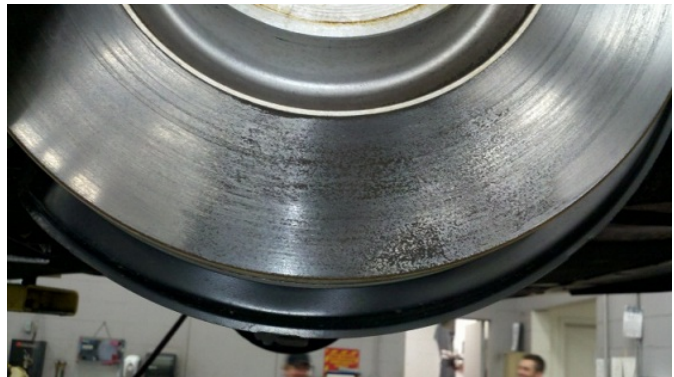
7. There are “ pad marks” on the brake disc as a result of brake pad material transferring to the discs (Figure 5). Pad marks can occur when a vehicle has been parked for long periods of time in a wet or snowy environment.

Figure 5. Brake pad material has transferred to the discs.
