Technical Bulletin

Model(s)	Year	Eng. Code	Trans. Code	VIN Range From	VIN Range To
Passat Sedan	2001-2010	All	All	All	All
Passat Wagon	2001-2010	All	All	All	All

50 14 01 November 24, 2014 2038981

Front Fender - Corrosion on Wheel Arch

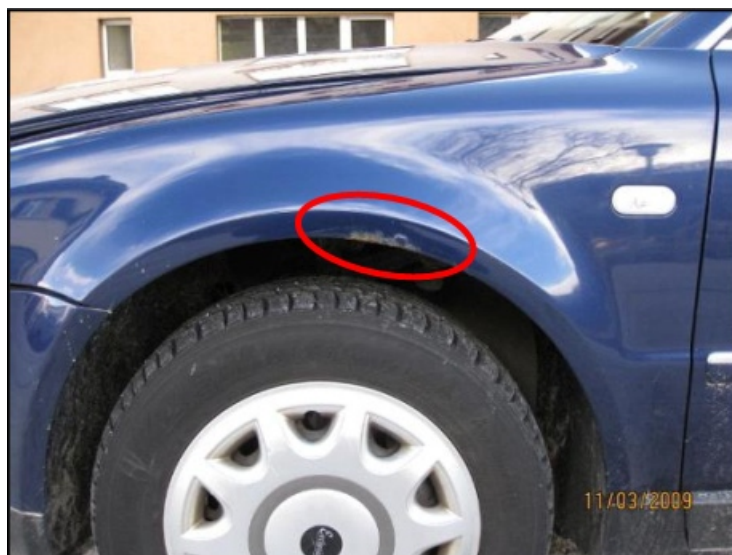
Figure 1 (corrosion on left wheel arch)

Corrosion on the wheel arch area of the front fender (Figure 1).

The wheel liner touches the arch area of the fender and rubs off the paint in the contact area.

The corrosion is caused by dirt accumulations and movements of the wheel liner.

1. Repair the fender: If the edge area is only slightly corroded (no through-corrosion/perforation), proceed as follows:

- Remove the front bumper according to the repair manual. See Repair Manual Group 63 in Elsa.
- Remove the side indicator (in fender, if equipped) according to the repair manual. See Repair Manual Group 94 in Elsa.
- Remove the front wheel liner according to the repair manual. See Repair Manual Group 66 in Elsa.
- Remove the corrosion with the pneumatic brush grinder VAS 6446.
- Apply a VOC compliant epoxy primer as an anti-corrosion treatment and primer (locally sourced).
- On the inner fender apply (in the complete contact/edge area) adhesive/sealer (part number: D 511 500 A2) as further edge protection (Figure 2, green line).
