# Product Service Bulletin

**MODEL:** C2

**SUBJECT:** SPEAKER GRILLE REPAIR

**BULLETIN:** 05R

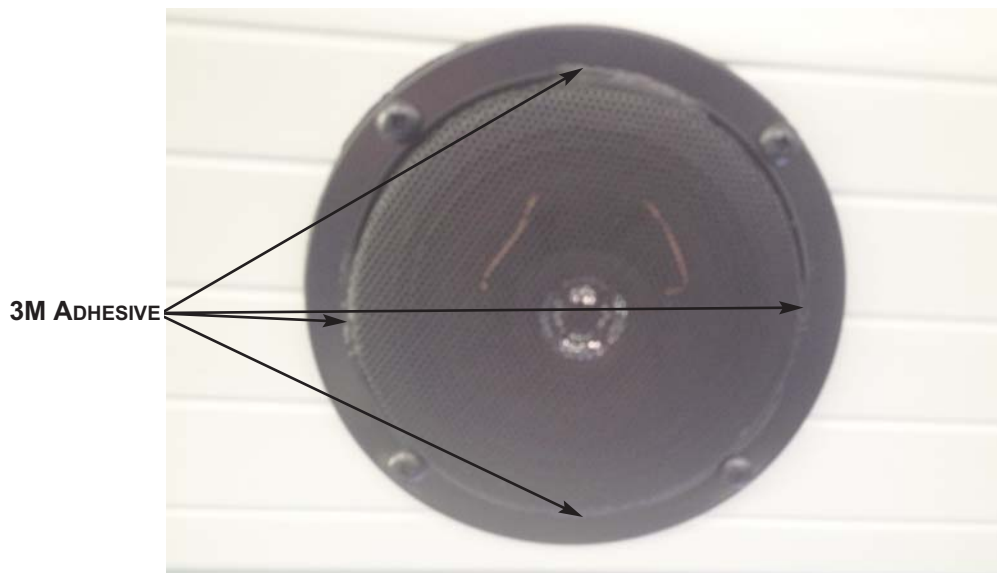
1. Chock wheels on bus and put into Park or Neutral.
2. Remove the Ground cable from Batteries.
3. Locate speakers that have grilles that are not staying fastened.
4. Place a small amount of the 3M weather stripping adhesive (approximately ½ inch long) in the areas of 12, 3, 6, and 9 o'clock as shown in picture below.

5. Once the adhesive is placed in the groove in the locations shown, gently push the grille into the groove until flush, all the way around the speaker.
6. Remove excess adhesive from around the outside of the grille.
7. Repeat the same process for each speaker in the bus that has same symptoms.
8. Connect ground cable back to negative side of battery.
9. Un-chock wheels.
