BTB 51970-52683 REV2 (1409)

## Recall: Driver's Airbag Inflator May Produce Excessive Pressure After Long-Term Exposure to High Absolute Humidity

Supersedes 14-029, dated September 12, 2014; to revise the information highlighted in yellow

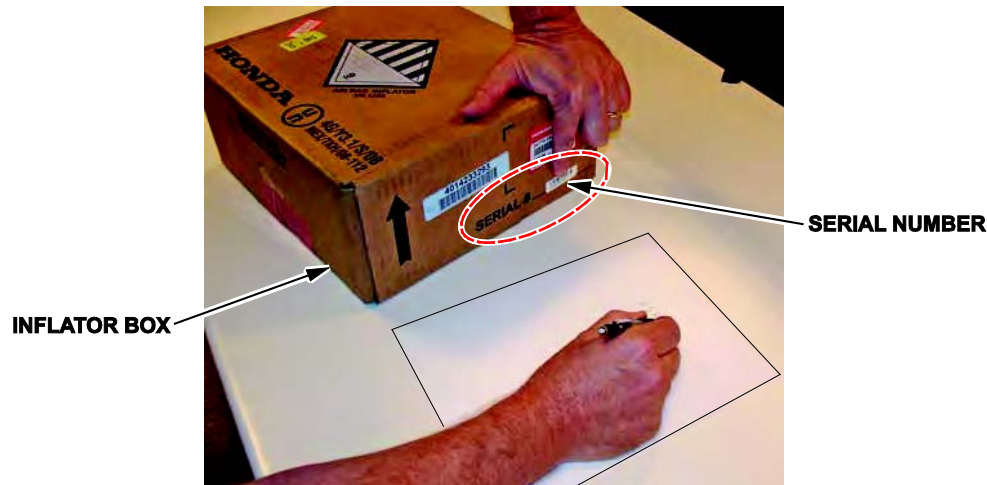
- Be careful not to damage any parts when replacing the inflator, and **follow the procedure exactly**.
  - If, before removing the airbag, you suspect that it may be the incorrect airbag for the vehicle or a counterfeit, **do not remove the airbag**. Contact your DPSM for assistance.
1. Remove the driver's airbag.
  2. Write down the serial number located on the right side of the new inflator's box. For the warranty claim to be paid, your warranty clerk must enter this serial number in the Diagnostic Trouble Codes field on the warranty claim.

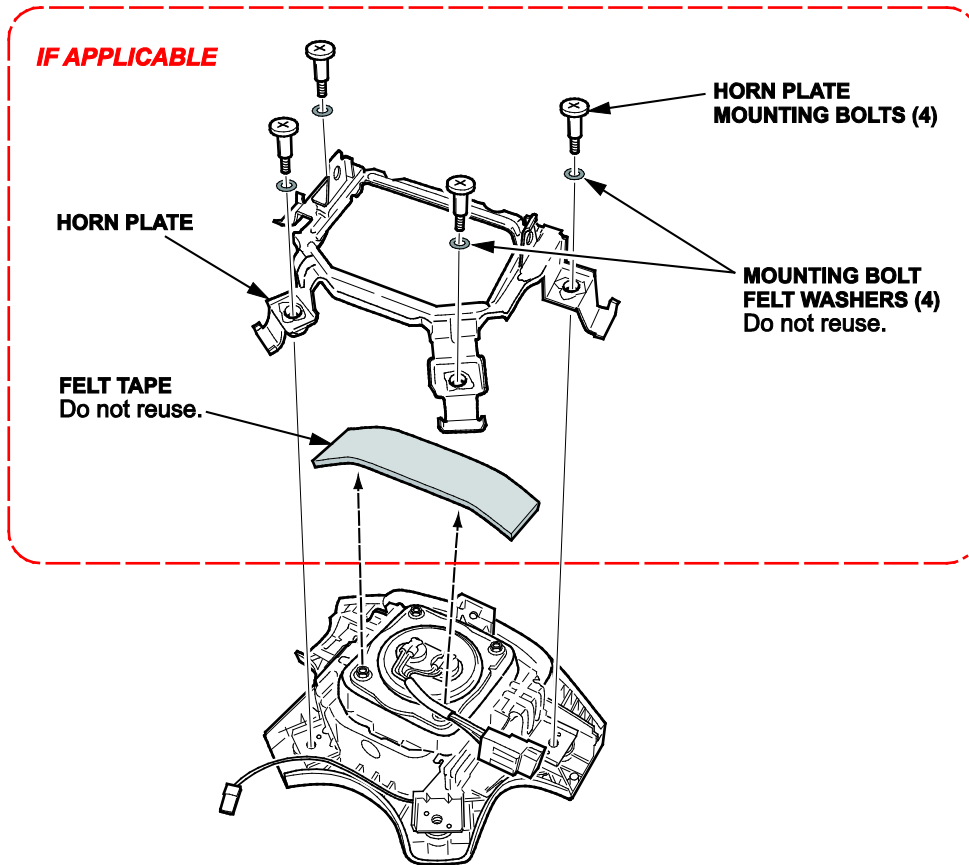
5. If there is no horn plate installed, go to step 7. If there is a horn plate installed, remove the four horn plate mounting bolts, the mounting bolt felt washers, the horn plate, and remove the felt tape covering the lower two inflator locknuts. The felt washers and felt tape will not be reused.

10. Cover the lower two inflator locknuts with new felt tape.

11. Reinstall the horn plate with new felt washers on its mounting bolts. Torque the mounting bolts to **3.4 N·m (2.5 lb-ft, 30 lb-in)**, then make sure the horn plate moves freely.

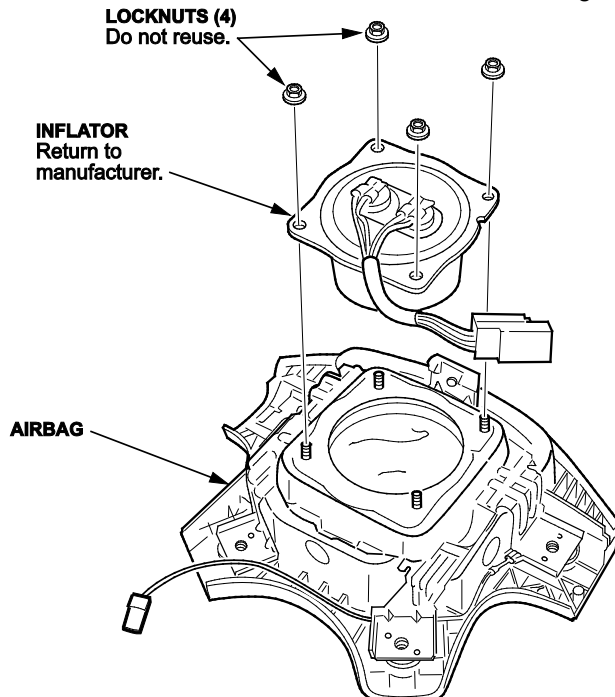
6. Using needle-nose vise grips **or a 3/8 in. 6-point socket**, remove the four locknuts from the inflator. The locknuts will not be reused.

NOTE: Do not remove the inflator from the airbag until you complete step 7.
