# Technical Bulletin

40 14 01 March 04, 2014 2033347 Supersedes V401301 dated March 20, 2013 to include additional model year applicability.

### CV Boot Replacement

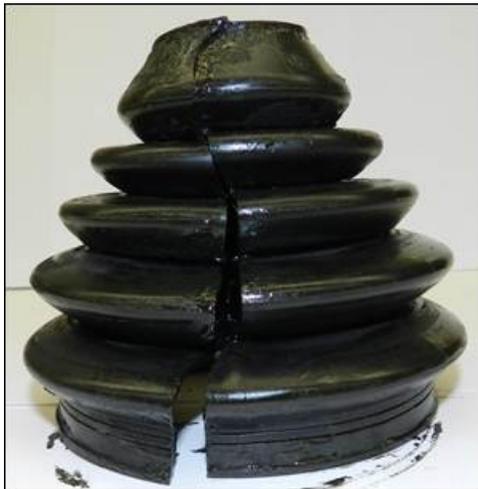
**CV Boots should not be cut or sliced upon removal.**

If it is determined that a CV boot needs to be replaced, the boot should be removed and replaced without cutting or slicing the boot open. Once the CV Joint is removed the boot will slide off the axle shaft. Refer to repair manual group 40, removal procedure for drive axle disassembly, in ElsaWeb.

Claims will not be accepted if the CV Boot is cut or sliced.

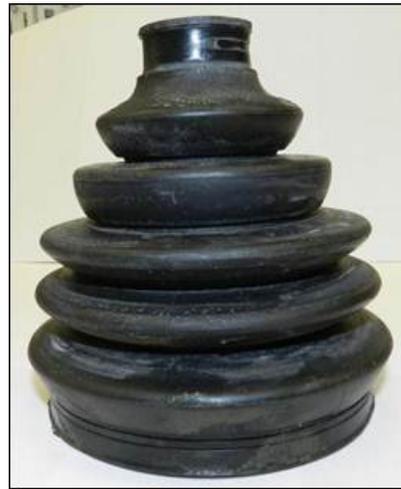
**CV Boots should slide off the driveshaft after the removal of the CV Joint.**
