# Technical Bulletin

23 14 03 March 20, 2014 2036656 Supersedes Technical Bulletin V231402 dated March 7, 2014 to include additional instruction.

**MIL ON, No Start, or Rough Running with DTCs P0087, P0088 or P0191 Stored in ECM Fault Memory (TDI ONLY)**

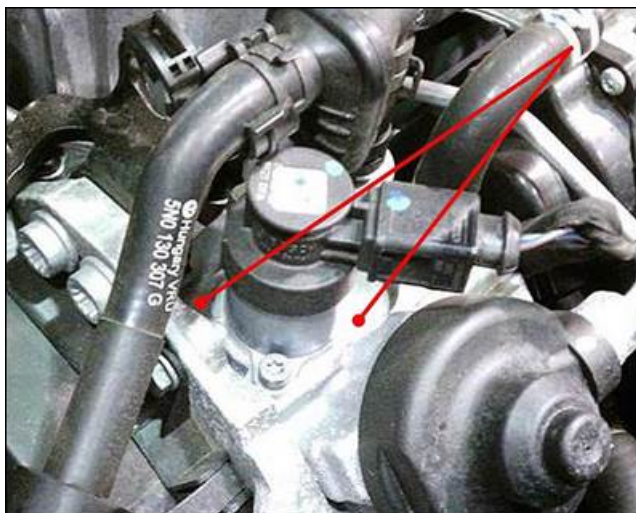
Figure 1. Surrounding Area

Prior to removing the N290 Fuel Metering Valve, the area surrounding the valve (Figure 1) must be clean and dried with compressed air to remove ALL debris from the area. See Repair Manual Group 20 Fuel Supply, General Information, Clean Working Conditions in Elsa.

If debris enters the fuel system, components may be damaged.

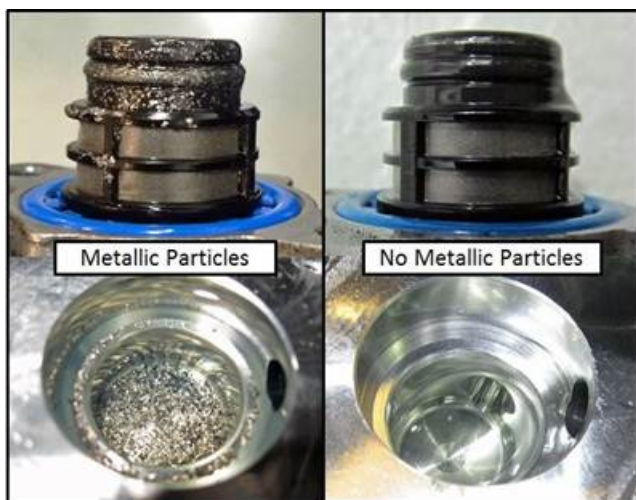
Figure 2. N290 Fuel Metering Valve and Valve Bore

1. Remove the N290 Fuel Metering Valve and inspect the valve and valve bore for the presence of metallic particles (see Figure 2).

2. If metallic particles are found on the N290 Fuel Metering Valve or in the valve bore, proceed to step 5.

If no metallic particles are found on the N290 Fuel Metering Valve or in the valve bore, do not replace the high pressure fuel pump. Reinstall the valve and continue with the diagnosis.

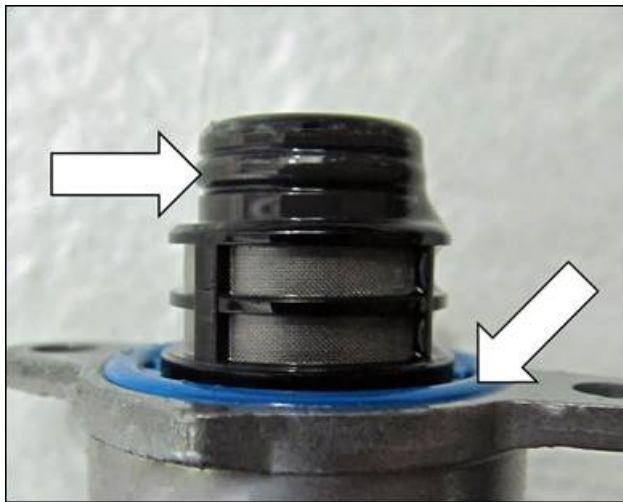
**Figure 3.** N290 Fuel Metering Valve O-rings

Prior to reinstallation of the N290 Fuel Metering Valve, ensure that both O-rings are not damaged. If they are damaged, the high pressure fuel pump must be replaced.

To prevent damaging the O-rings when reinstalling the N290 Fuel Metering Valve, lubricate the O-rings with diesel fuel (**see Figure 3**).

3. Install the N290 Fuel Metering Valve into the valve bore using light pressure.

4. Install and hand tighten both M5 fasteners, ensuring that the threads are clean and dry.

**Pre-tighten to 2 Nm, then to 6.5 – 7 Nm.**

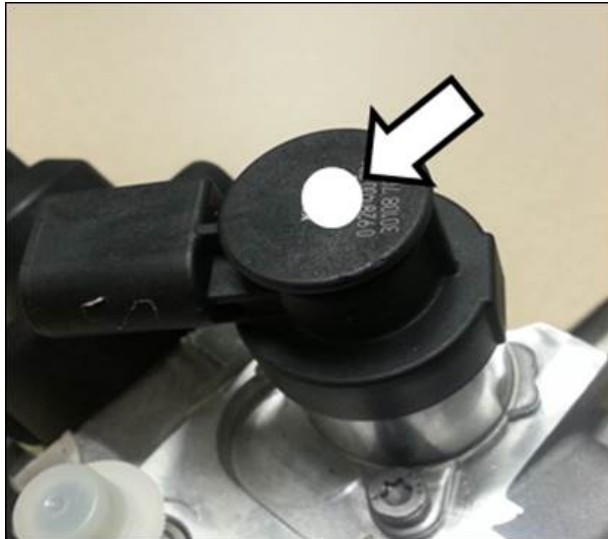
**Figure 4.** White dot on N290 Fuel Metering Valve

Using a paint marker or equivalent, mark the top of the N290 Fuel Metering Valve with a white dot as shown in figure 4.

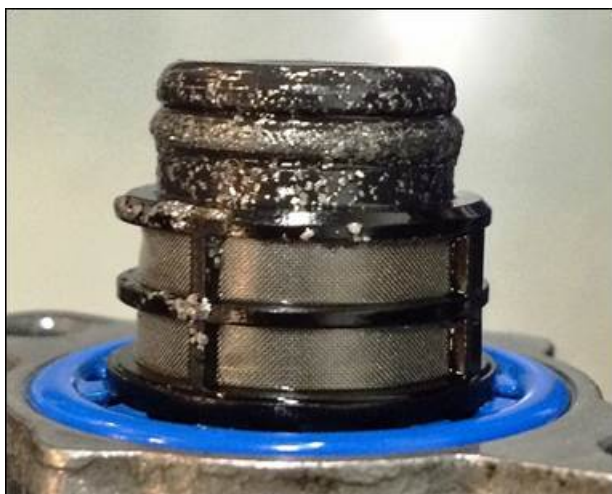
**Figure 5.** N290 Fuel Metering Valve with Metal Particles

5. If metallic particles are found on the N290 Fuel Metering Valve or in the valve bore, open a VTA ticket and contact the Volkswagen Technician Helpline before continuing with the repair. **Clear pictures showing the metallic particles in the N290 Fuel Metering Valve and bore, as well as the GFF diagnostic log are required to continue with diagnosis and/or release of the High Pressure Fuel Pump.** Reference the pictures below for examples. (see Figures 5 & 6).

Prior to calling the Technician Helpline, have the pictures and the GFF log attached to the VTA ticket. This will help to ensure a timely repair.
