Technical Bulletin

Model	Year	Eng. Code	Trans. Code	VIN Range From	VIN Range To
Passat	2012-2014	2.0L TDI (CKRA)	ALL	ALL	ALL

21 14 01 March 13, 2014 2036110

Engine Lacks Performance, Shaft of Turbine Fan of Turbo Charger Broken or Seized

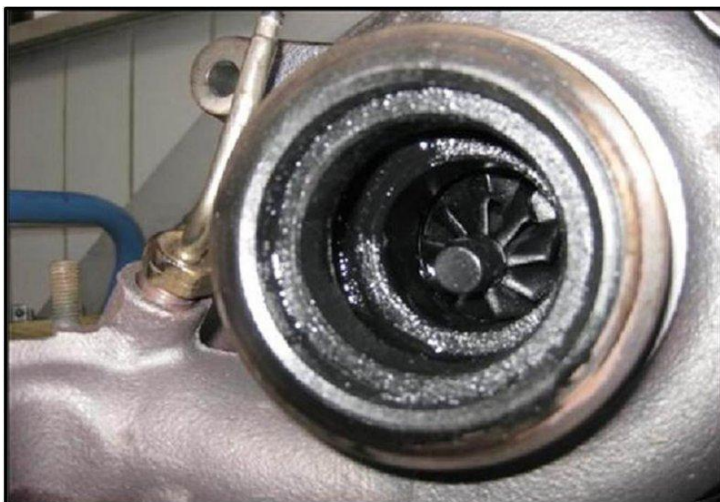
To confirm a broken shaft on the turbocharger the diesel particulate filter (DPF) must be detached on the turbocharger. This is the only way to check the turbocharger for damage and engine oil ingress on the exhaust side (figure 1).

Figure 1 (broken turbocharger shaft, engine oil ingress on exhaust side)

If no damage is found this technical bulletin does not apply.

- If turbocharger is found to be damaged, the DPF must be reattached at the turbocharger before proceeding to the following steps:

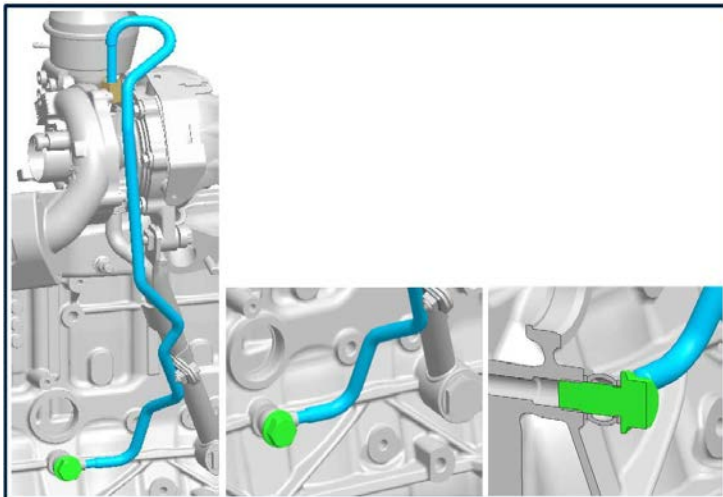
Figure 2

- Replace the oil filter according to the repair manual and thoroughly clean the inside of the oil filter housing.
- Drain the engine oil according to the repair manual.
- Unscrew the banjo bolt for the oil supply pipe on the cylinder block. Replace the banjo bolt with the hex head bolt with part number WHT 005 747 (figure 2, in green) and tighten it according to the repair manual to block oil supply to the damaged turbocharger.

Flush out the oil circuit while the faulty turbocharger/particulate filter is installed and the intake hose removed from the turbocharger.

- Fill up the engine oil according to the manufacturer guidelines.
- Run the engine at idle speed for about 15-20 minutes.
- Replace the oil filter according to the repair manual and thoroughly clean the inside of the oil filter housing.
- Replace the oil filter housing cap (03L 115 433).
- Drain the engine oil according to the repair manual.
