Tech Tips

TT 20-09-06

2000-2014 Vehicles with 1.9 or 2.0 TDI Engine - N75 Solenoid Valve Diagnosis

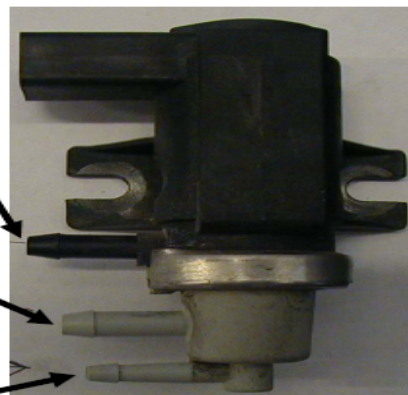
TDI N75 Testing

Top line of N75 Valve goes to the air cleaner assembly and should **NOT** hold vacuum with KOEO

Middle line of N75 Valve goes to the turbocharger assembly and should **NOT** hold vacuum with KOEO

Bottom line of N75 Valve goes to the vacuum pump assembly and **should** hold vacuum with KOEO

Use the diagram below to test the N75 Solenoid Valve in the event of a turbocharger fault code such as P0299 or P0234. This applies to Mechanical Injection Style Diesel Engines, Pumpe Duse Style Diesel Engines and the new Common Rail Style Diesel Engines.
