Technical Service Bulletin

87 A/C compressor replacement

87 14 58 2035582/2 October 17, 2014. Supersedes Technical Service Bulletin Group 87 number 13-46 dated October 21, 2013 for reasons listed below.

Audi

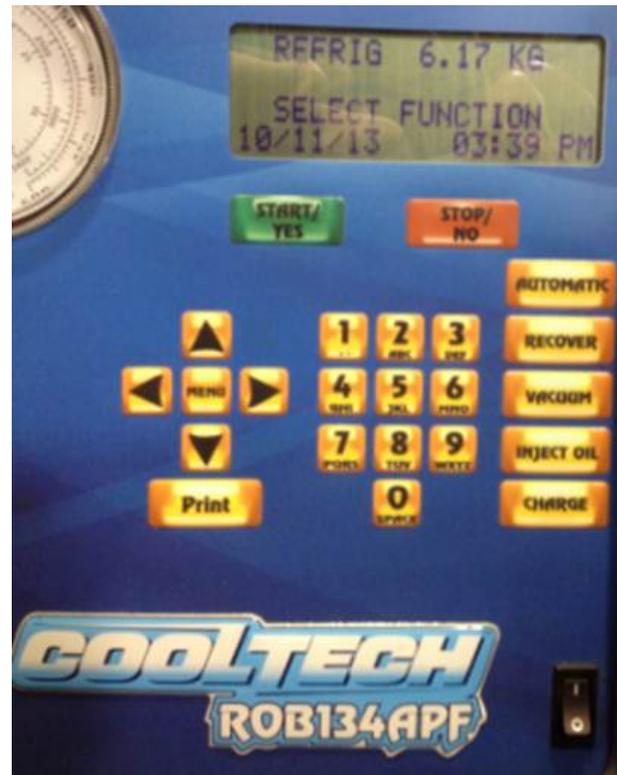
Figure 1. Date and time screen.

1. Ensure that the A/C service unit shows the correct date and time (Figure 1). If the date and time are incorrect, use the menu to program the correct date and time before proceeding.

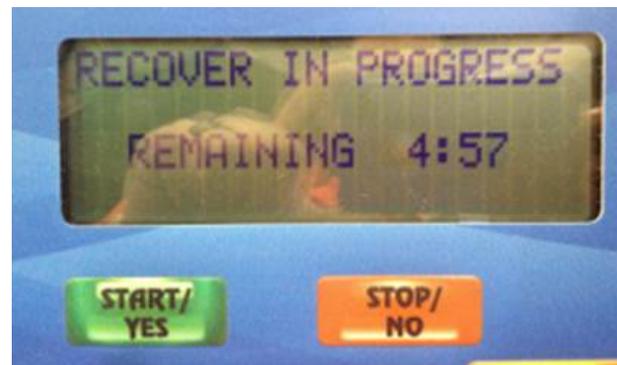
Figure 2. System recover in progress.

2. Connect the A/C service unit to the vehicle.
3. Perform a recovery of the system (Figure 2).

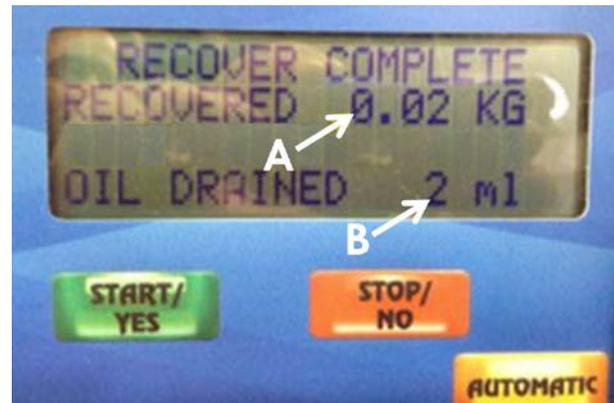
Figure 3. Amount of refrigerant recovered (A), and amount of oil drained (B).

- Record values for **RECOVERED** and **OIL DRAINED** (Figure 3) on the repair order.

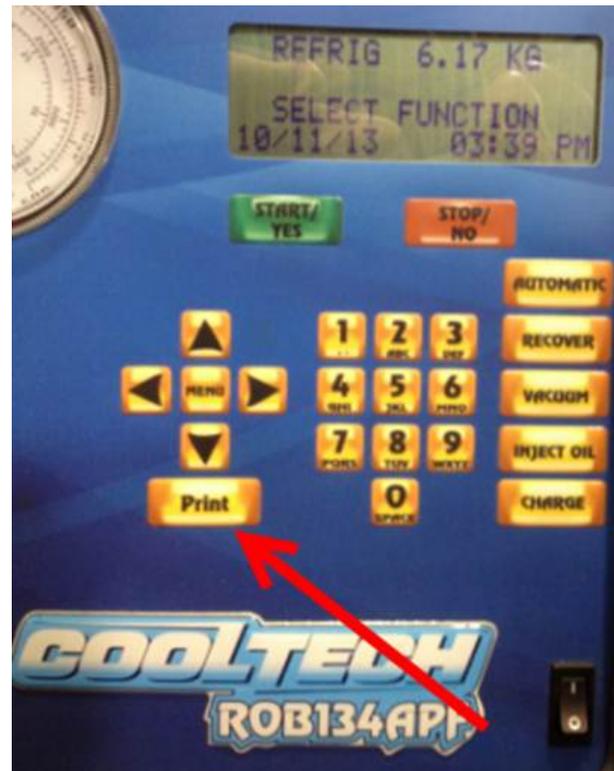
Figure 4. Location of the Print button.

- Immediately after recovery, select the **Print** button (Figure 4).

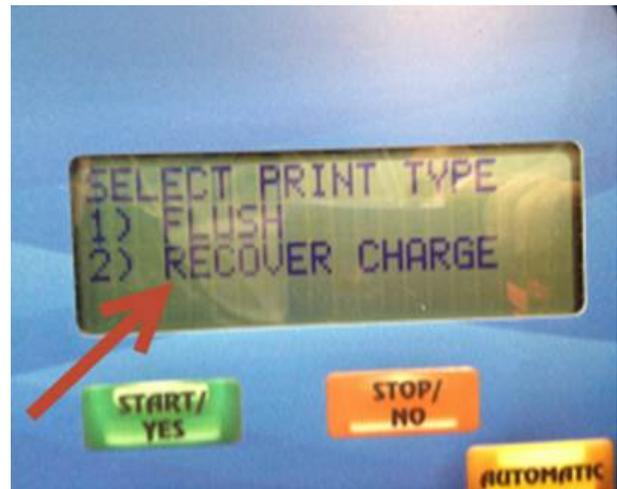
Figure 5. Selecting a print type.

6. When the SELECT PRINT TYPE screen opens, use the keypad to select **2) RECOVER CHARGE** (Figure 5).

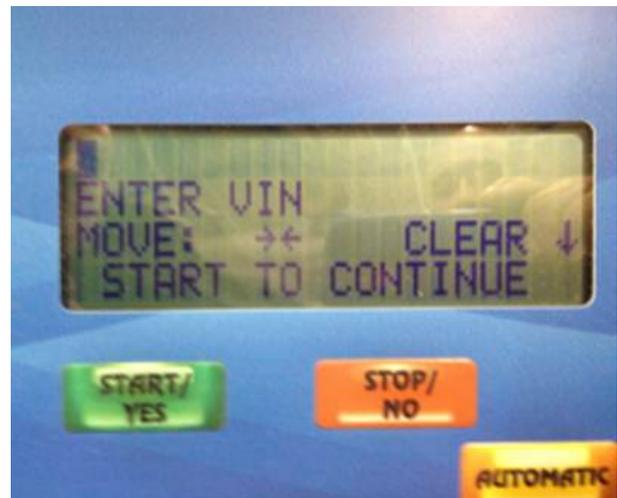
Figure 6. Enter VIN screen.

7. On the next screen, use the keypad enter the last 8 digits of the VIN then press the **START/YES** key (Figure 6).

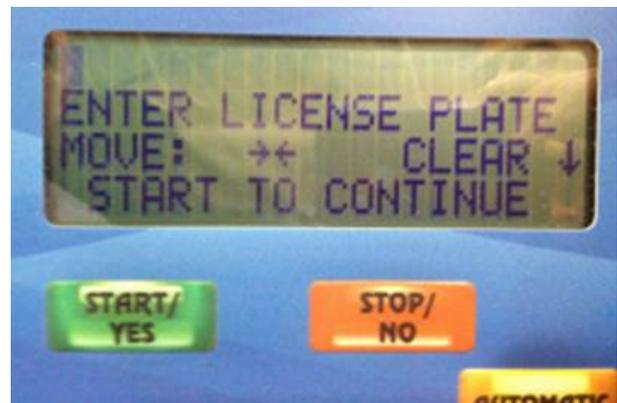
Figure 7. Enter license plate screen.

8. The next screen will request the license plate (Figure 7). Entering the license plate is not necessary. Press the **START/YES** key to continue.

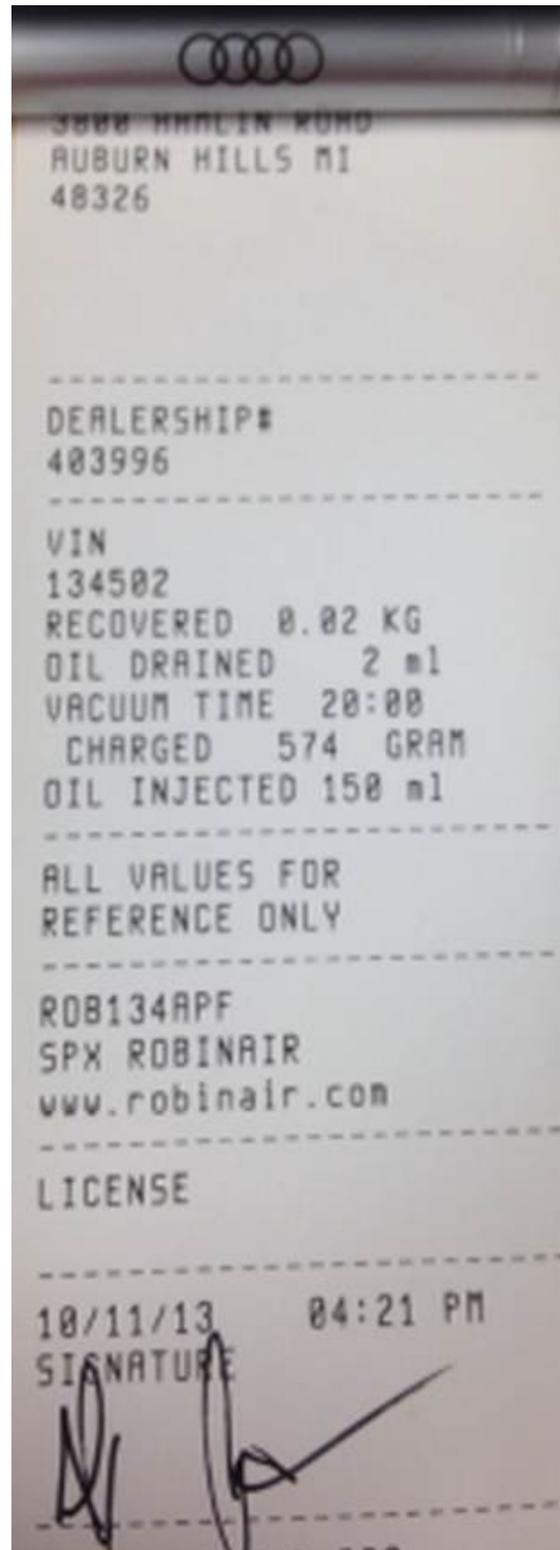
Figure 8. Printed report.

9. The A/C service unit will create a printed report (Figure 8).
Send the printed report with the defective A/C compressor.
Package the defective compressor in empty packaging from the replacement compressor.
