# Technical Service Bulletin

## 19 Dried coolant or small leak around coolant pump

19 14 53 2039018/1 November 18, 2014.

Model(s)	Year	VIN Range	Vehicle-Specific Equipment
All	2010 - 2014	All	V6 engine

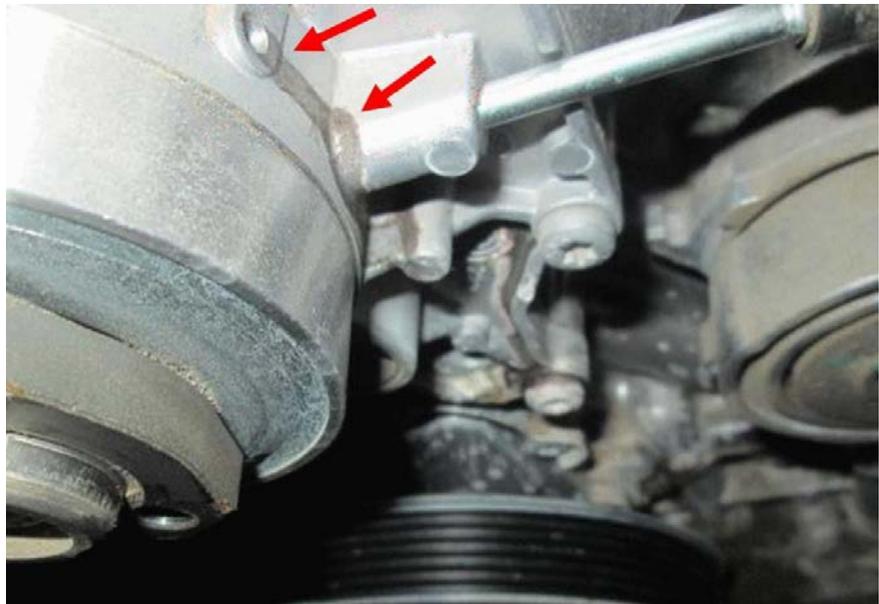
- A small amount of dry or crusted coolant is seen on the coolant pump housing (Figure 1, Figure 2, and Figure 3).
- The coolant level warning is not on.

*Figure 1. Dried coolant.*

A minor coolant leak is possible during the break-in phase of the coolant seal on the coolant pump. The dry coolant marks are normal.

If dried coolant is found on the coolant pump housing and there is no customer complaint, no repair is necessary. Replacement of the coolant pump is not necessary; a new coolant pump would also show dried coolant during break-in.

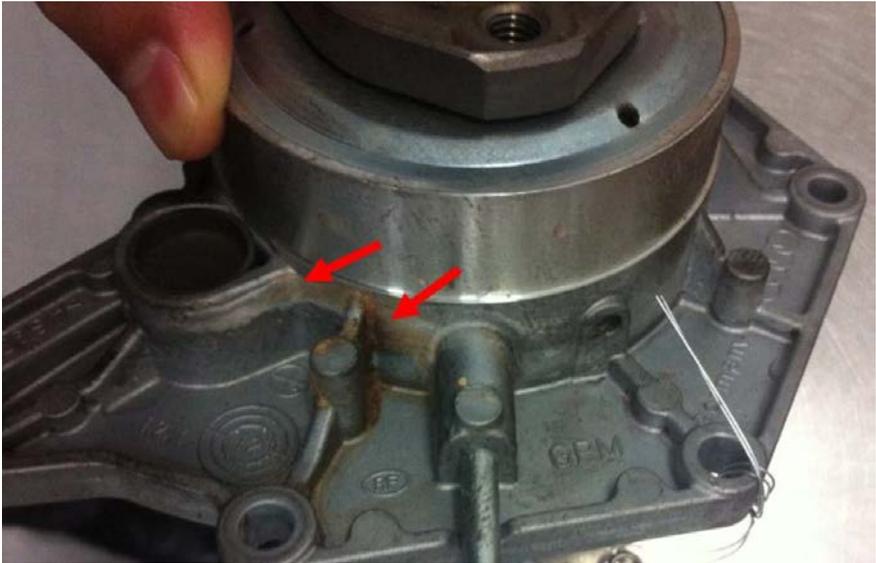
*Figure 2. Dried coolant.*

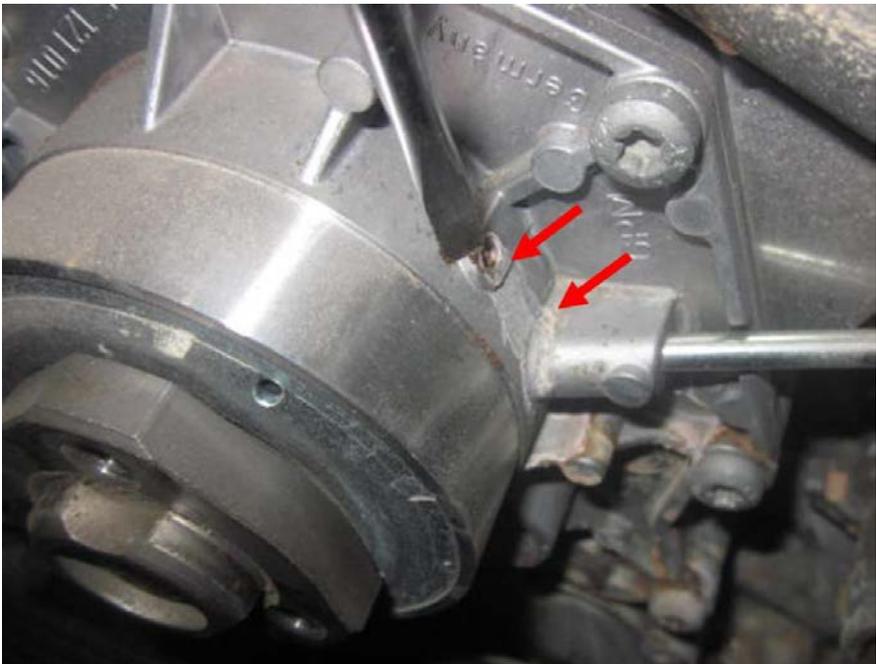
*Figure 3. Dried coolant.*
