# Technical Service Bulletin

## 46 Brake noise analysis and handling

46 14 68 2034181/6 February 3, 2014. Supersedes Technical Service Bulletin Group 46 number 14-67 dated January 21, 2014 for reasons listed below.

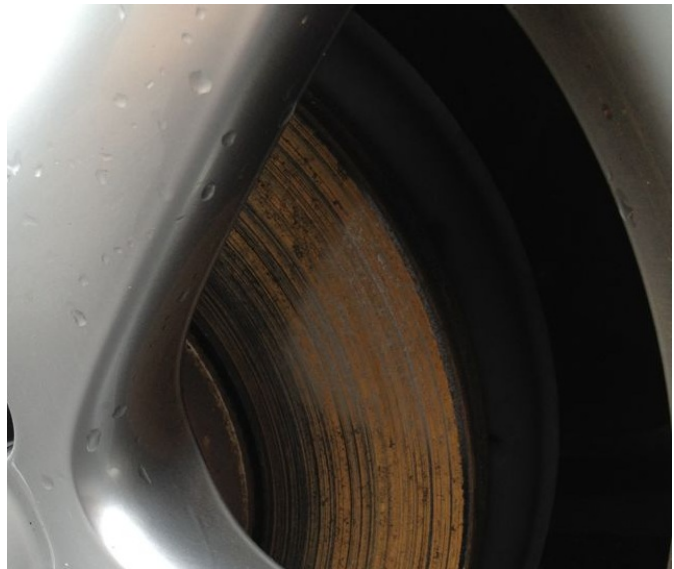
- Discs are covered with rust. Rust can form when the vehicle has not been driven for a long period of time (Figure 1).

**Figure 1.** Disc covered with rust.

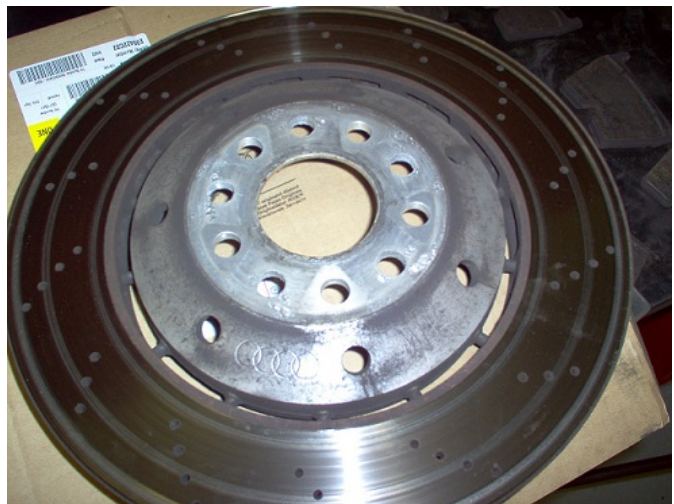
- Discs are grooved (Figure 2).

**Figure 2.** Grooved disc.

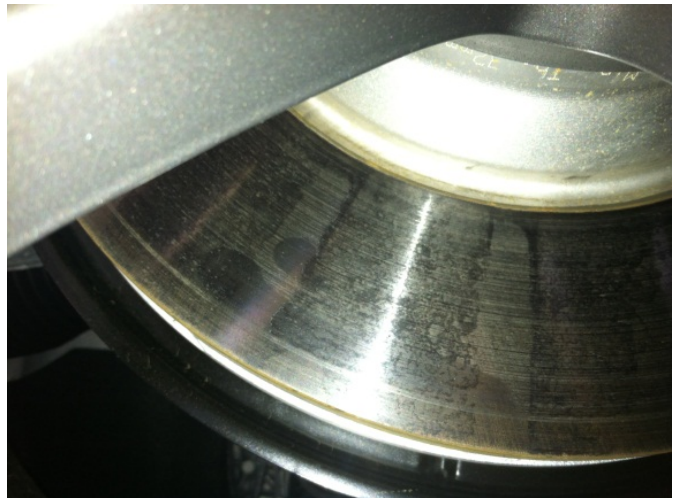
6. There is chemical contamination on the braking surface of the brake disc due to wheel or tire cleaner being sprayed directly onto the brake disc (Figure 3 and Figure 4).

**Figure 3.** Discoloration on the brake disc due to chemical contamination from cleaner that was sprayed directly onto the disc.

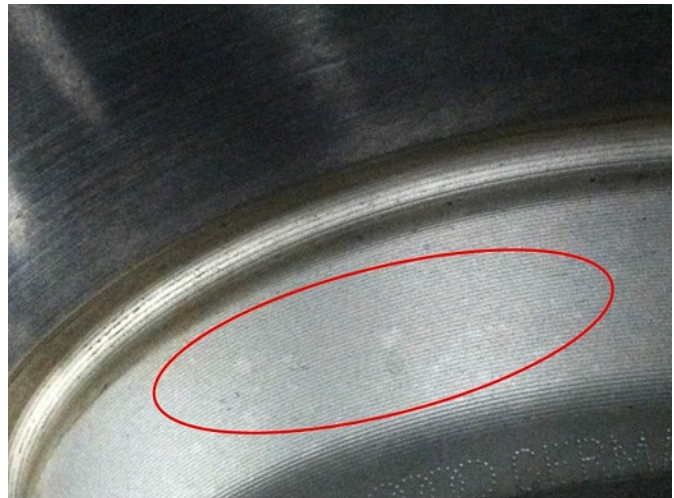
**Figure 4.** Small spots and discoloration due to chemical contamination from cleaner that was sprayed directly onto the disc.

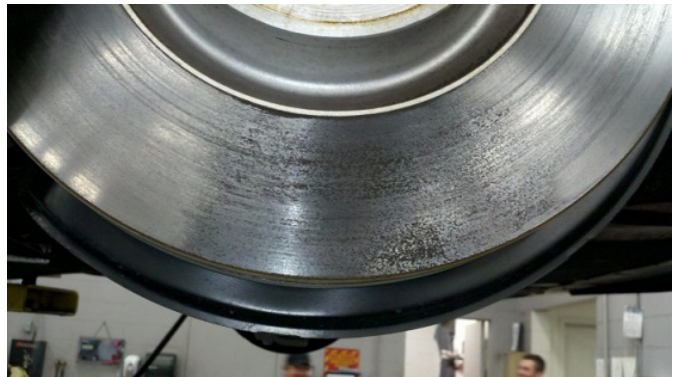
7. There are “pad marks” on the brake disc as a result of brake pad material transferring to the discs (Figure 5). Pad marks can occur when a vehicle has been parked for long periods of time in a wet or snowy environment.

**Figure 5.** Brake pad material has transferred to the discs.
