Technical Service Bulletin

74 Front seat backrest cover damaged

74 14 18 2036572/1 February 26, 2014.

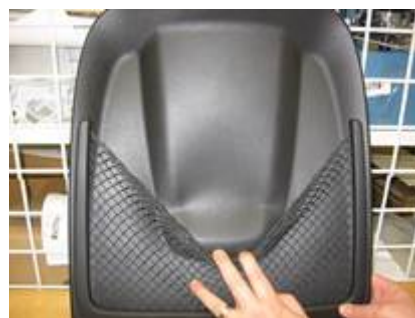
- The panel on the back of the front seat is warped or dented (Figure 1).
- The headrest on the rear seatback may also be damaged.

Figure 1. Damaged front seatback panel.

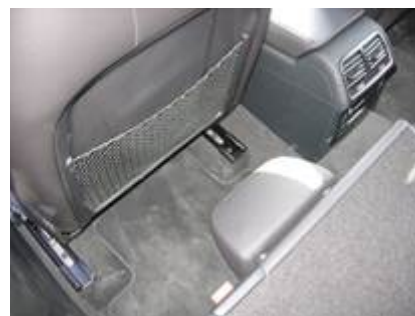
The damage is caused when the headrest of the rear seat backrest comes in contact with the back of the front seat.

This occurs when the rear seat is folded down with the headrests installed (Figure 2), and the front seat is moved back far enough to make contact with the rear seat headrest (Figure 3).

Figure 2: Folded-down rear seat backrest with headrest installed.

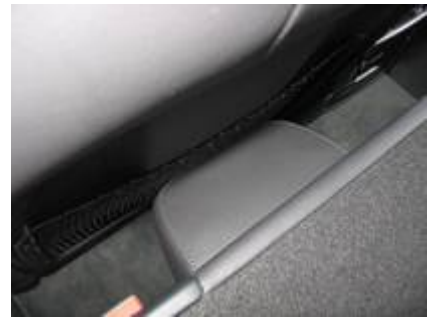
Figure 3: Front seat moved back far enough to make contact with rear seat headrest.

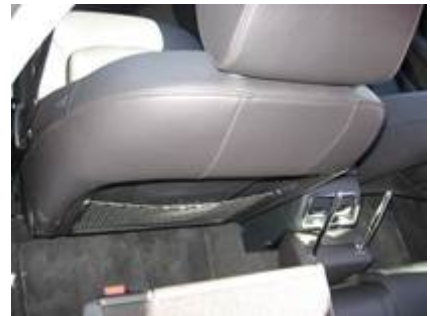
Figure 4: Rear seat backrest folded down with headrest removed.

- When the rear seat seatbacks are folded down, the rear seat headrests must be removed to accommodate the front seats (Figure 4).
- With the rear seat headrests removed, there is adequate clearance to accommodate the front seats even if they are adjusted as far back as possible (Figure 5).
- When the rear seats are folded back up and locked, the headrests must be reinstalled. The procedure for removal and reinstallation of the rear seat back headrests can be found in the Owner's Manual.

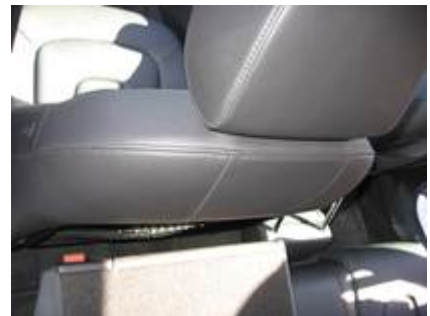
Figure 5: Front seat adjusted as far back as possible.
