General Information

DEF Return-Line Fitting Heater Installation

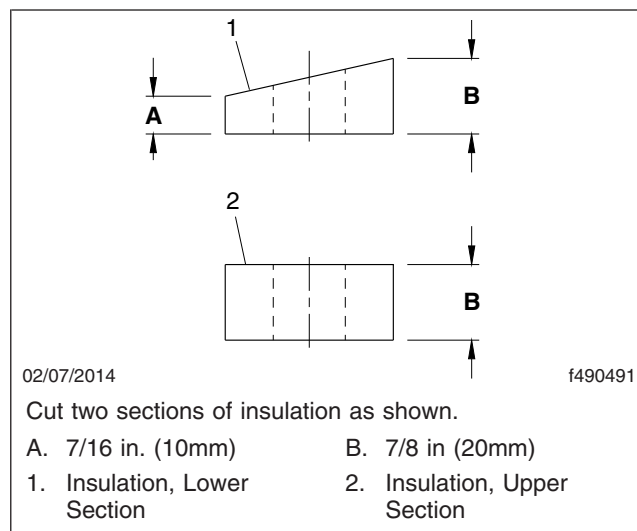
Fig. 1, Cutting the Insulation

1. Park the vehicle on a level surface, shut down the engine, and set the parking brake. Chock the tires.
2. Remove the DEF tank cover if equipped.
3. Disconnect the DEF return line at the tank fitting closer to the filler neck.
4. Clean the surface of the fitting with hot water to allow the adhesive on the heater to stick to it.
5. Cut two pieces of insulation as shown in [Fig. 1](#).

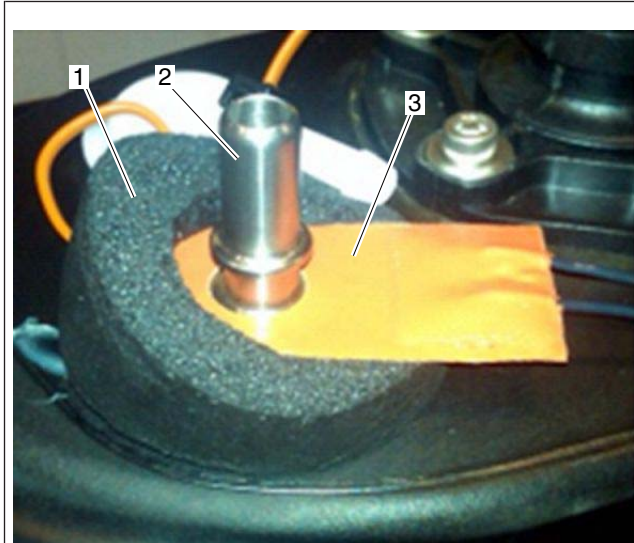
Fig. 2, Installing the Heater

1. Lower Insulation
2. DEF Fitting
3. DEF Return-Line Fitting Heater

6. Cut a section of reflective sleeve material 10 in. (250mm) long, and split it lengthwise.
7. Install the lower piece of the insulation with the short edge of the angle-cut side facing the DEF line. See [Fig. 2](#).
8. Peel the tape off of the the return-line fitting heater then put it over the fitting and press it to stick on the DEF fitting. See [Fig. 2](#).
9. Install the upper half of the insulation.
10. Connect the DEF return line.
11. Position the reflective sleeve over the fitting and insulation, then secure it with zip ties as needed. See [Fig. 4](#).
12. Locate the DEF heater pigtail connector above the DEF module that matches the connector on the heater pigtail (there is only one). See [Fig. 5](#).

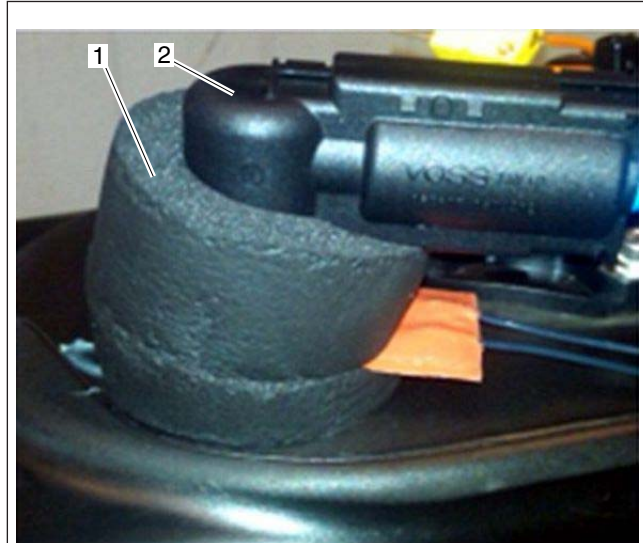
Fig. 3, Installing the Upper Half of the Insulation

1. Upper Insulation
2. DEF Return Line

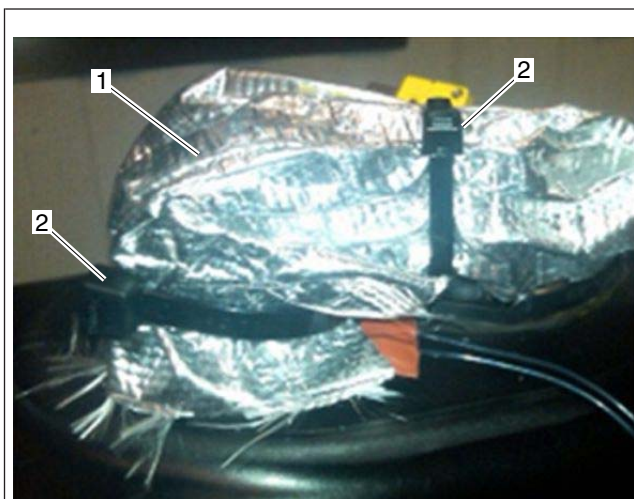
Fig. 4, Installing the Reflective Sleeve

1. Reflective Sleeve
2. Zip Tie

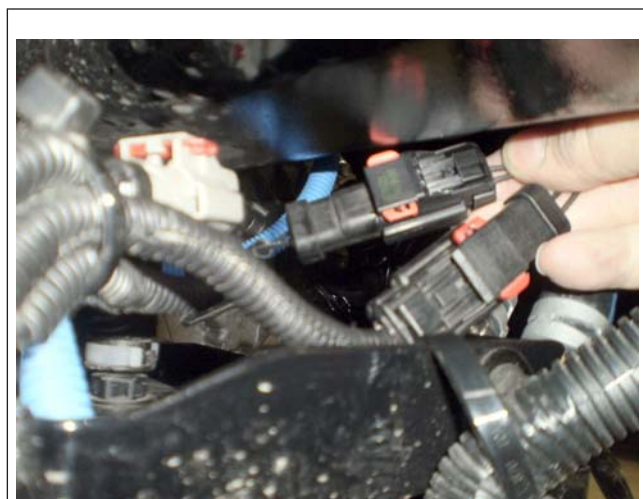
Fig. 5, Heater Connectors

13. Disconnect the DEF heater pigtail connector at the wire harness.
14. Connect the DEF return line heater connector in series between the original DEF heater pigtail connector and the harness. Secure the wires with zip ties as needed.
15. Install the DEF tank cover if equipped.
