**No.: 14 TS-4**  
February 28, 2014

SUBJECT: **Valve and Liner Installation Tool Issue**

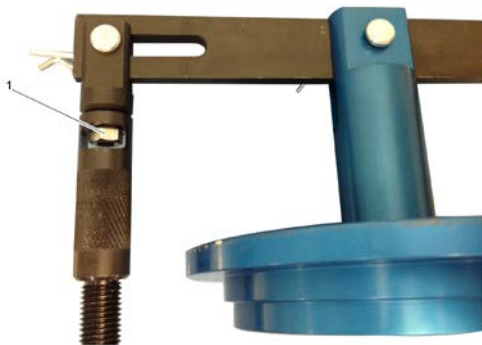
d580153

Valve and liner installation tool part numbers J-47406 and J-47407 have lock nuts on the swivel lever retainers that could loosen unexpectedly. This can potentially cause injury if the nut (1) falls off the threads during use.

Prevent this issue by adding a thread-locking compound (Loctite or equivalent) to the nut threads before the next use. Use care not to tighten the nut to prevent the swivel from rotating during repairs.
