Carpet Pulls Out From Under the Door Sill Trim

(Supersedes 09-072, dated September 18, 2009, to revise the information marked by the black bars)

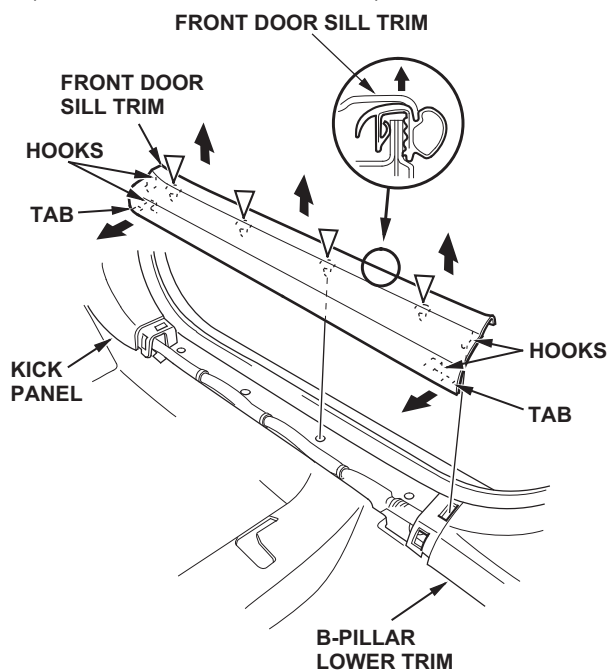
1. Remove the passenger's side door sill trim. (4-door shown, 2-door similar)

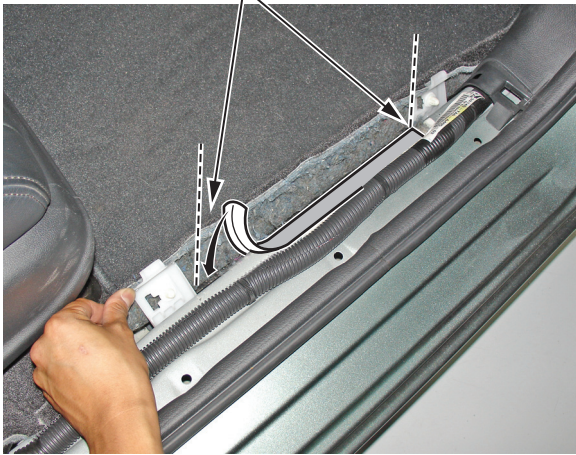
2. Unfasten the rear carpet clip from the body.
3. Cut a 270 mm (10.5 inches) strip of 3M double-sided tape, and apply it to the body starting at the front carpet clip and along the edge of the wire harness.

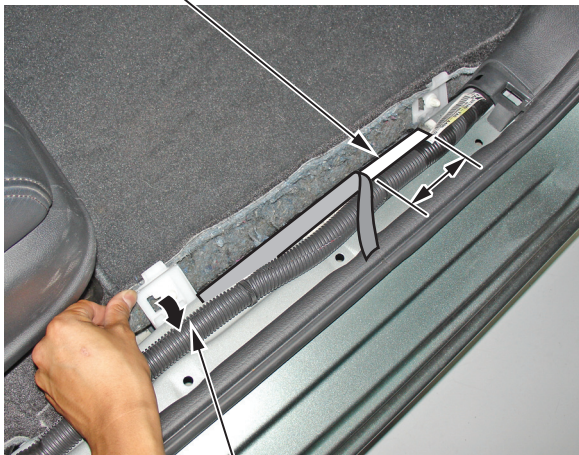
4. Peel back about 50mm (2 inches) of the tape backing starting at the front carpet clip.

① Peel back 50 mm of the tape backing.

② Refasten the rear carpet clip.

5. Fasten the rear carpet clip back into place, and finish removing the rest of the tape backing.

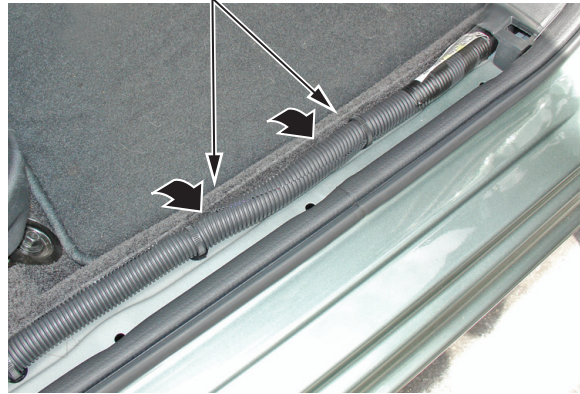
6. Pull the carpet tight, as far past the edge of the tape as possible. Then press the carpet down, along its entire length, to make firm contact with the tape.

Pull the carpet past the tape and press down.

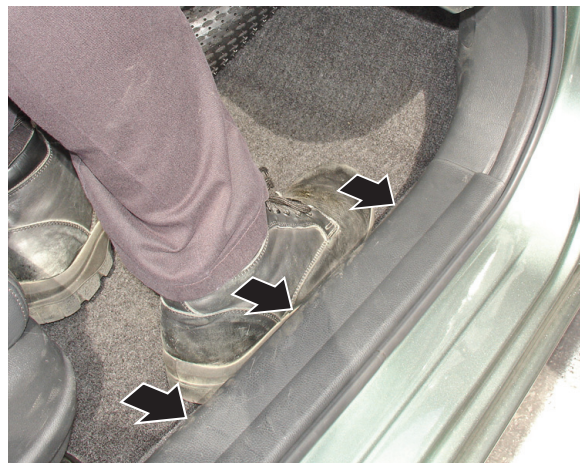
7. Reinstall the passenger's side carpet trim.
8. Allow the repair to set for an hour before testing.
9. Test the repair by sitting in the passenger's seat and pushing down on the side wall of the carpet with your foot.
