ATB 51252 (1405)

Driver's Power Seat And Seat Memory Settings Do Not Work Properly

AFFECTED VEHICLES

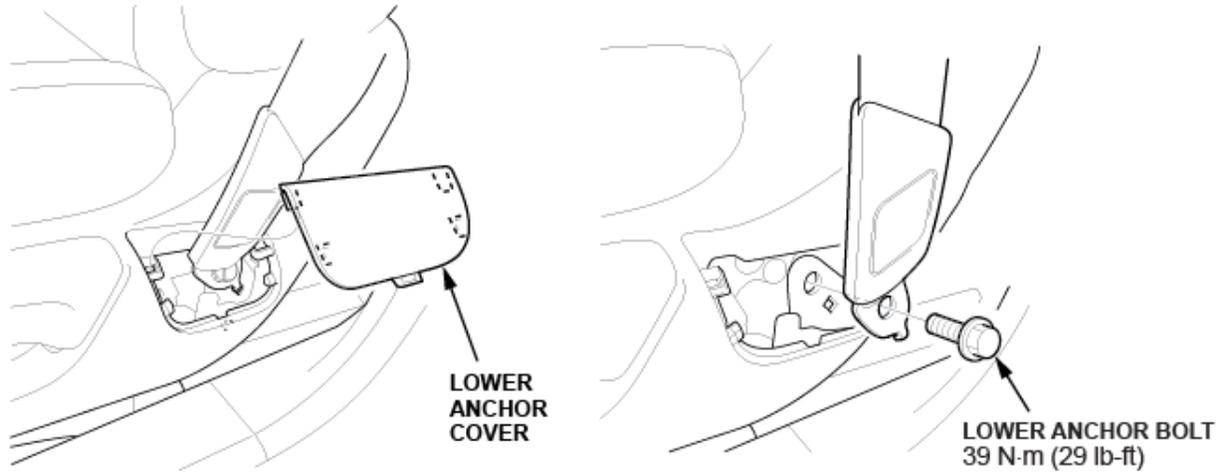
1. Remove the driver's seat belt lower anchor bolt.

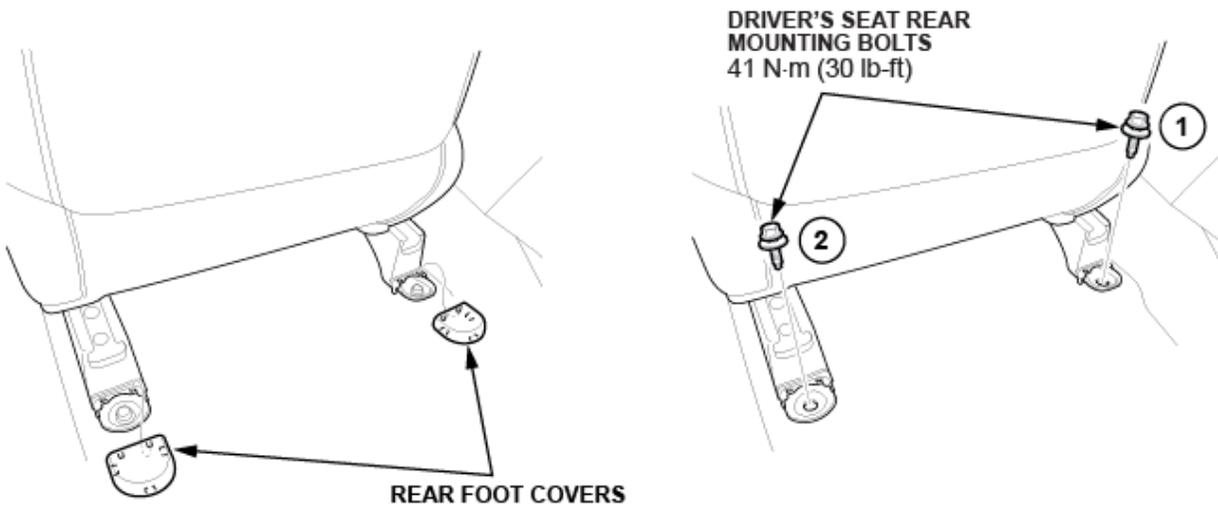
2. Remove the driver's seat rear foot covers and rear mounting bolts.

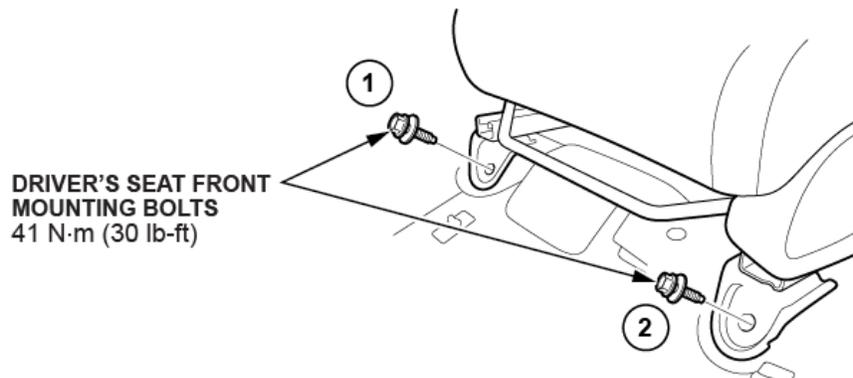
3. Move the driver's seat all the way back.
4. Remove the driver's seat front mounting bolts.

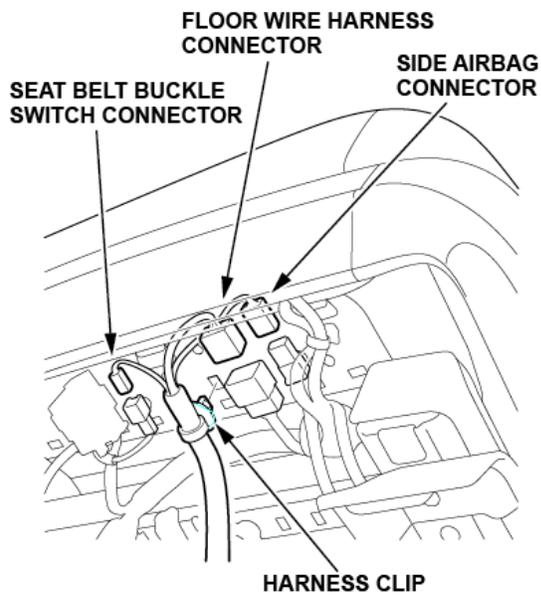
2-DOOR

6. Lift up the front seat, and then disconnect the connectors and release the harness clip.

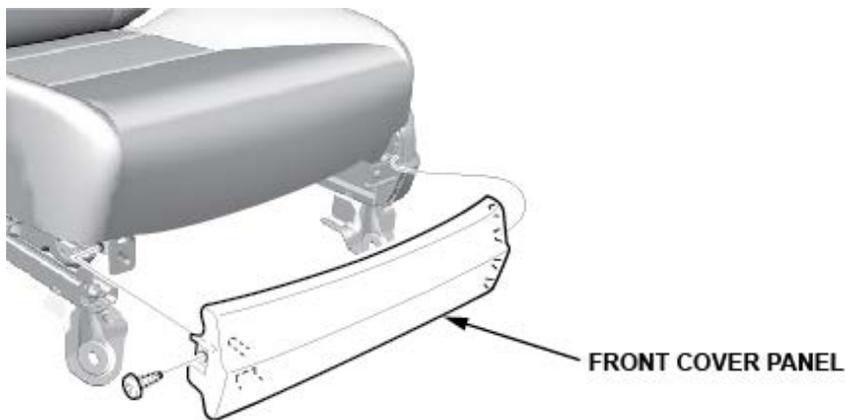
7. Remove the driver's seat.
8. Remove the driver's seat front cover panel.

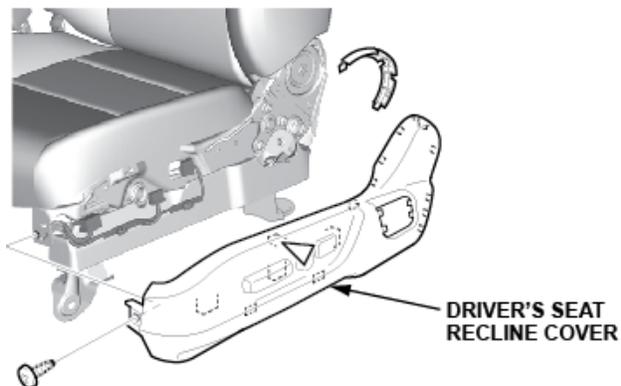
9. Remove the driver's seat recline cover.

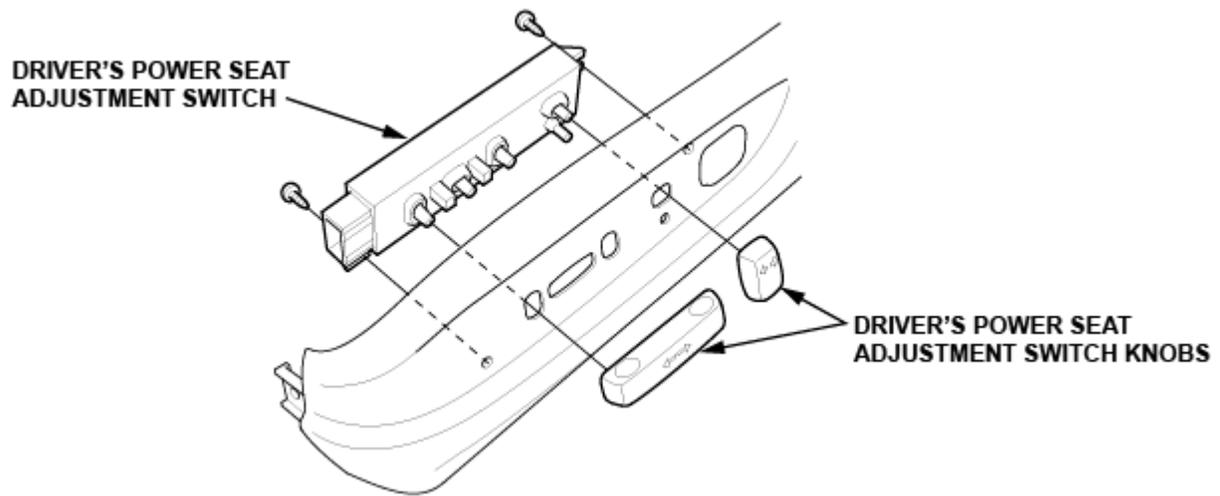
10. Remove the driver's power seat adjustment switch knobs and remove the driver's power seat adjustment switch.

11. Install the new driver's power seat switch.

12. Reinstall all parts in reverse order of removal and reconnect the battery negative cable.
