| <b>Countries:</b> | CANADA, UNITED STATES, MEXICO, PUERTO RICO | <b>Document ID:</b> | IK1200535 |

## Title: Diagnosing Turbocharger Oil Discharge

**Applies To:** VT 275, VT365, DT 466, DT 570, HT 570, MAXXFORCE 5, 7, DT, 9, 10 Engines

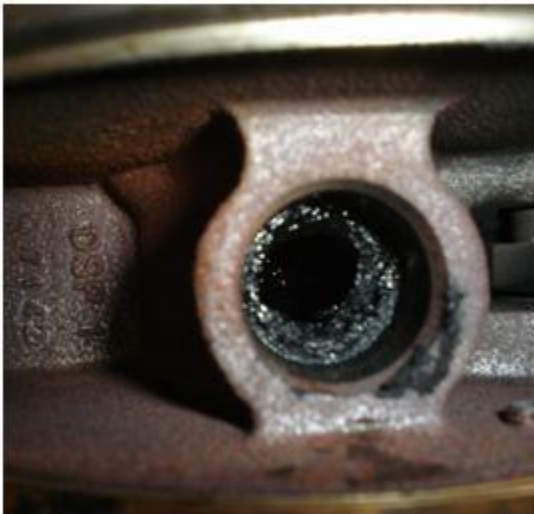
### Examples of Probable Cause for Oil Discharge at Turbine Outlet

Note the restricted oil drain from the bearing housing.

6. A plugged turbo oil drain will cause excessive oil pressure in the bearing housing causing oil to migrate to the turbine and compressor housings.
  - a. Extended oil drain intervals, hot shut downs and excessive oil temperature are the mostly likely causes.

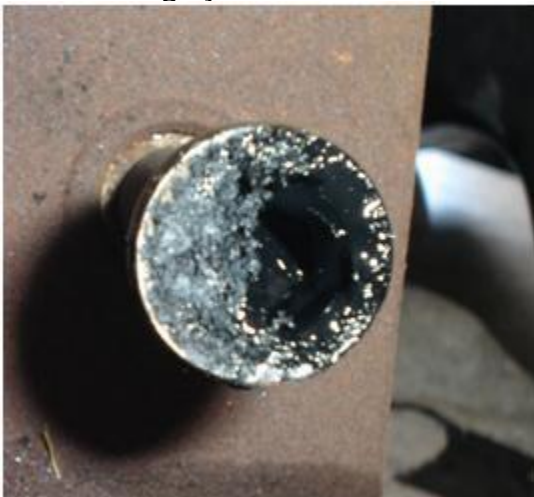
Note the highly restricted oil drain tube from bearing housing.

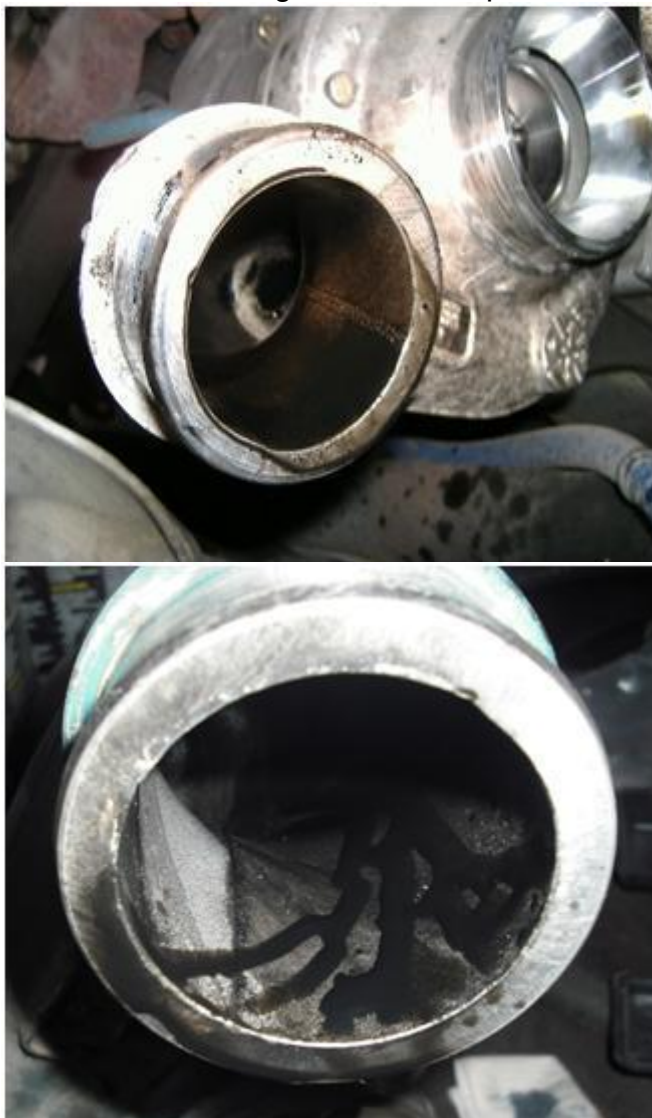
### Examples of Oil Discharge at Compressor Outlet

Note the oil discharged at the compressor outlet.

1. Exhaust engine brake (Inline 6 cylinders)
2. A plugged air filter
3. Excessive engine idling
4. A worn or defective air brake compressor
5. Excessive crankcase pressure
6. A plugged turbo oil drain
7. Excessive exhaust backpressure
8. Excessive turbine shaft radial and axial bearing clearance (wheel contacting the housing)
