**Document ID:** IK1200633  
**Revision:** 5  
**Created:** 8/1/2011  
**Last Modified:** 2/12/2014  
**Author:** Robert Beckett

**Title:** High Fuel Temperature on 2010 MaxxForce 7

**Applies To:** 2010 6.5L MaxxForce 7 Engine

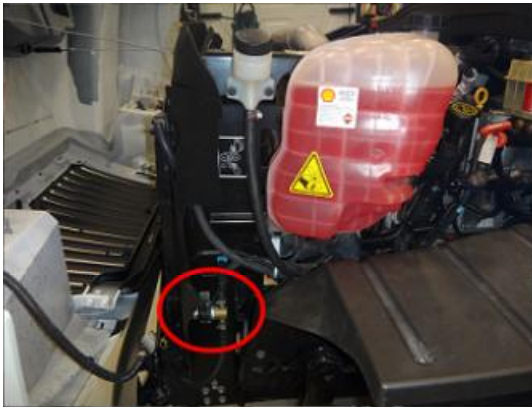
**LOCATION:**

The Fuel Cooler Valve (FCV) is mounted to the radiator support bracket on the driver side of the cooling package. The FCV is used to redirect coolant through the fuel cooler. The ECM uses the Engine Fuel Temperature (EFT) sensor to monitor fuel temperature and control the FCV to maintain the desired temperature. The ECM controls this valve to warm and cool the fuel as required by weather and operating conditions. The FCV is normally open allowing coolant to pass through the cooler.

**DURASTAR CHASSIS** - MODELS MAY HAVE THE FCV MOUNTED IN A DIFFERENT LOCATION.

The word : IN (inlet) will be stamped on the FCV.

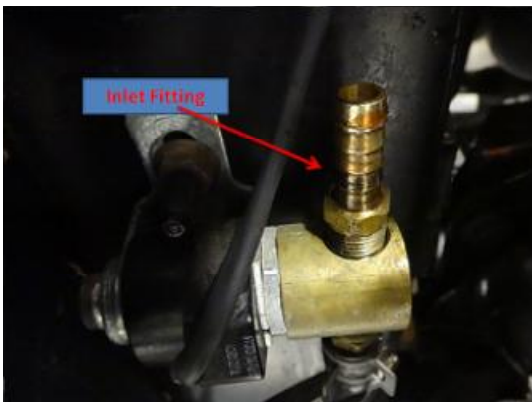
2. Remove the Inlet Fitting hose.

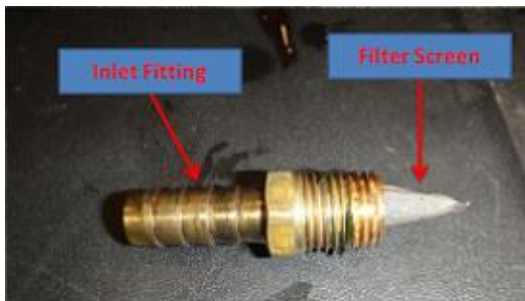
4. Remove the filter screen from the Inlet Fitting and discard the screen.

**NOTE: ONCE THE SCREEN IS REMOVED DO NOT PUT A NEW ONE IN IT'S PLACE OR FAILURE MAY REOCCUR.**

Verify coolant flow through the secondary radiator. Check hose routing to insure no kinked hoses to and from fuel control valve. Check for restriction or debris on the screen located on the inlet side of valve.

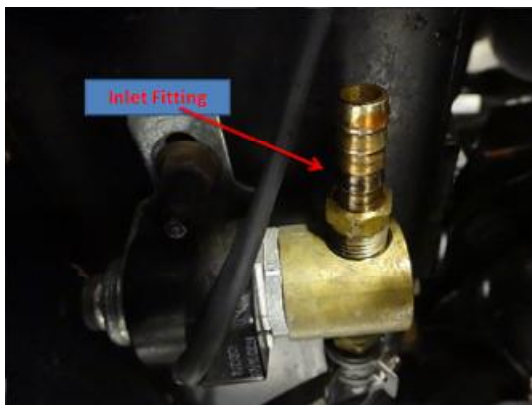
5. Re-install Inlet Fitting onto the FCV.
