Document ID: IK1200739
Revision: 9
Created: 3/16/2012
Last Modified: 2/4/2014
Author: Daniel Modesto

Title: EGR Valve - SPN 27 FMI 7 and SPN 27 FMI 4

Applies To: 2010 Emissions MaxxForce 11 & 13 Liter Engines

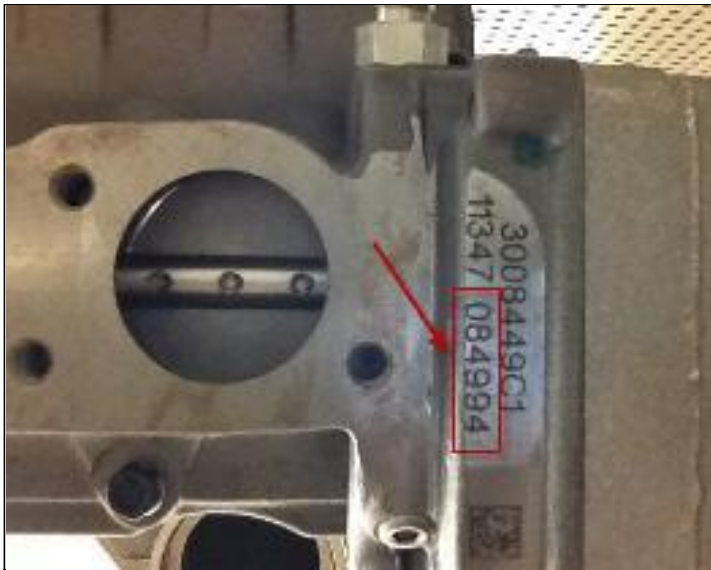
- **Requirement** : Include the Serial Number of the failed and new EGR Valve in the subsequent warranty claim "CCC" and the "Failed Serial #" fields (See Photo Below).
- **Requirement** : Be sure the replacement EGR Valve Serial # starts with a 2(Serial Number location shown below).
