**Document ID:** IK1201090  
**Revision:** 0  
**Created:** 3/11/2014  
**Last Modified:** 4/11/2014  
**Author:** Aaron Wenthold

**Title:** 2010 - 2013 11/13 Liter Coolant in the Intake**Applies To:** 2010 MaxxForce 11/13

### DESCRIPTION

Provide repair advice for 2010 - 2013 11/13 Liter vehicles that exhibit Coolant in the Intake, after following [IK1201066 2010 MaxxForce 11 & 13L Coolant Consumption and SPN-111 FMI-1](#)

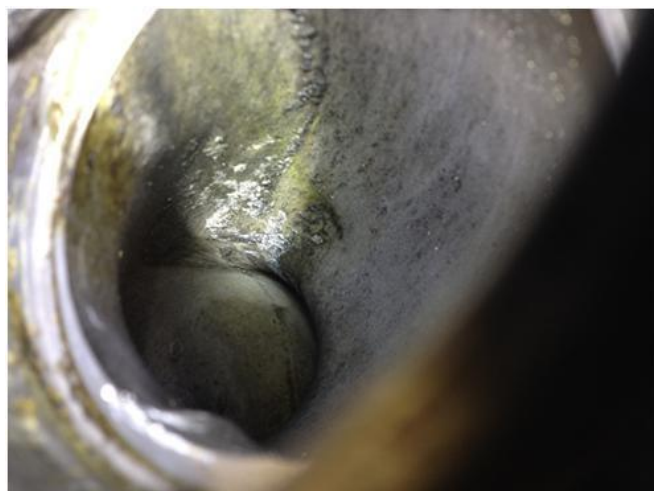
**Figure 1: Porous HP turbocharger air inlet duct leaking coolant into the intake.**

| Step | Action | Decision |
|---|---|---|
| 6 | <u>Visually inspect HP turbocharger air inlet duct for signs of coolant and/or coolant residue.</u><br>-<br>-<br>-<br>-<br><ul style="list-style-type: none"> <li><u>Inspect for coolant seeping through the casting (porosity).</u></li> <li><u>Figure 1 shows a porous HP turbocharger air inlet duct leaking coolant into the intake.</u></li> </ul> -<br>-<br>-<br><u>Is the HP turbocharger air inlet duct leaking?</u> | <b><u>Yes: Replace HP turbocharger air inlet duct following the procedure in the Engine Service Manual. Repair complete.</u></b><br>- |

| Step | Action | Decision |
|---|---|---|
| | | <b><u>No: Go to step 7</u></b> |

| Kit Description | Part Number | Quantity Required | Ordering Instructions |
|---|---|---|---|
| HP turbocharger air inlet duct | 3005313C* | 1 | Order from Navistar |
