# PREVOST

## WARRANTY BULLETIN

### WB14-06G

| SUBJECT : | "BITZER" LARGE A/C SYSTEM IMPROVEMENT | | |

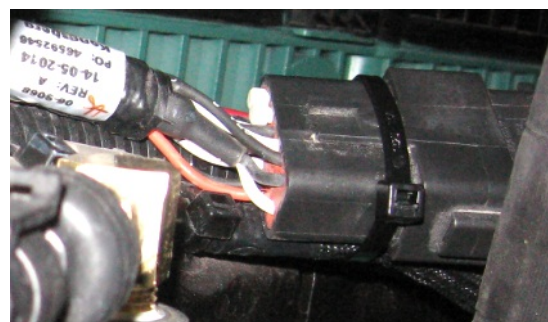
Look on cable management bracket located on the right hand side of the engine. (Fig 5)

Figure 4 Connector C228

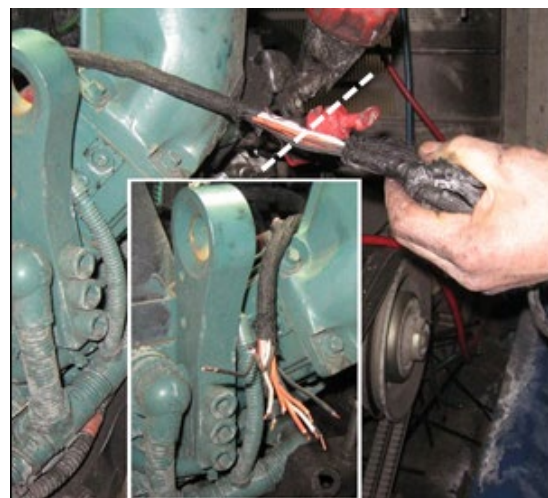
On vehicle side, take the main branch leading to the old compressor pigtail. Remove loom, tape above the pigtail junction. (Fig. 6)

Cut two inches (2in.) above junction and strip the wires to install ten (10) Deutsch terminals. See table.

Figure 5 Vehicle harness stripping

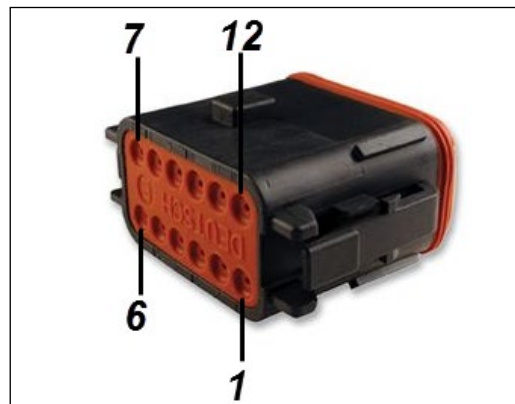
On Deutsch connector #563227 (C228), assemble the stripped wires with terminals and insert them in the indicated positions per wire circuit (Fig 14). Note the different circuit numbers for X3-45 coaches and other models

Figure 6 Connector cavity reference

<sup>1</sup> Positions 4 & 10: any wire printed "30 or 13"

<sup>2</sup> Positions 7 & 8: any wire printed "0RA2"

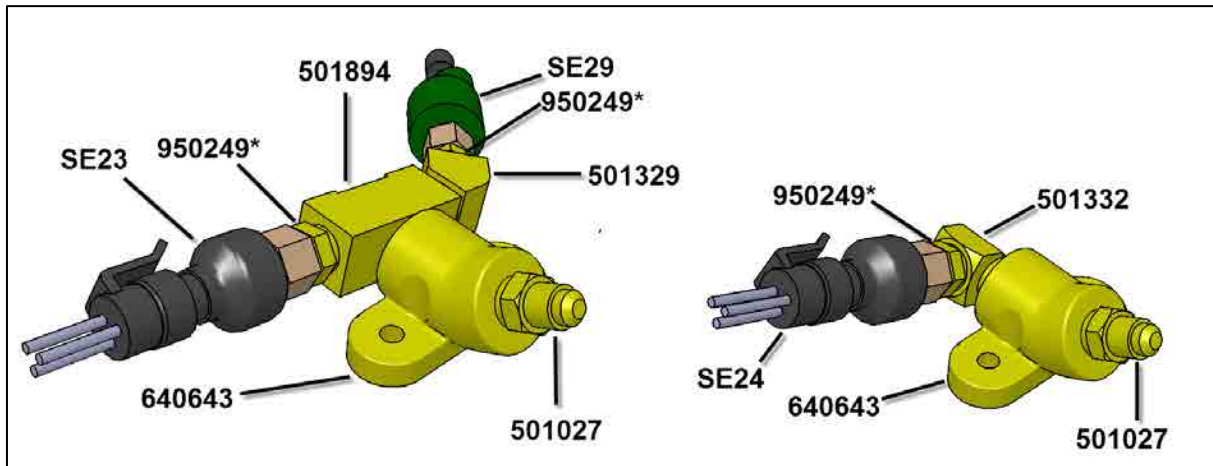
Assemble one each of the two fitting assemblies (Fig 9).

Apply Loctite 567 sealant.

Figure 9 : Fitting Assemblies

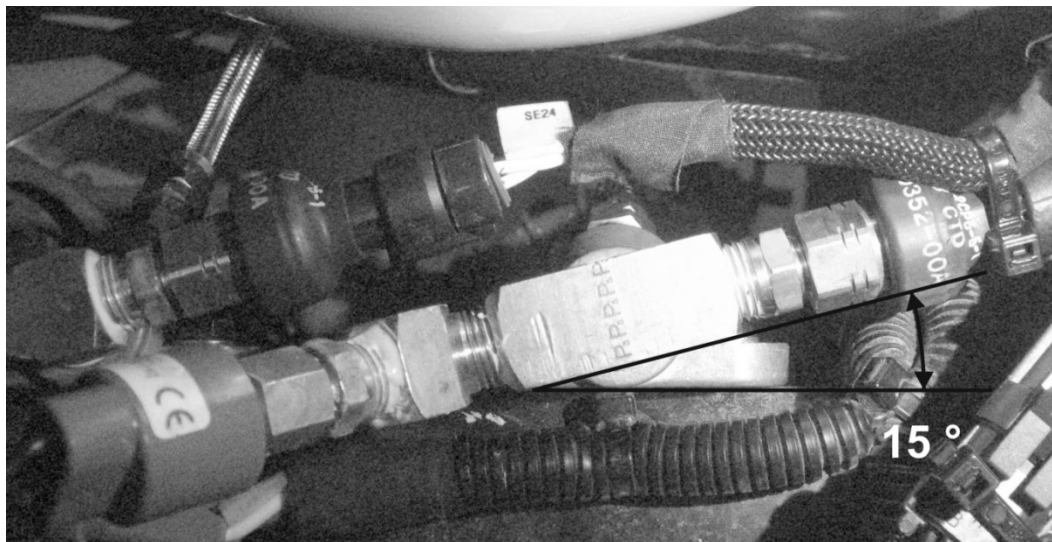
Rotate tee and elbow at about 15degrees from 640643 mounting flange. (Fig. 11)

Install Instruments SE23, SE24 and SE29 as shown.(Fig 10)

Figure 10 Fitting Assembly Orientation.

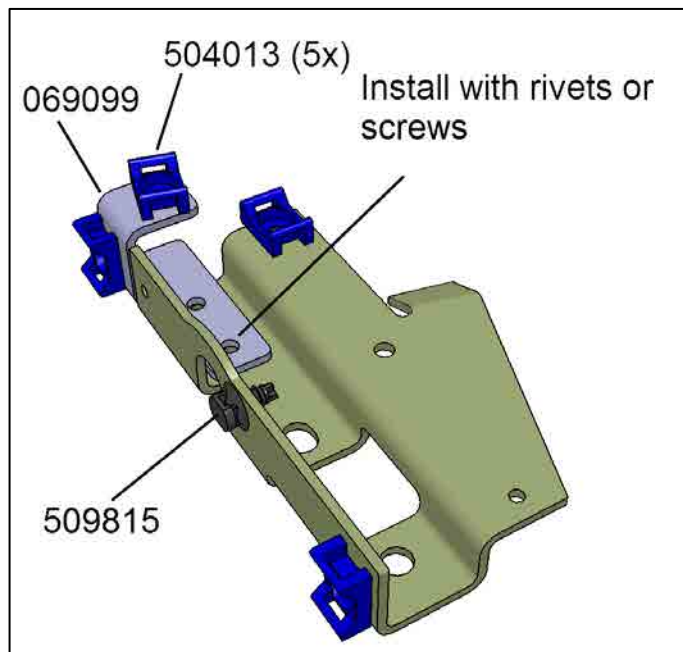
Figure 12

Addition of this support is recommended for all brackets, new and existing to route the unloader cable properly and avoid a sharp edge. You may install the bracket with screws or rivets.

If using screws, drill 7/32" holes using bracket 069099 as template. (Fig 12)

If using rivets, drill with a #10 (0.1935") drill.

Install with a pneumatic riveter if available using two #504379 rivets. Otherwise use two 5001241 screws and nut 5001180.

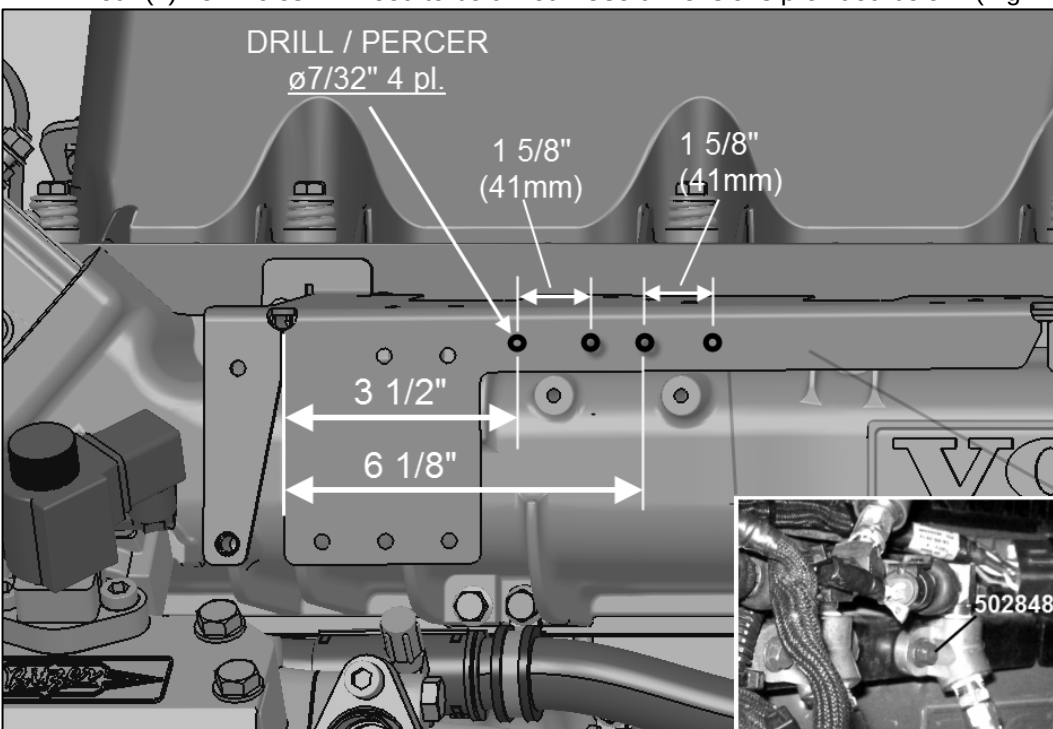
- 2.11.** Using cable tie anchor holes as reference, drill two new diameter  $7/32''$  holes towards the center, 41mm apart.

Use flanged elbow **640643** as a drilling template to get 41mm dimension.

- 2.12.** On certain vehicles the cable support will not have reference holes. Four (4) new holes will need to be drilled. Use dimensions provided below. (Fig. 17)

**Figure 16: Drilling on the cable support**

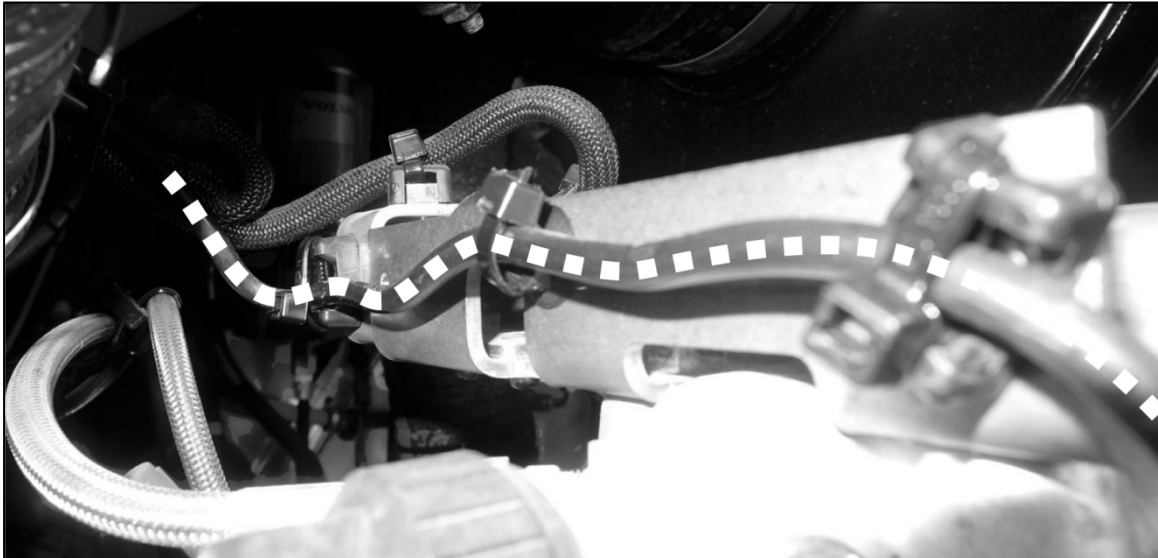
- 2.13.6. According to table, splice wires with butt slice #562228. Crimp and solder. Inspect to make sure you have a good crimp and solder.
- 2.13.7. Seal each wire with shrink tube. Seal over the two wires and cable isolation with the larger shrink tube. (Fig. 19)
- 2.13.8. Attach clutch cable along bracket as shown.(fig. 20)

**Figure 19 –Clutch cable.**

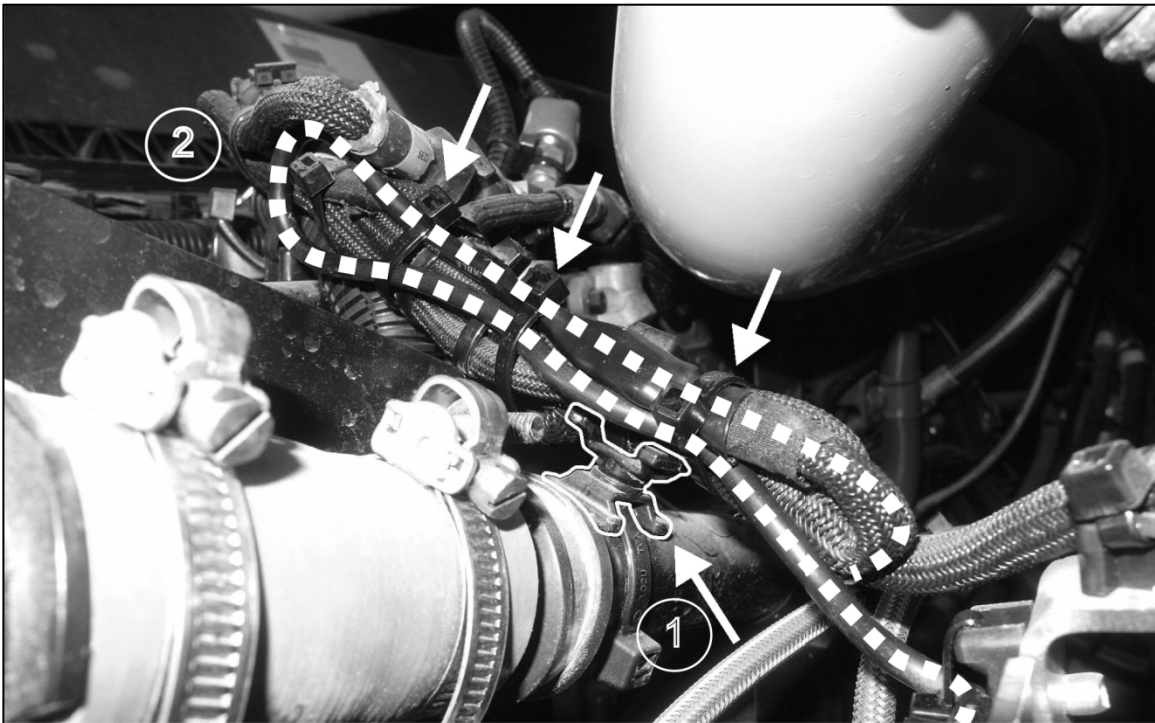
- 2.13.9. Install a swivel cable tie base 504751 slightly below the flexible section of the oil fill tube and attach harness. Secure main strand of harness to cable tie base (1) and route towards engine above oil fill tube. (fig. 21).
- 2.13.10. Attach the excess length of clutch cable (2) along main strand of harness as shown in fig. 21.

**Figure 20- Cable tie base and clutch cable.**

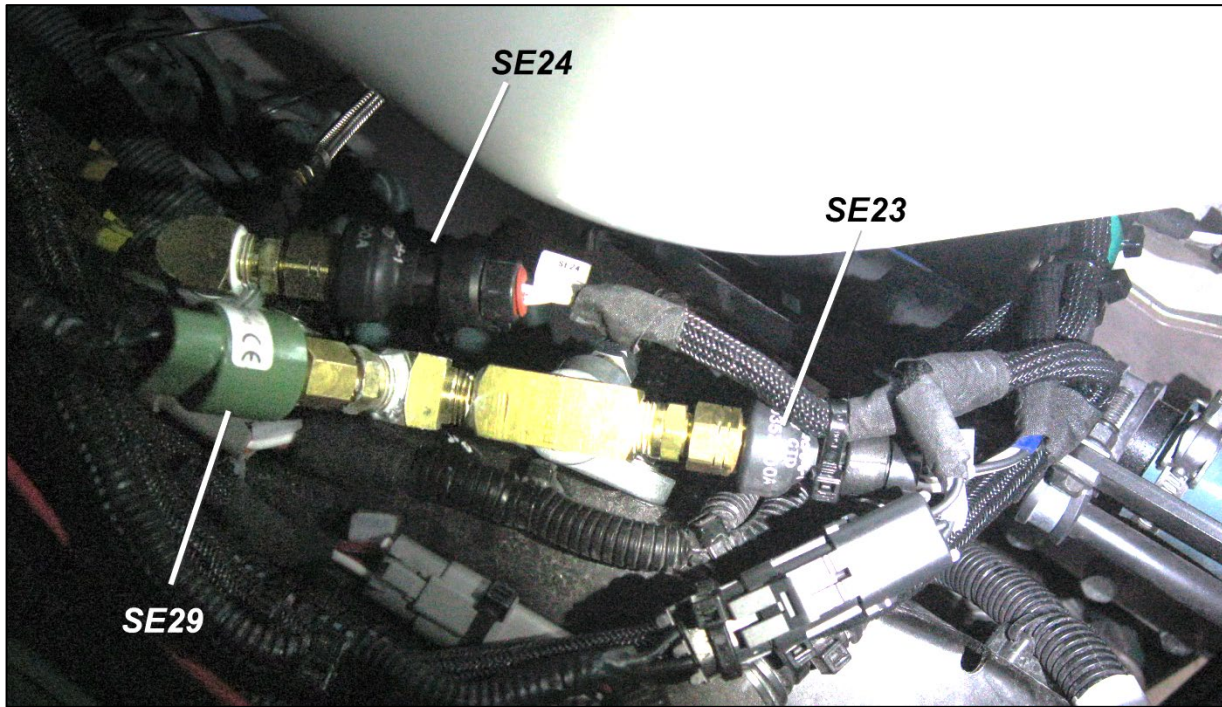
Route harness towards engine and connect to the transducers and switch installed on the fitting assemblies. (Fig. 24) Secure with cable ties.

Figure 23 Harness routing to remote instruments on engine.

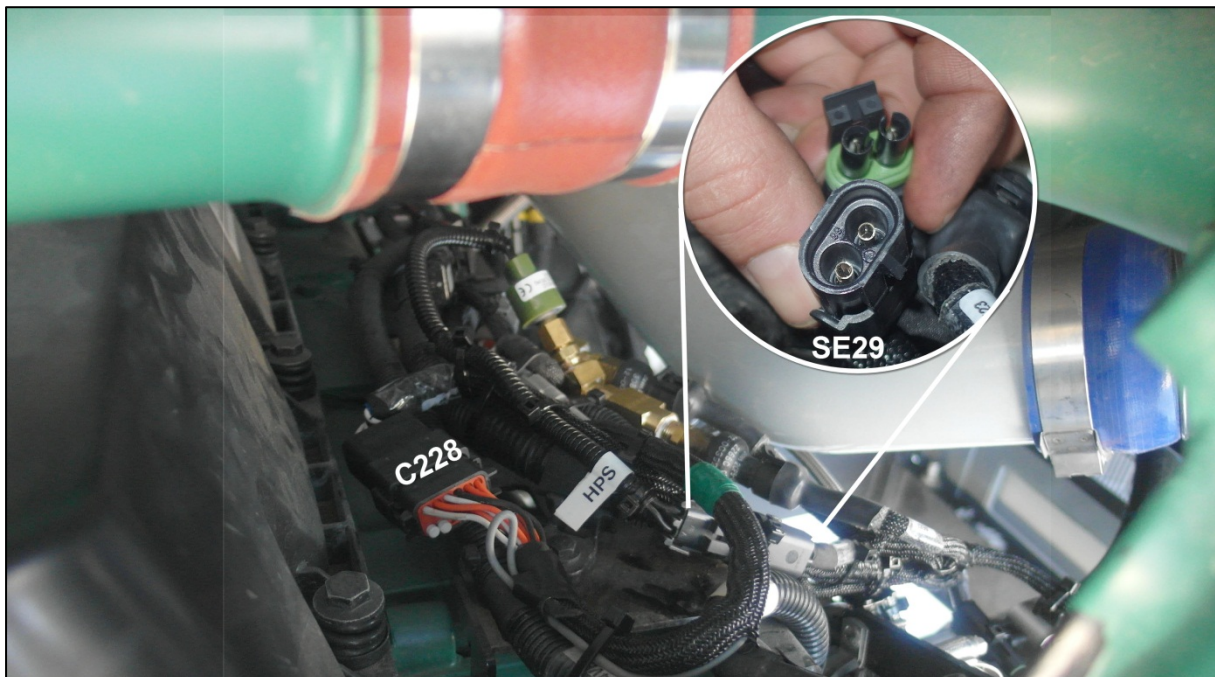
Connect Harness to C228 and secure connector according to best practices, making sure deconnection is possible.(Fig. 25)

Inspect Pressure Switch SE 29 connector to make sure the pins are mating.(Fig. 23)

Figure 24 : SE29, C228.

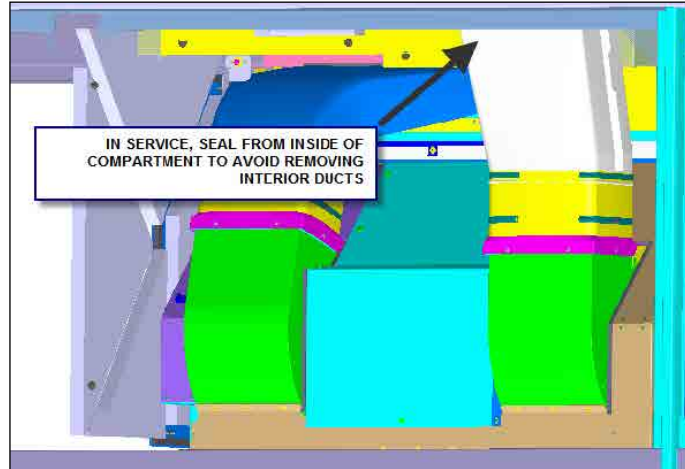
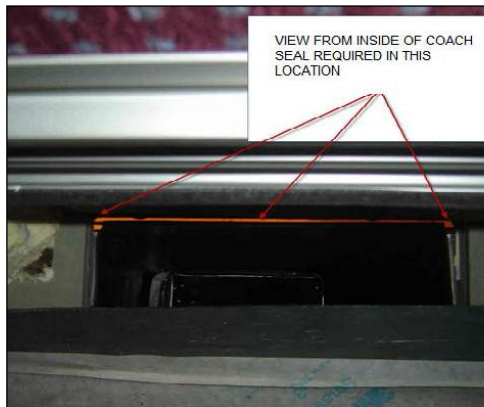
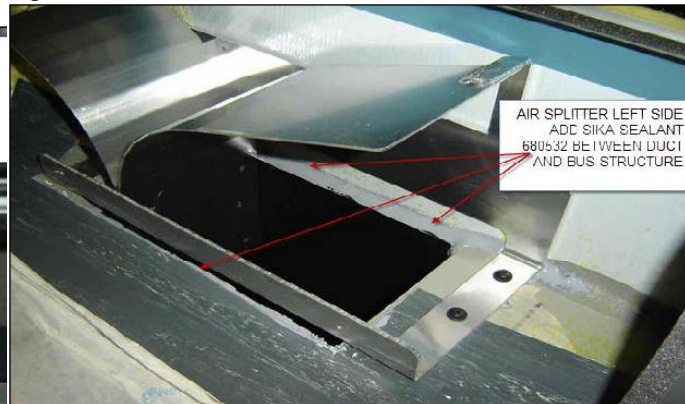
Inspect before performing any work.  
Some vehicles up to **E-5526** may present a gap between the road side air flow splitter, floor and vehicle structure.

To avoid removing the passenger side floor ducts, sealing can be performed from the evaporator compartment.

Add a Sika sealant joint #680532 between discharge duct and structure and between duct and floor.

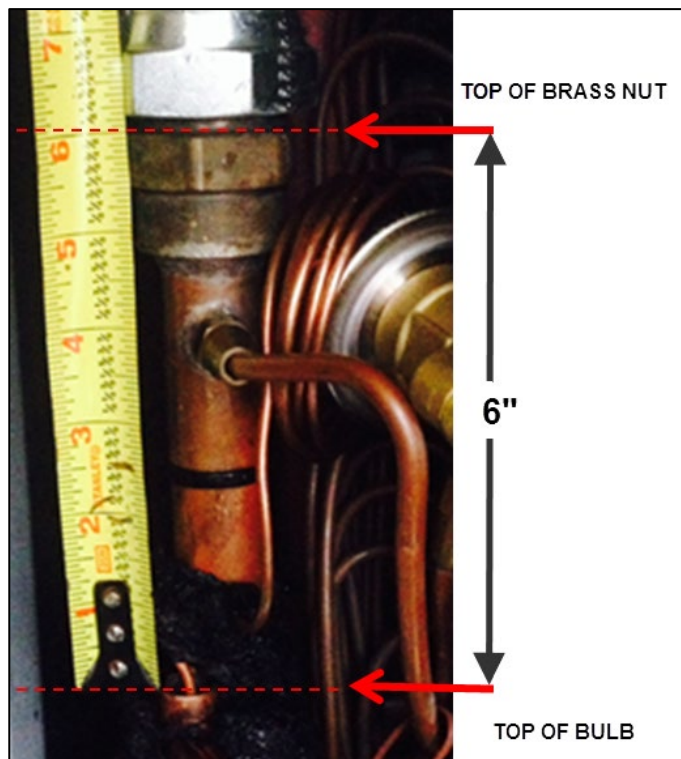
Figure 28

On the evaporator, inspect the expansion valve bulb position.

Adjust to 6" from top of brass nut, as indicated in fig 31.

Clean thoroughly the contact surfaces on the tube and on the bulb with a "scotch brite" type scouring pad.

Isolate bulb and tube section with insulating tape #680091.

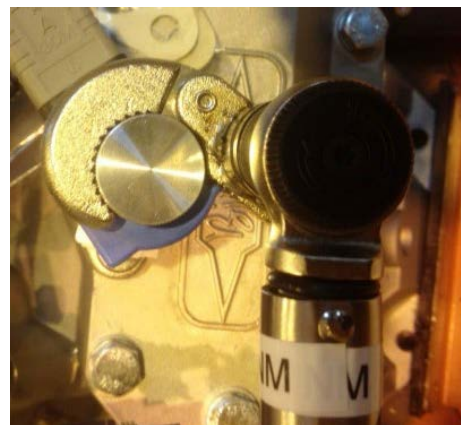
- a. Check torque wrench is set for **3Nm**
  - b. Hold the coil in desired position
  - c. Tighten the cap with the wrench **set at 90° to the clamp assembly** –see Figure 1 below.

**Clamp and Torque Wrench**

**Figure 1**  
Torque Wrench Position  
For Setting Torque

- 5. While holding the coil in the desired position, install and tighten the aluminum cap by hand.
- 6. Use the clamp tool and torque wrench to set the final torque on the cap;
