DIODE ADDITION TO 24CO CIRCUIT
Prevost vehicles

On the vehicles affected by this special bulletin, add a 3 amp diode to the corresponding 24CO circuit to prevent the combined charging and starting system F81 fuse from blowing.

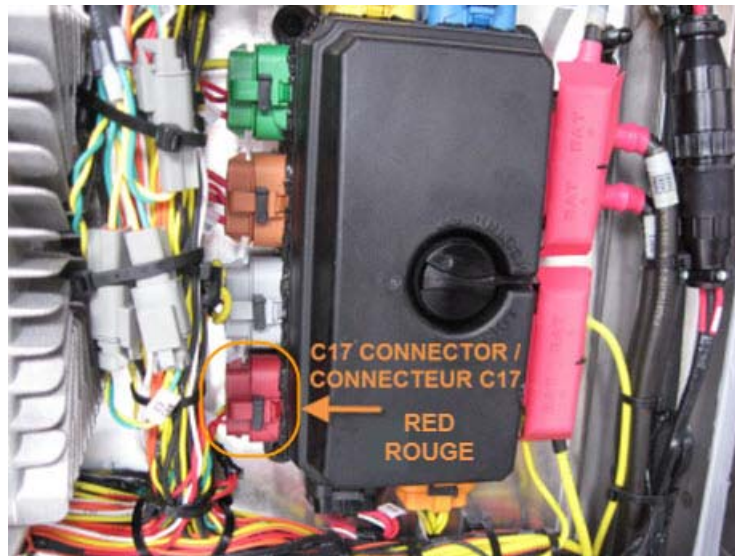
Fig.4 C17 connector on H serie vehicles.

2. Locate the junction box red C17 connector.

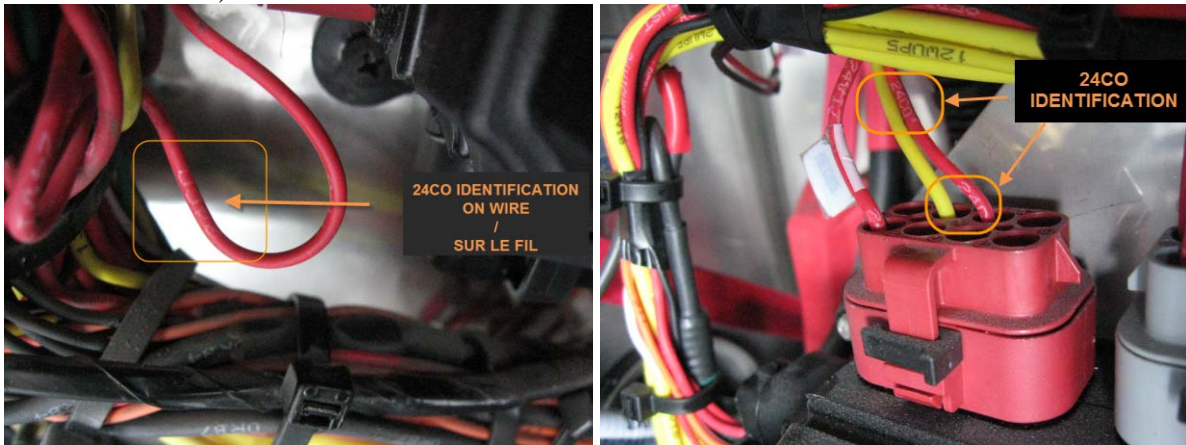
Fig.6 24CO Wire identification on H series (Left) and X series (Right) vehicle.

3. Locate the 24CO red wire at the back of the connector (wires are factory identified on their insulation sleeve).
