# HV Battery Cooling Fan Maintenance for Severe Usage Vehicles

YEAR(S)	MODEL(S)	ADDITIONAL INFORMATION
2013 – 2014	ES300H

## Introduction

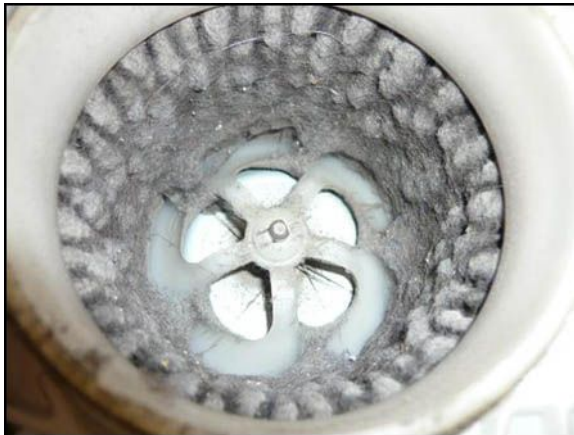
**Figure 1. HV Battery Cooling Fan BEFORE Cleaning**

For vehicles that are used under certain severe operating conditions, the HV Battery Cooling Fan may exhibit an excessive buildup of dust, lint, or other debris that can reduce the efficiency of the HV Battery Cooling System. HV Battery Cooling Fan maintenance and cleaning should be performed to address this condition.

- [2013](#) / [2014](#) ES 300h:  
*Engine/Hybrid System – Hybrid/Battery Control System – “Hybrid/Battery Control: Battery Blower: Removal”*
3. Using vacuum, and compressed air, if necessary, clean any dust, lint, or debris buildup from the HV Battery Cooling Fan blades, module, and ducts.
