SRS Airbag Light "ON" - B0111/B0116 Open Side Squib Circuit

YEAR(S)	MODEL(S)	ADDITIONAL INFORMATION
2004 – 2009	Sienna

The information contained in this bulletin supersedes SB No. T-SB-0162-10.

Some 2004 – 2009 model year Sienna vehicles may exhibit an SRS lamp "ON" condition with Diagnostic Trouble Code (DTC) B0111 and/or B0116. An updated repair procedure is available to address this condition. Follow the procedures in this bulletin to repair the floor harness and the side airbag squib circuit.

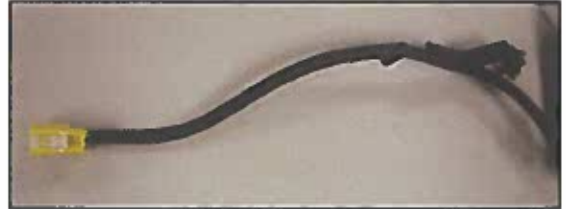
Figure 1.

- Remove the tape from around the corrugated tubing. Remove and save the corrugated tubing.

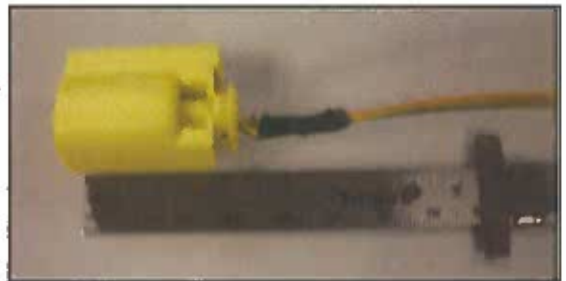
Figure 3.

- Measure 80 mm (3.15 in.) from the tip of the floor harness connector and cut the wires.

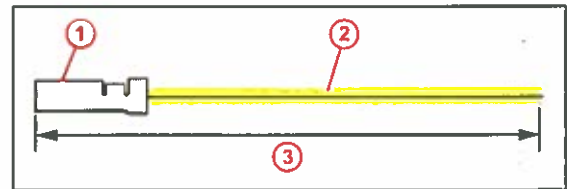
Figure 7. P/N 82998-45040: Repair Wire Harness (Female, Wire Color: Yellow-Green)

1	Female Terminal
2	Wire
3	Length (160 +/- 10 mm)

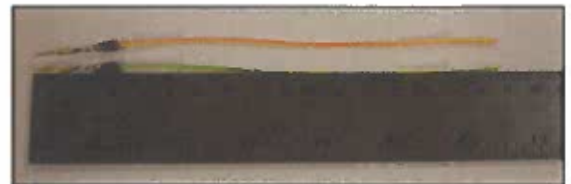
Figure 29.

- A. Measure from the tip of the male terminal and cut each wire.

Power Seat, Left: 348 mm (13.7 in.)

Power Seat: 175 mm (6.89 in.)

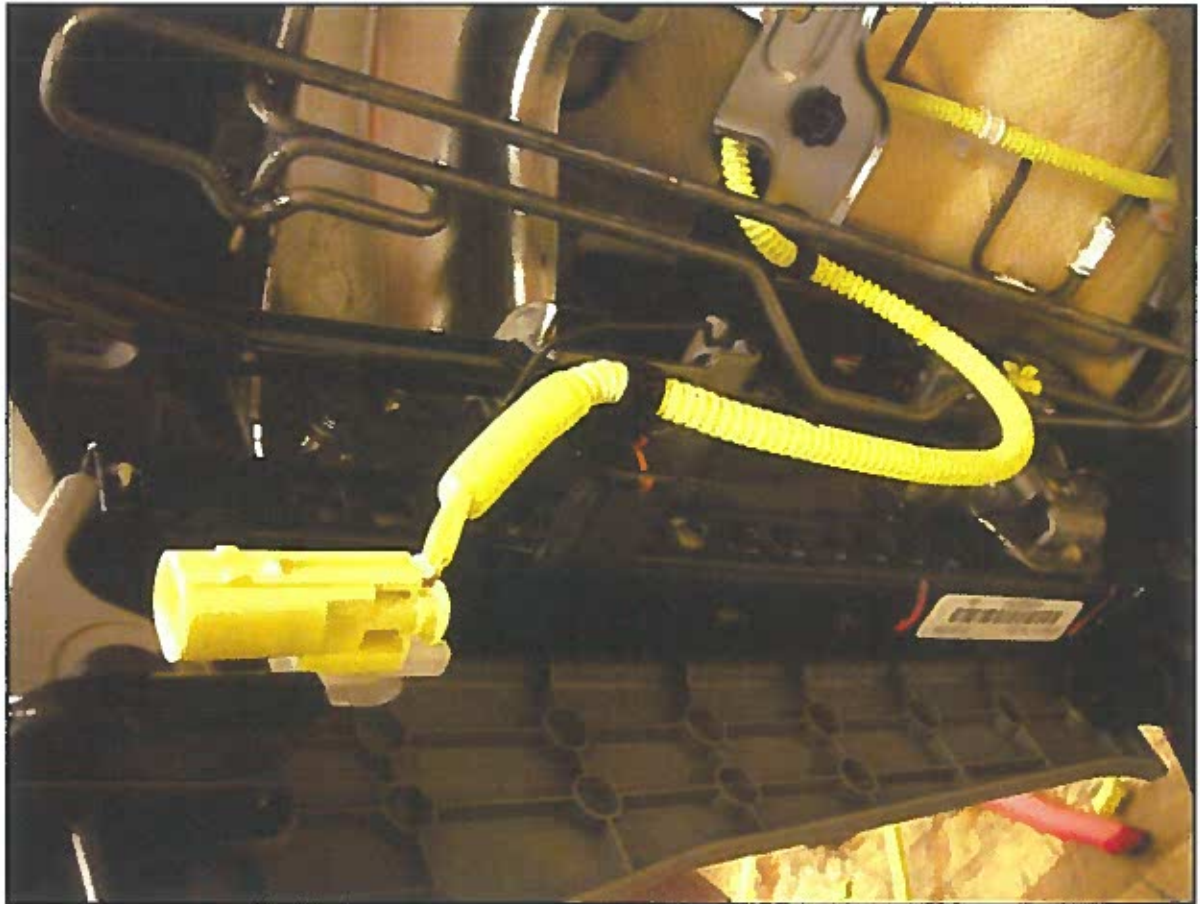
Figure 31.

1. Unclip the SRS seat harness connector. Remove the yellow corrugated tubing and discard.

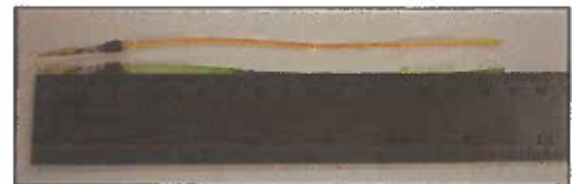
Figure 38.

- A. Measure from the ends of the male terminals and cut the new wires.

Manual Seat, Left: 95 mm (3.74 in.)

Manual Seat, Right: 80 mm (3.15 in.)

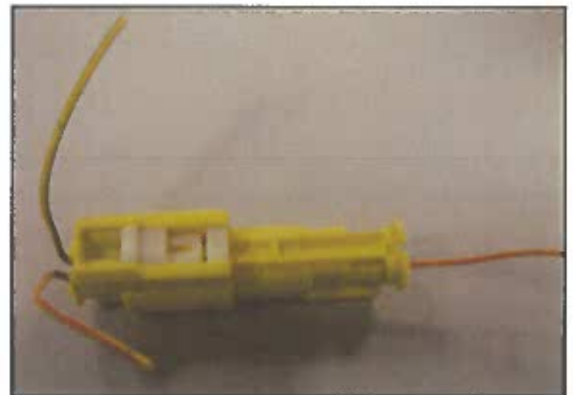
Figure 52.

- B. Install the old SRS floor harness approximately 15 mm onto the new SRS seat connector.

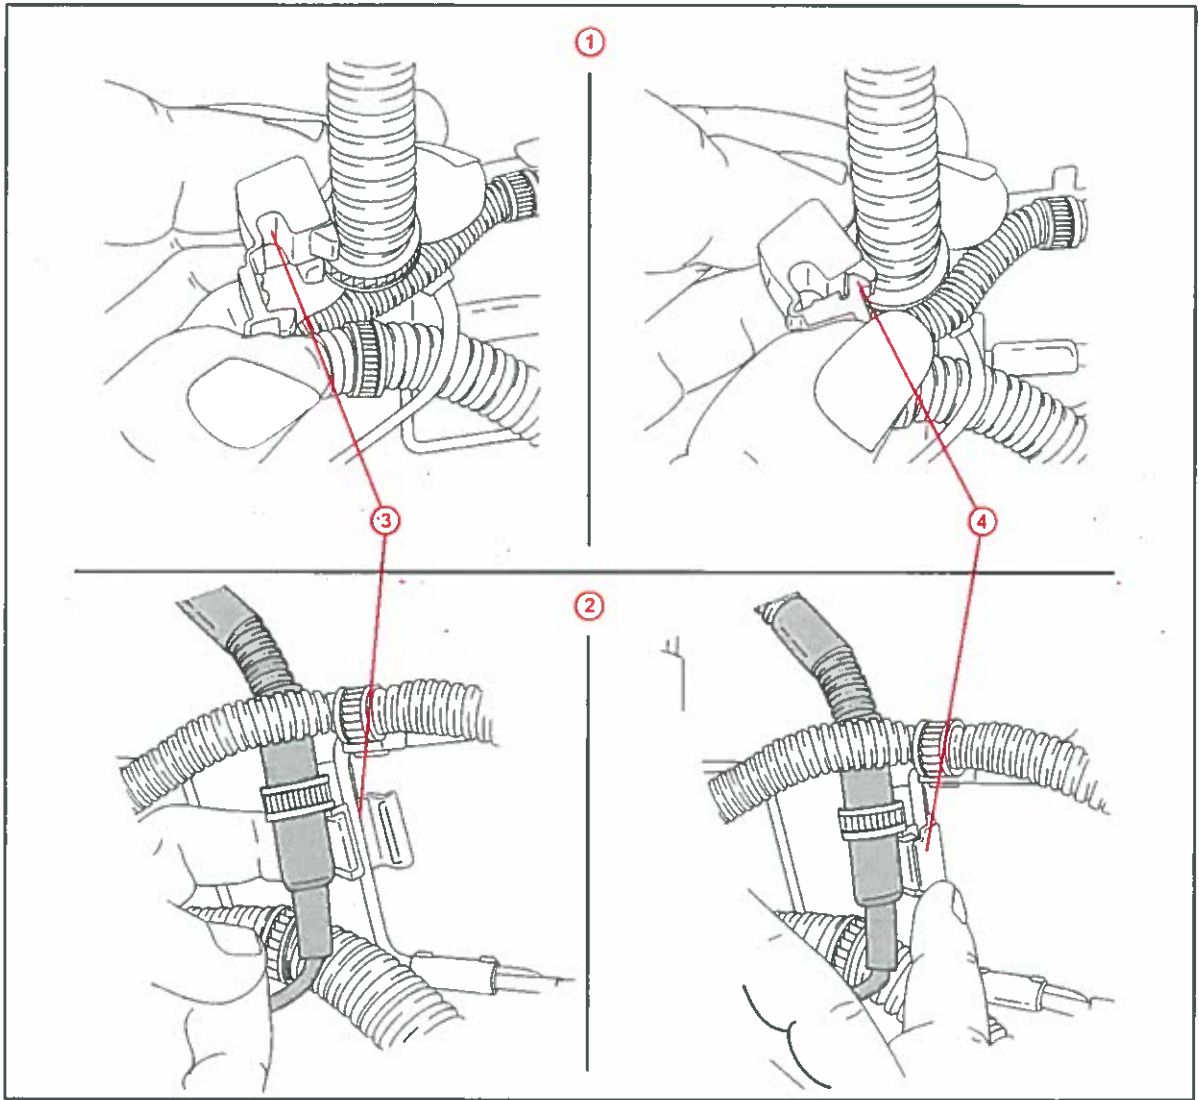
1	Installation for Clip No. 4
2	Installation for Clip No. 5

3	Place Spring in Ditch Part of Clip
4	Inserting the Locking Clasp
