Rear Brake Groan or Squeak Noise when Cold

Service
Category Brake

Section Brake (rear)

YEAR(S)	MODEL(S)	ADDITIONAL INFORMATION
2012 – 2014	Prius V

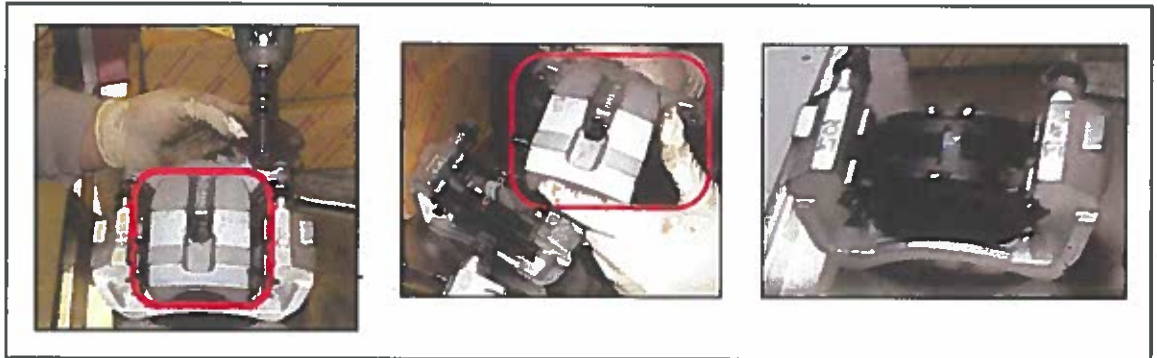
Figure 1.

- B. Separate caliper from the mounting bracket.

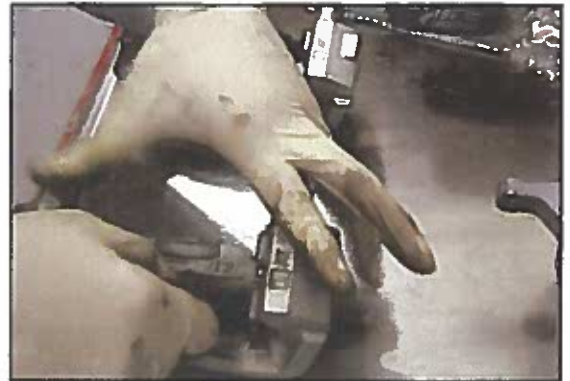
Figure 2.

- C. Remove brake pads.

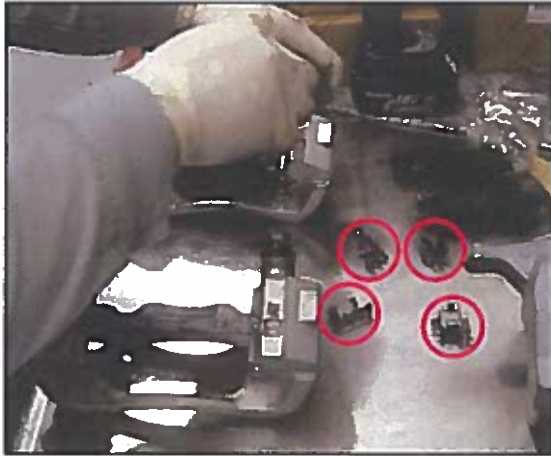
Figure 3.

D. Remove pad support.

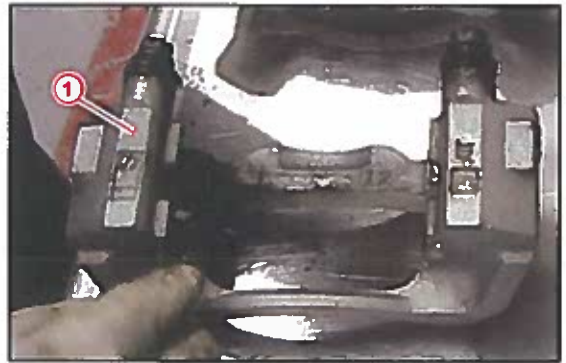
Figure 4.

1	ORIGINAL Mounting Bracket with Brake Pads/Pad Support Removed
----------	--

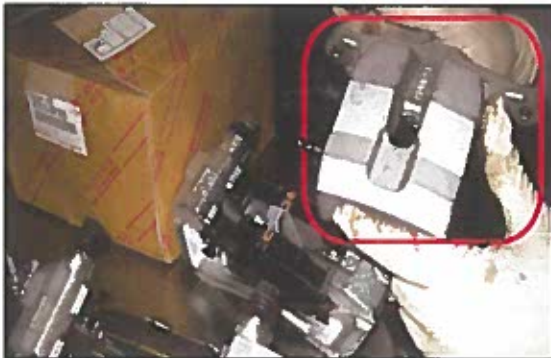
Figure 5.

A. Remove caliper from P/N 47810-47100 / 47820-47100.

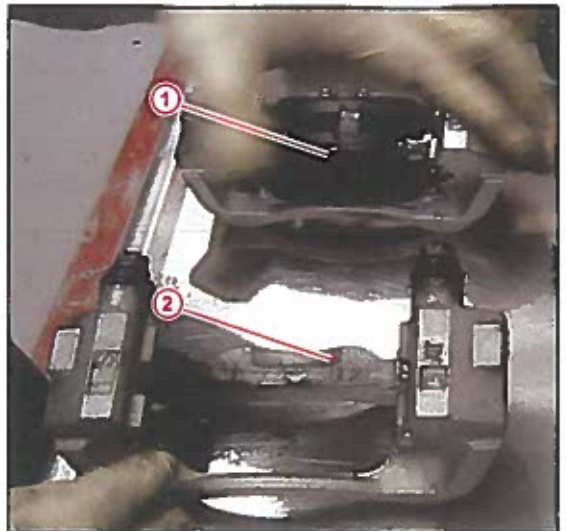
Figure 6.

1	NEW Mounting Bracket
2	ORIGINAL Mounting Bracket

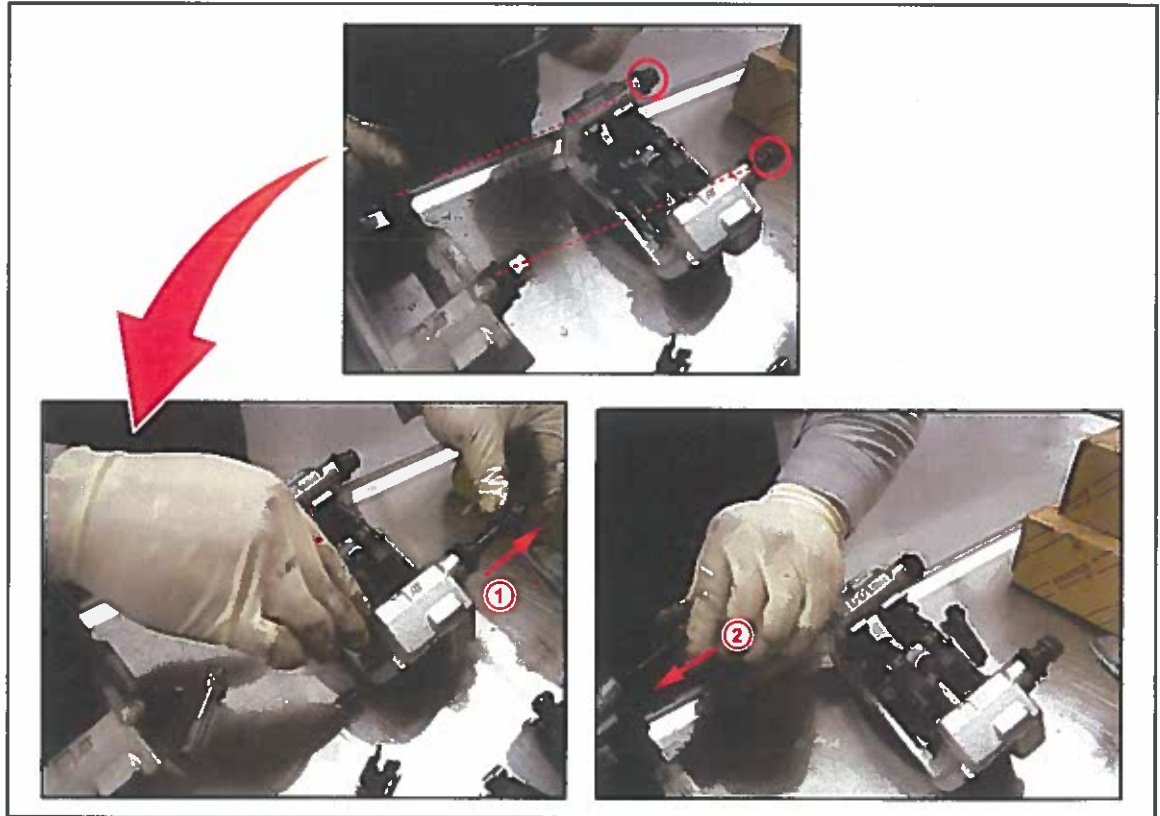
Figure 7.

- B. Remove slide pin No. 1 and No. 2 from the NEW mounting bracket and install into the ORIGINAL mounting bracket.

1 Remove 1 Slide Pin at a Time

2 Install 1 Slide Pin at a Time

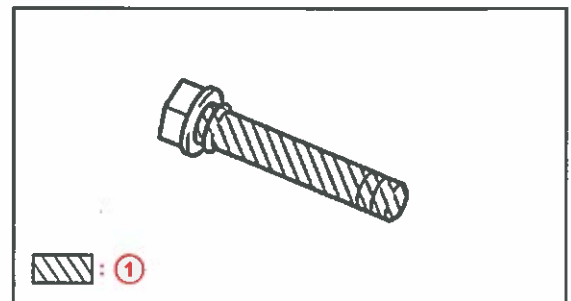
Figure 8.

Before installing slide pin, apply a light layer of Lithium Soap Based Glycol Grease to the sliding parts and the sealing surface of each rear disc brake cylinder slide pin.

1 Lithium Soap Based Glycol Grease

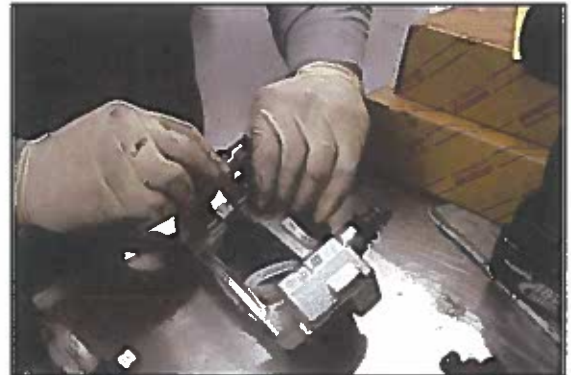
Figure 9.

- C. Remove pad support from the NEW mounting bracket and install into ORIGINAL mounting bracket.

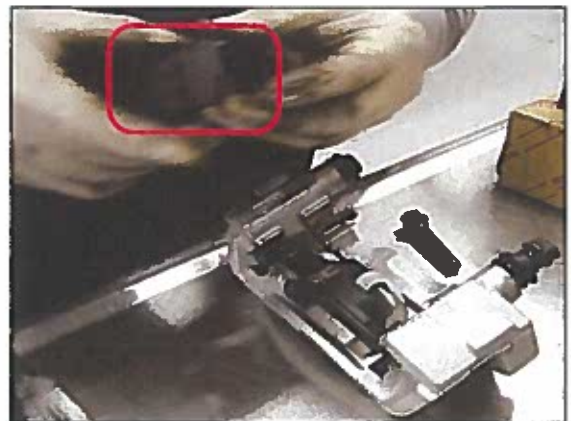
Figure 10.

- D. Remove brake pads from the NEW mounting bracket and replace into ORIGINAL mounting bracket.

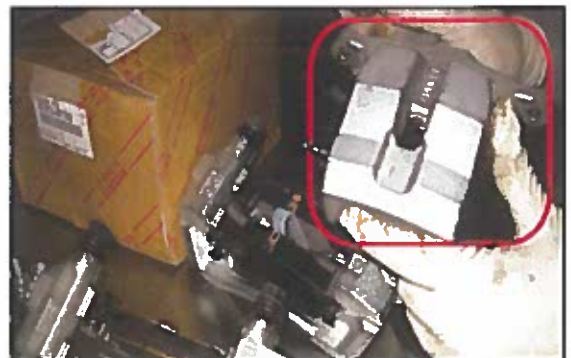
Figure 11.

- E. Install the NEW caliper into the ORIGINAL mounting bracket.

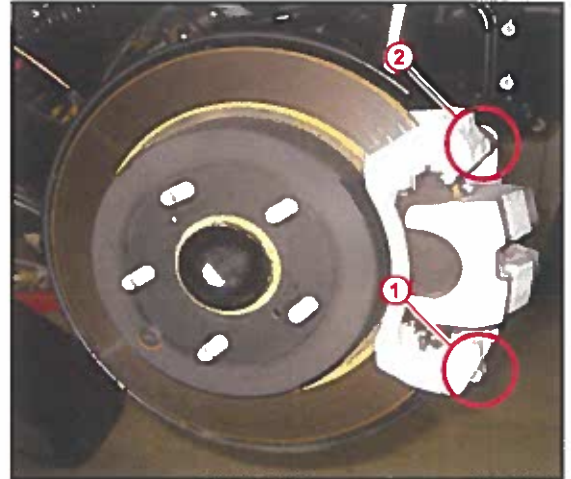
Figure 12.

- F. Tighten the slide pin bolts as follows.

After the main slide pin No. 1 is tightened, tighten slide pin No. 2. This will prevent the slide pin bushing from going too far in one direction.

The main slide pin No. 1 is always located at lower section of caliper when installed on the vehicle.

1	Slide Pin No. 1
2	Slide Pin No. 2
