Driveline Vibration

Service Category Drivetrain

Section Drive Shaft/Propeller Shaft

Some 2005 – 2014 model year Tacoma vehicles equipped with 1GR-FE engine (PreRunner and 4WD) and automatic or 6-speed manual transmission may exhibit a vibration felt in the seat, floorboard, and steering wheel between 15 – 25 mph caused by a second order drivetrain vibration under acceleration. The following Repair Procedure may improve this condition.

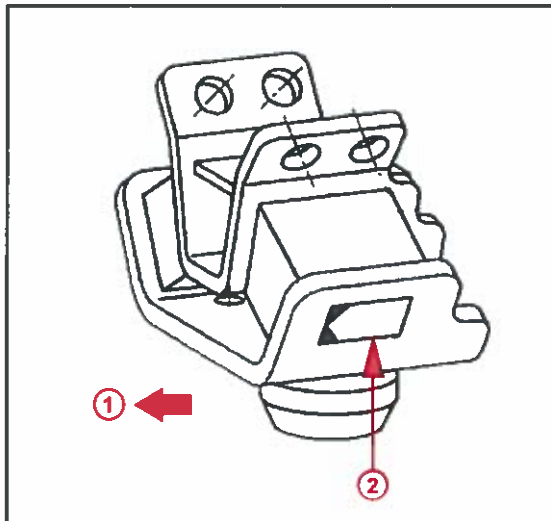
Figure 1. PreRunner Rear Engine Insulator

1	Front of Vehicle
2	Label

ENGINE	I.D. ON LABEL	LABEL COLOR
1GR	VA	Green

Refer to Figures 1 and 2 to confirm the proper part identification by examining the label on the part, and for the proper positioning of the new engine mount in ATM equipped trucks.

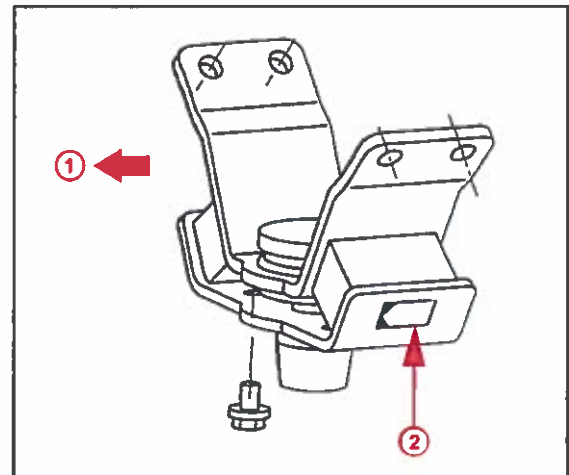
Figure 2. 4WD Rear Engine Insulator

1	Front of Vehicle
2	Label

ENGINE	I.D. ON LABEL	LABEL COLOR
1GR	VA	Green

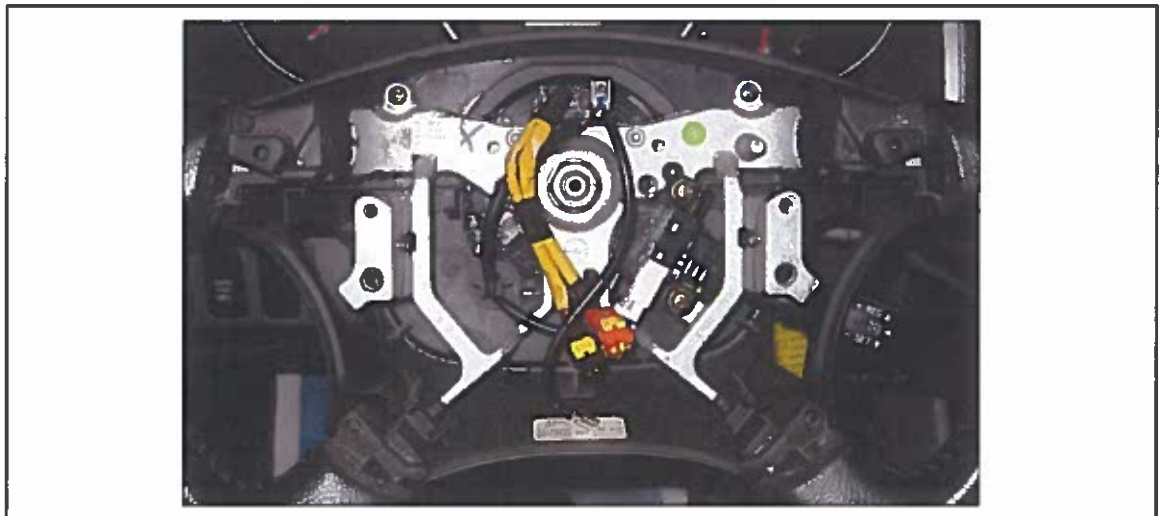
Figure 3. 2005 – 2011 MY Steering Wheel

- B. Remove the steering wheel switch wire harness retainer bracket (only for vehicles with steering wheel mounted switches).

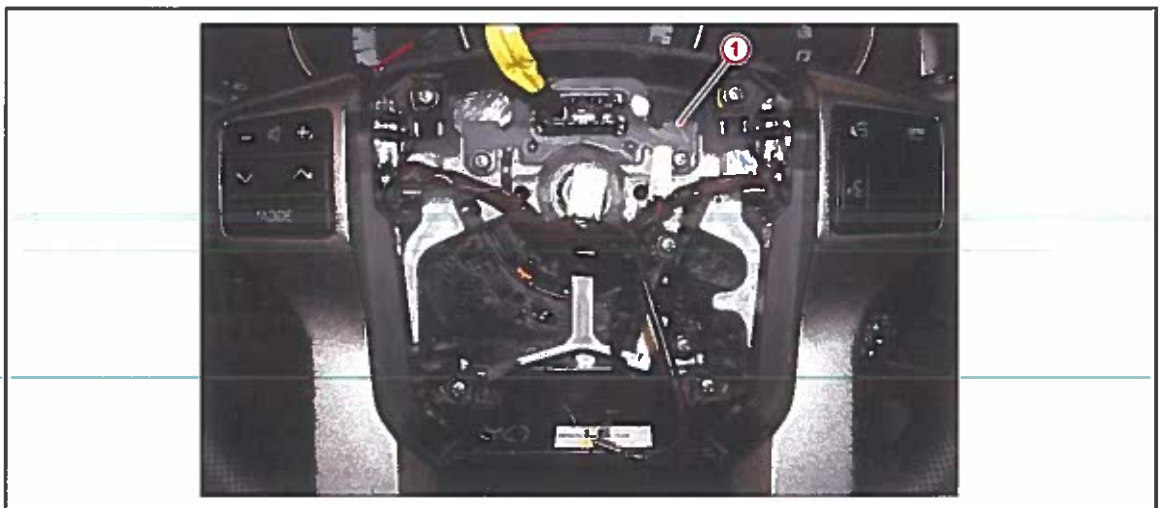
Figure 4. 2012 – 2014 MY Steering Wheel

Is the steering wheel switch wire harness retainer bracket present? (See Figure 4.)

1	Steering Wheel Switch Wire Harness Retainer Bracket
----------	--

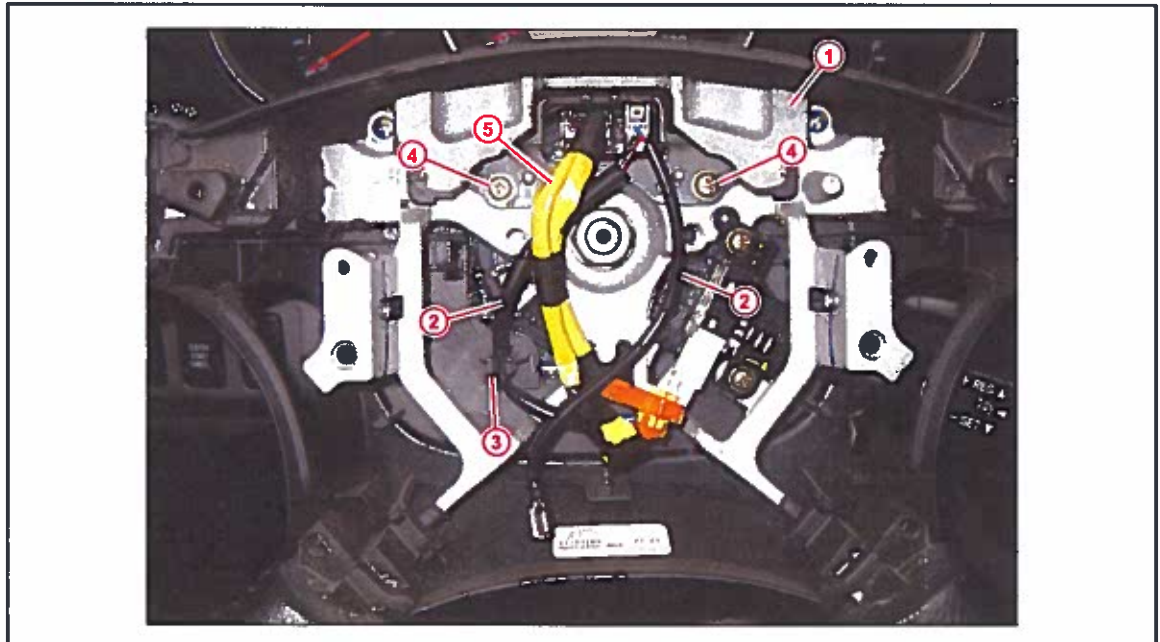
Figure 5. 2005 – 2011 MY Steering Wheel

1	Damper
2	Cruise Control Wire Harness
3	Wire Retainer Hooks

4	Screw
5	Driver Side Airbag Wire Harness

- C. Install the Steering Wheel Damper with 2 new screws in the location shown in Figures 5 and 6.

Torque: 2.35 N*m (24 kgf*cm, 20.8 in*lbf)

Secure the steering wheel switch wires to the steering wheel damper bracket hooks as seen in Figures 5 and 6.

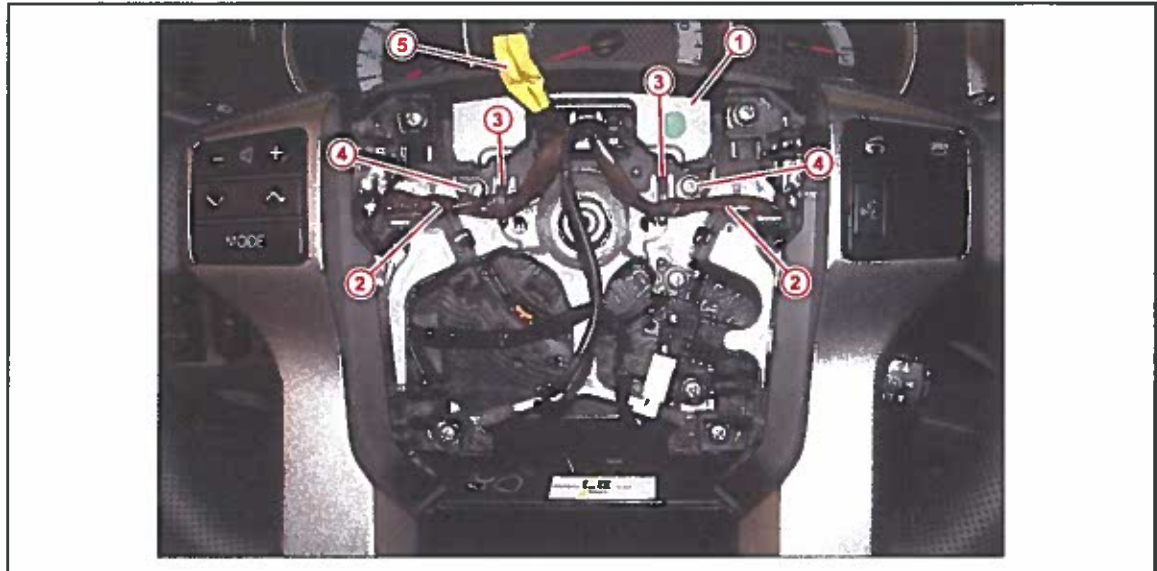
Figure 6. 2012 – 2014 MY Steering Wheel

1	Damper
2	Steering Wheel Switch Wire Harness
3	Wire Retainer Hooks

4	Screw
5	Driver Side Airbag Wire Harness

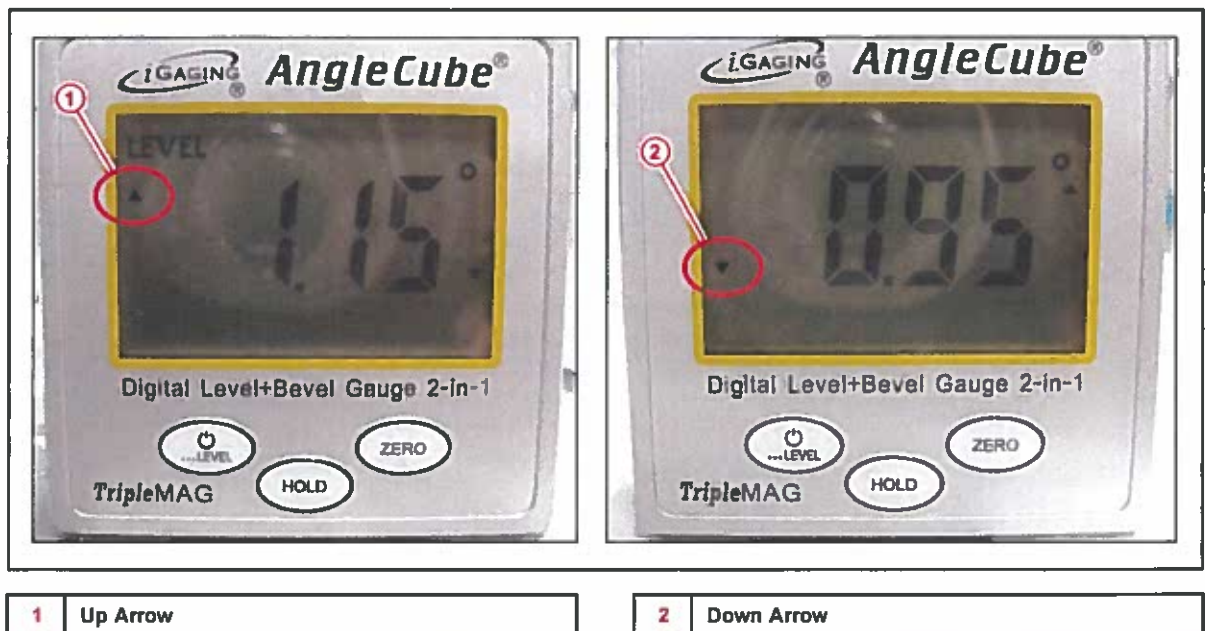
Figure 7.

All measurements must be taken from the passenger side of vehicle facing the driver side. Refer to Figure 7 below to ensure that the angles measured have the correct positive (+) or negative (-) values assigned.

- Arrow pointing up indicates a positive angle. In the example on the left, the angle measured is a positive 1.15 (+1.15).
- Arrow pointing down indicates a negative angle. In the example on the right, the angle measured is a negative 0.95 (-0.95).

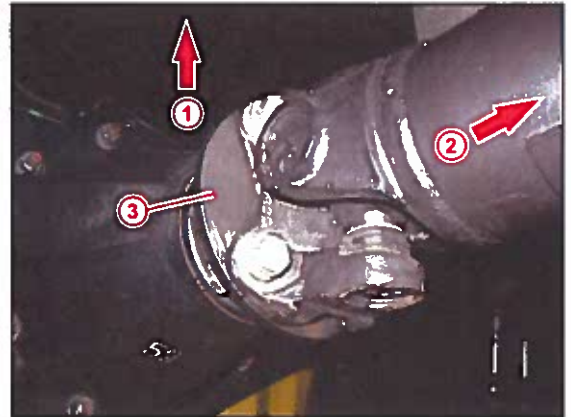
- (1) Rotate pinion flange to the correct position as shown in Figure 8.

1	Up
2	Front
3	Pinion Flange

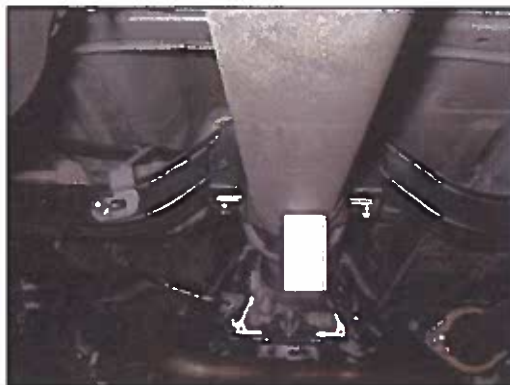
Figure 9. CORRECT Placement of Protractor

- (2) Use the protractor and measure the angle of the rear section of the 2-piece propeller shaft. Ensure protractor is placed along the centerline of the propeller shaft as shown in Figure 9.

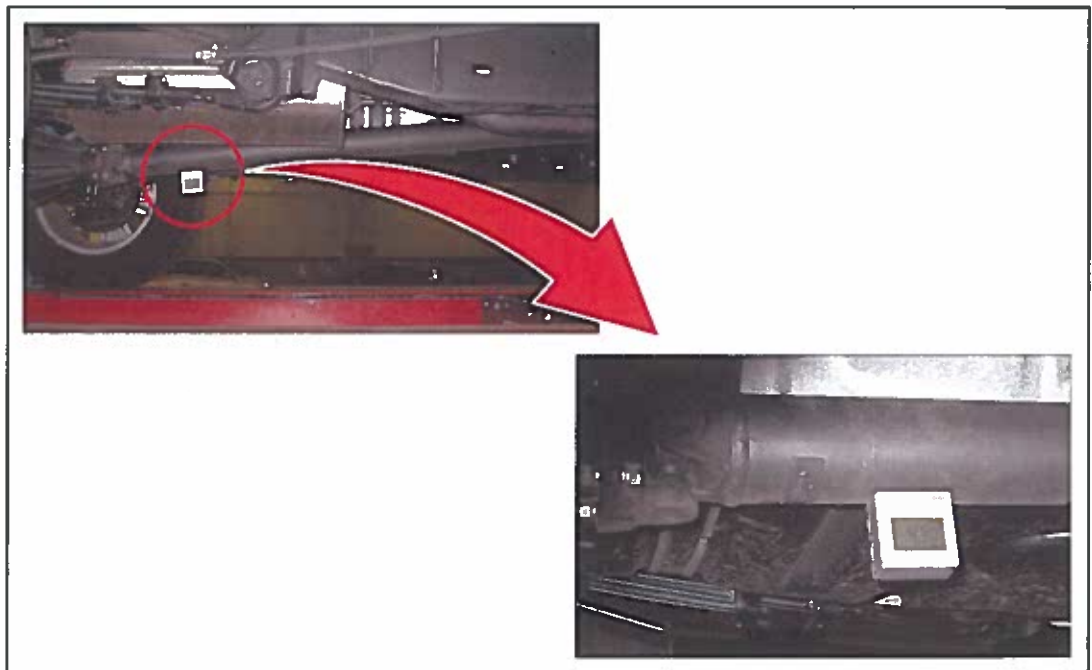
Figure 11.

- (3) Record the Propeller Shaft Angle (P/A).

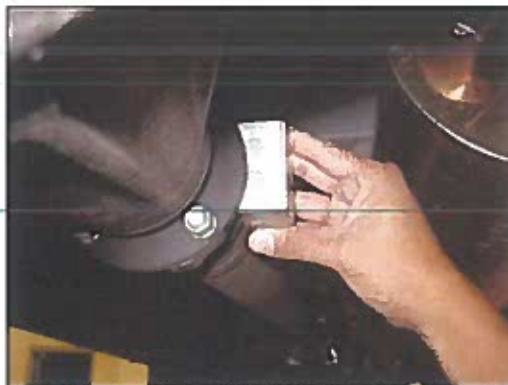
Figure 12. CORRECT Placement of Protractor

- (1) Place protractor against flange surface.

Ensure protractor is firmly against the flange to obtain an accurate Pinion Flange Angle as shown in Figure 12.

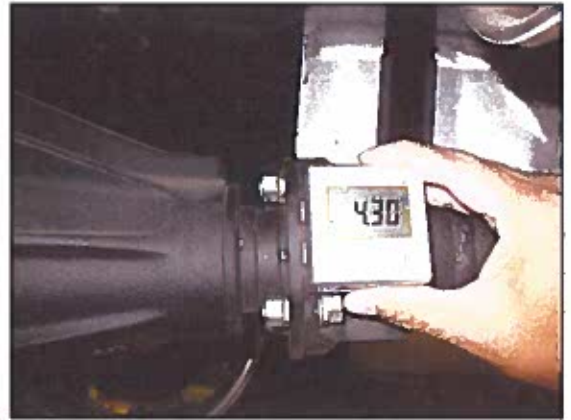
Figure 14.

- (2) Record the Pinion Flange Angle (F/A).

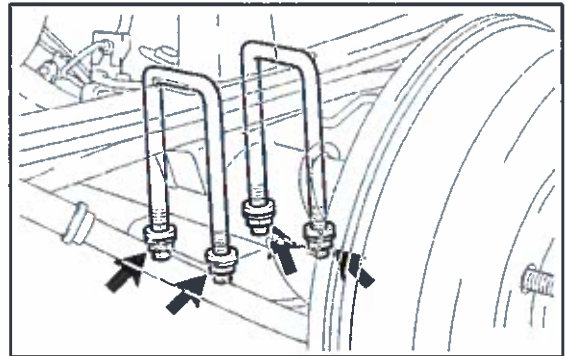
Figure 15.

8. Replace the leaf springs with the applicable part numbers from one of the tables above.

When tightening U-bolt nuts, be sure to set to the following torque:

Torque: 60 N*m (610 kgf*cm, 44 ft*lbf)
