Horn Radiator Support Bracket

Service Category Vehicle Exterior

Section Horn

YEAR(S)	MODEL(S)	ADDITIONAL INFORMATION
2005 – 2014	Tacoma

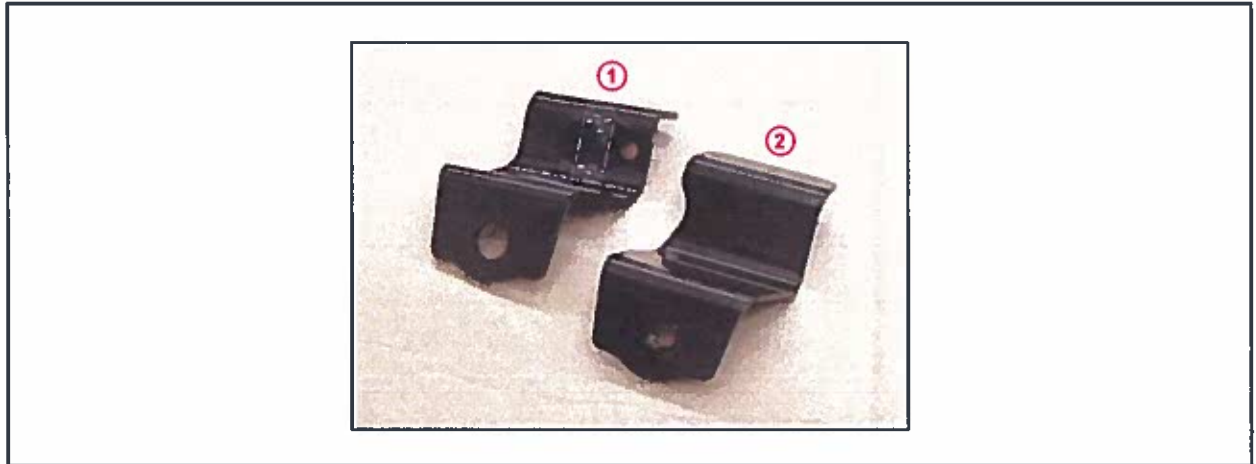
Figure 1. Replacement Horn Mounting Brackets

1 Horn Mounting Bracket No. 2

2 Horn Mounting Bracket No. 3

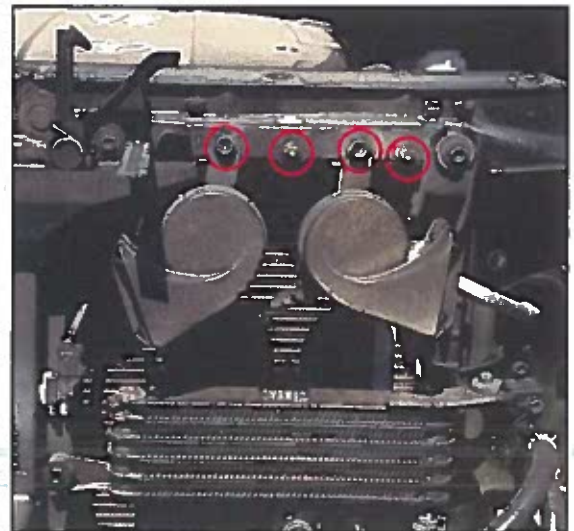
Figure 2.

- [2005](#) Tacoma:
Vehicle Exterior – Exterior Panels/Trim – “Front Bumper Cover: Replacement”
 - [2006](#) / [2007](#) / [2008](#) / [2009](#) / [2010](#) / [2011](#) / [2012](#) / [2013](#) / [2014](#) Tacoma:
Vehicle Exterior – Exterior Panels/Trim – “Exterior: Front Bumper: Removal”
 - [2005](#) Tacoma:
Vehicle Exterior – Door/Hatch – “Hood: Adjustment”
 - [2006](#) / [2007](#) / [2008](#) / [2009](#) / [2010](#) / [2011](#) / [2012](#) / [2013](#) / [2014](#) Tacoma:
Vehicle Exterior – Door/Hatch – “Engine Hood/Door: Hood: Disassembly”
2. Remove upper radiator support plastic cover (if applicable).
 3. Remove hood lock lever, horn, and horn cable for clearance.

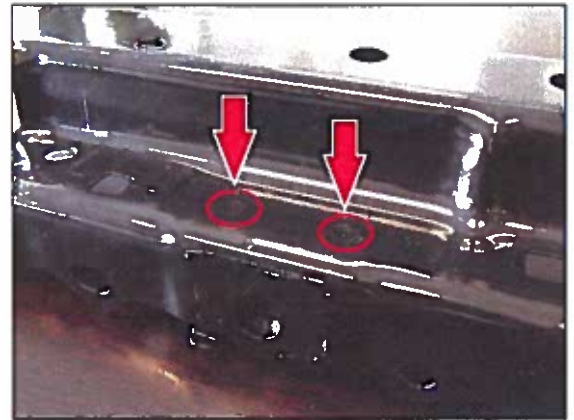
Figure 3.

4. Identify 4 spot welds (2 per bracket) retaining the horn mount weld nut brackets to the upper radiator support (Figure 3). If horn mount weld nut brackets are missing, proceed to Preparation for Horn Mounting Bracket Installation.

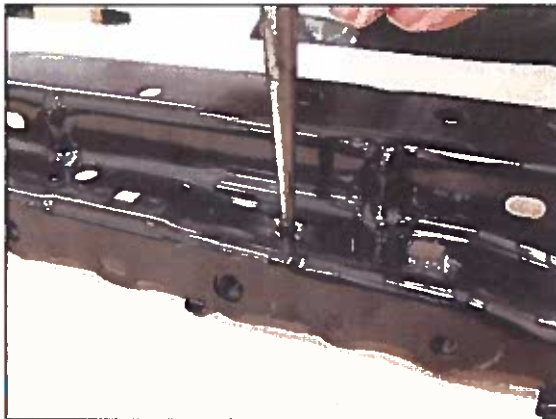
Figure 4.

5. Center punch spot welds (Figure 4), then drill using 5/16 inch spot weld cutter or equivalent drill bit (Figure 5).

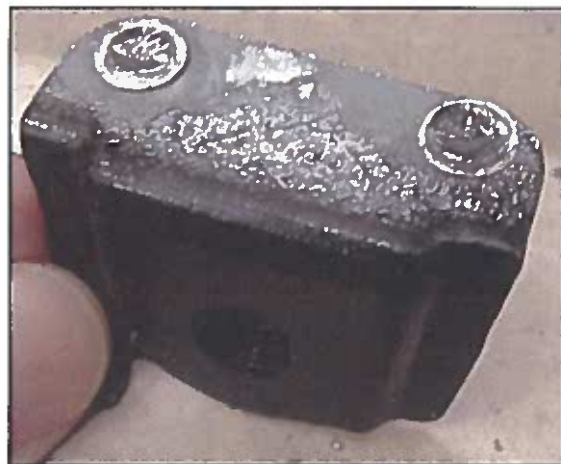
6. Remove original horn mount weld nut bracket from underside of upper radiator support and discard.

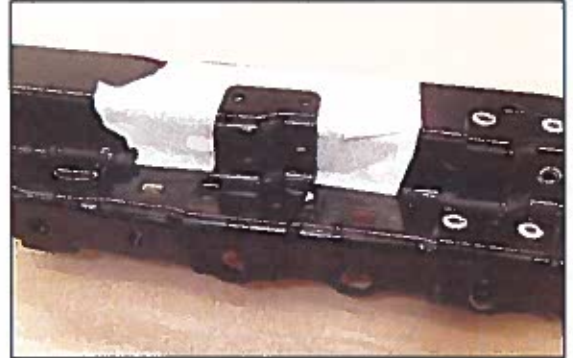
Figure 7.

1. Remove any burrs or rough edges on the upper radiator support.
2. Apply masking tape to the upper radiator support as shown. Temporarily install and center Horn Mounting Bracket No. 2 onto the upper radiator support.

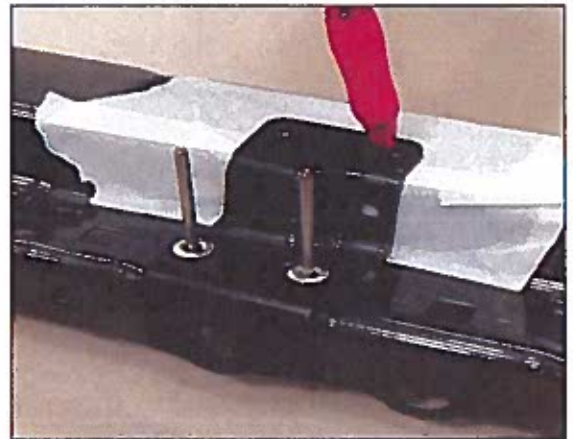
Figure 8.

3. Using the supplied rivets, align the bracket with the removed spot welds. Using the bracket as a template, mark the 3 hole locations onto the upper radiator support with a pen as shown.

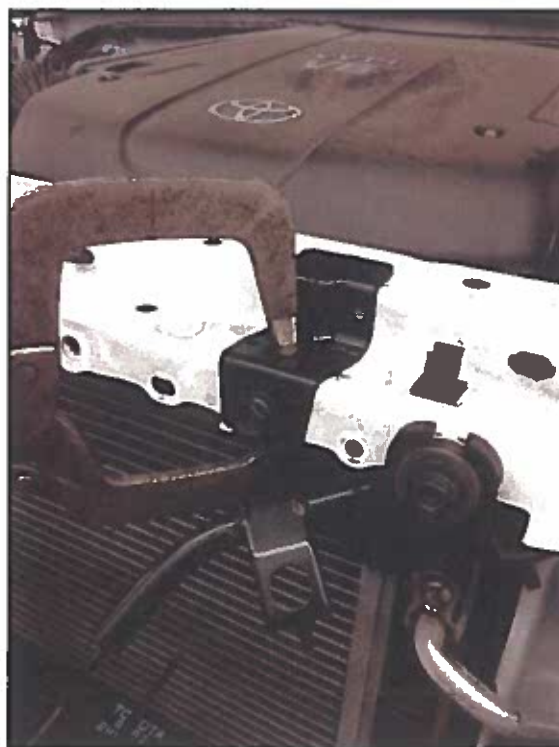
4. Using a vise grip, clamp Horn Mounting Brackets No. 2 and No. 3 together. **Figure 9.**

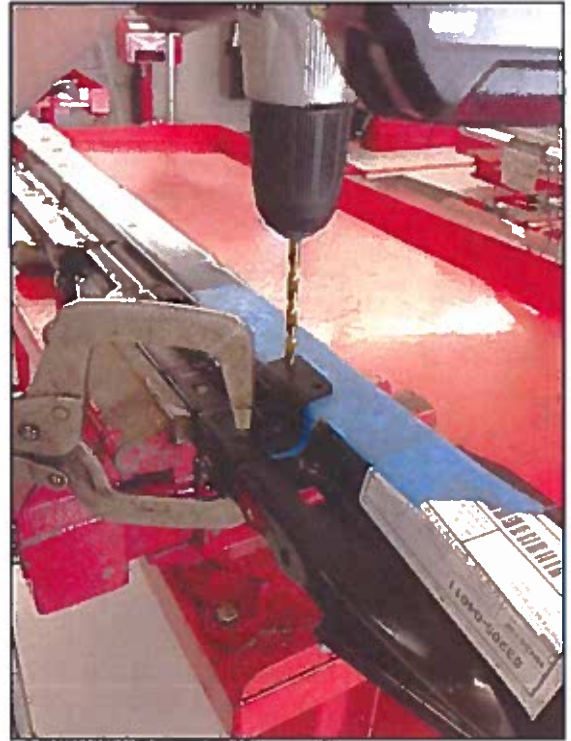
5. Using a 5 mm drill bit, drill 5 hole locations through Horn Mounting Bracket No. 3. **Figure 10.**

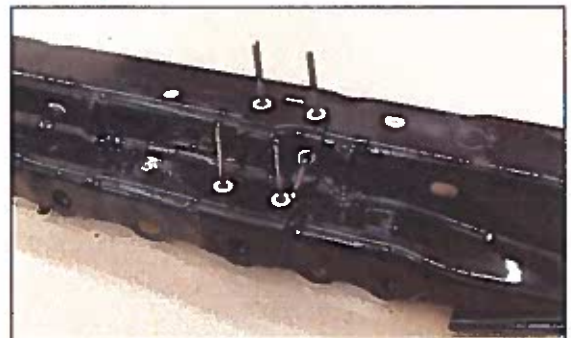
6. To prevent corrosion, use an automotive grade paint primer to coat the edges of the holes that were drilled. A brush-on type is recommended for a more accurate application.
7. Test fit all 5 rivets through Horn Mounting Bracket No. 2, upper radiator support, and Horn Mounting Bracket No. 3. **Figure 11.**

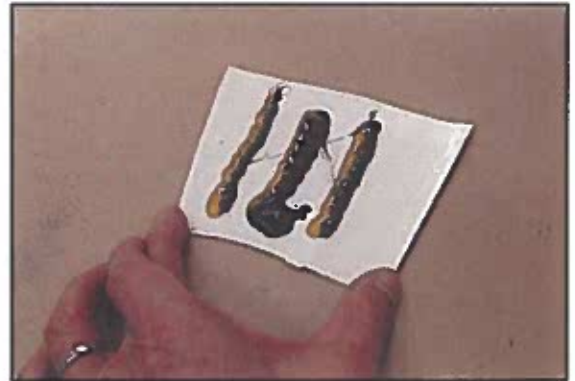
Figure 12.

- A. Dispense three 2-inch beads of epoxy panel adhesive and mix thoroughly.

Epoxy Panel Adhesive:
3M™ Scotch-Weld™ Epoxy Adhesive DP125
 or
3M™ Panel Bonding Adhesive 08115
 or
LORD Fusor® 380NS/383NS Adhesive,
 or Equivalent

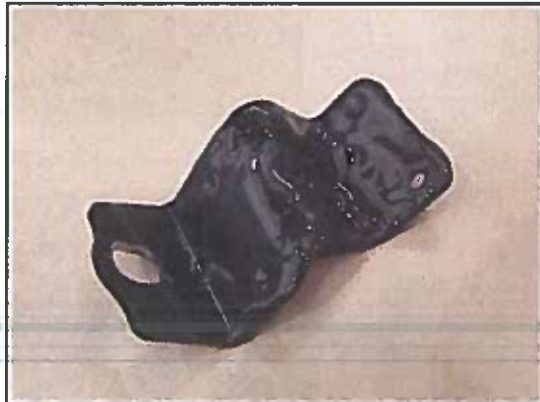
- B. Apply epoxy panel adhesive to the bottom side of Horn Mounting Bracket No. 2 (Figure 13) and top side of Horn Mounting Bracket No. 3 (Figure 14), and set onto the upper radiator support aligning the bracket holes to the upper radiator support holes.

Figure 13. Adhesive Applied to Bottom of Horn Mounting Bracket No. 2

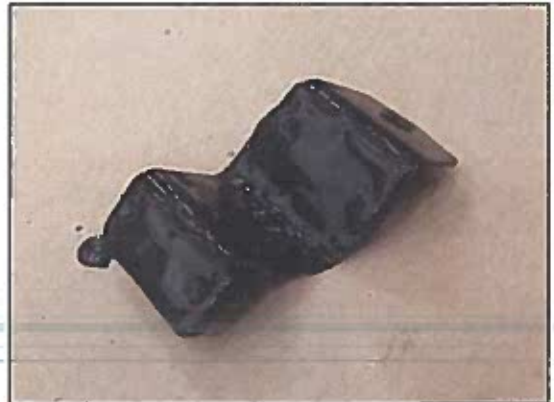
Figure 14. Adhesive Applied to Top of Horn Mounting Bracket No. 3

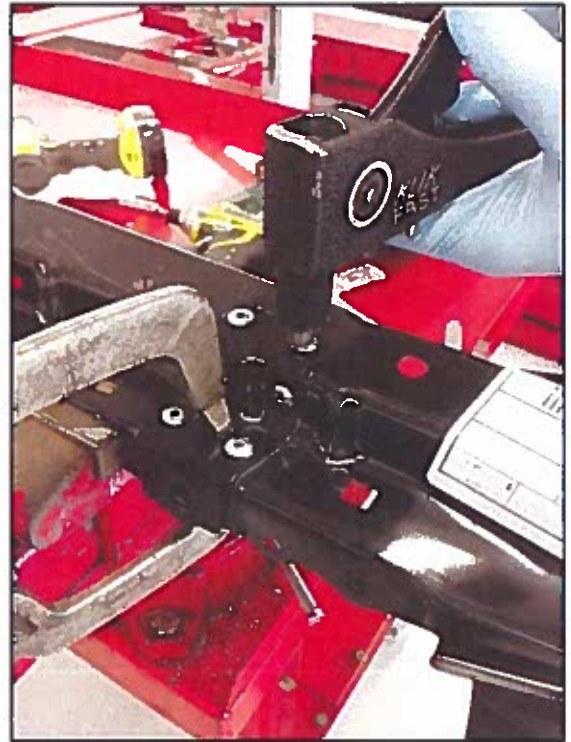
Figure 15.

- E. Permanently install the 5 rivets making sure both Horn Mounting Brackets No. 2 and No. 3 have been secured to the upper radiator support.

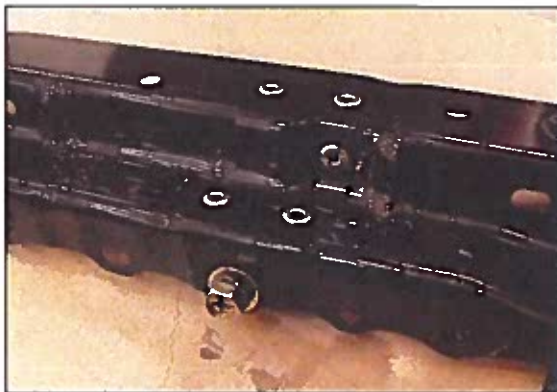
Figure 16. Top View of Completed Repair

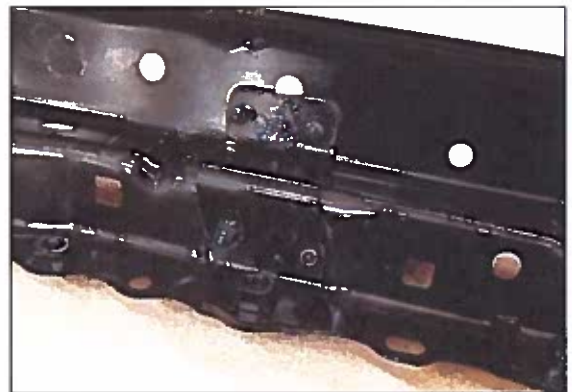
Figure 17. Underside View of Completed Repair
