Excess Headlamp Moisture

Service Category Vehicle Exterior

Section Lighting (ext)

Introduction

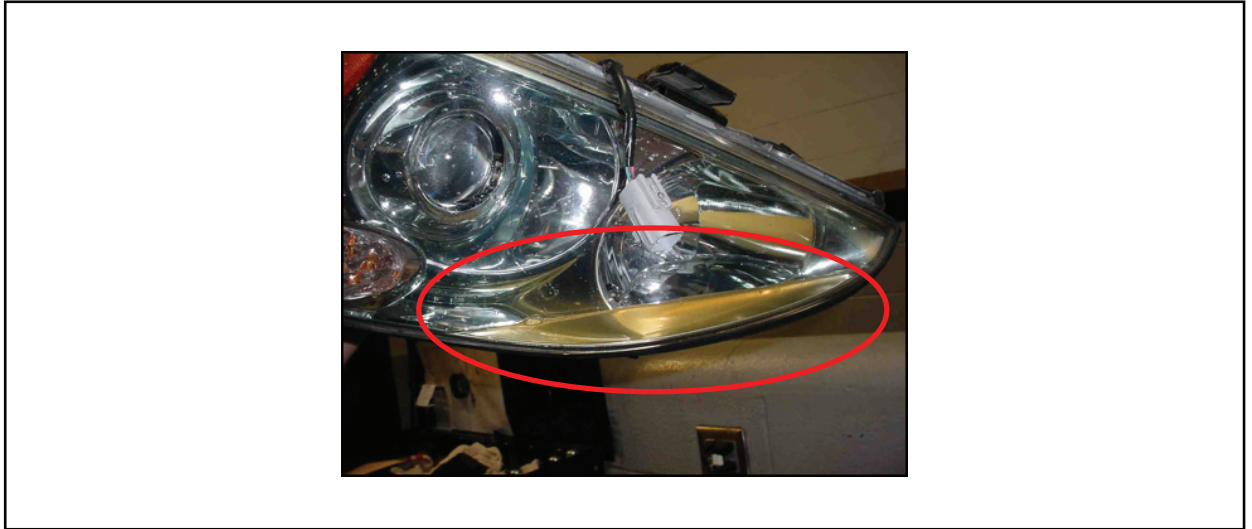
Figure 1. Examples of Excess Moisture: Pooling

Figure 1 shows pooling of water at the bottom of the headlamp.

2. Is there excess moisture on the interior of the headlamp(s)?
 - **YES** — Continue to step 3 for the headlamp housing.
 - **NO** — This bulletin does NOT apply.
3. Remove and replace the headlamp housing.

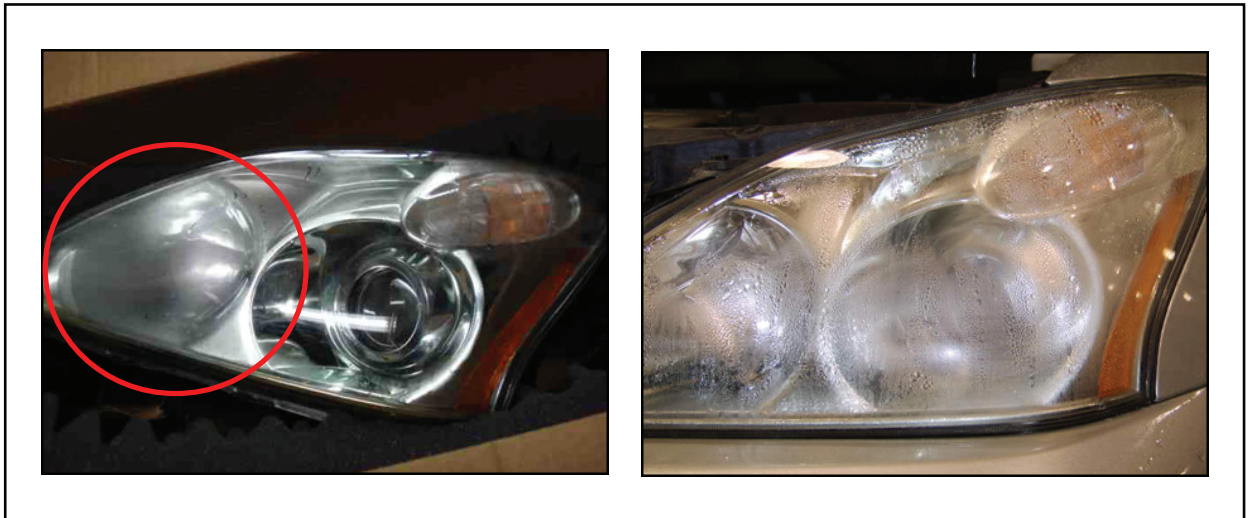
Figure 2. Examples of Excess Moisture: Streaks

Figure 2 shows noticeable streaks that run down the interior of the headlamp lenses that do not clear with normal use of the vehicle in dry weather conditions.

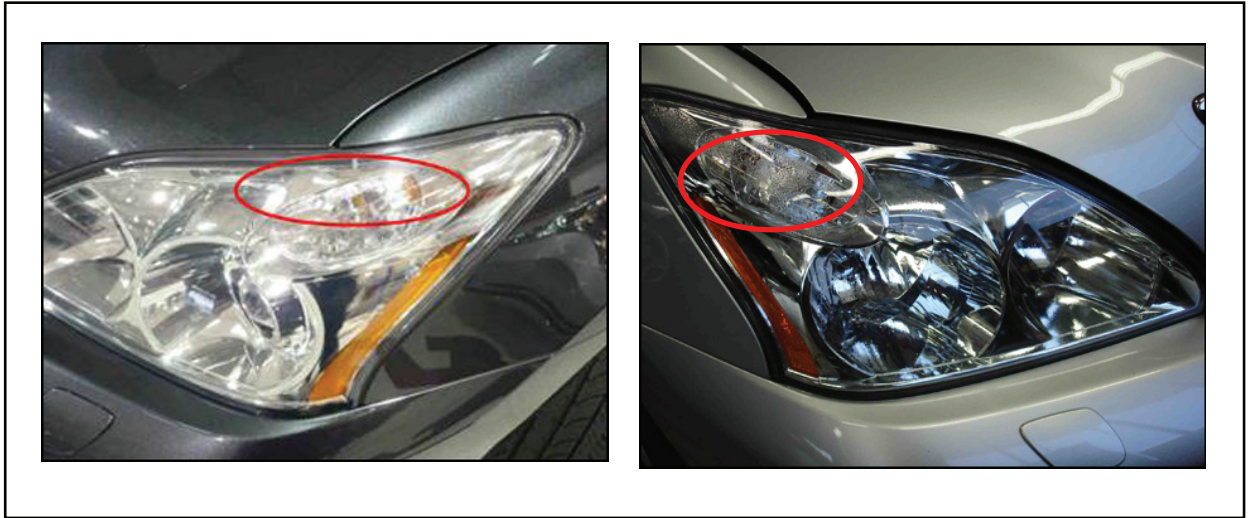
Figure 3. Examples of Normal Moisture

Figure 3 shows normal moisture on the interior of the headlamp lens.
