Power Steering Rack Leak from Right Side: Overhaul Procedure

YEAR(S)	MODEL(S)	ADDITIONAL INFORMATION
2004 – 2009	RX330, RX350	WMI(s): 2T2

The information contained in this bulletin supersedes SB No. L-SB-0107-12.

A new repair procedure and overhaul kit have been developed for repairing the power steering rack to improve the overall serviceability and reduce ownership cost. This repair procedure only applies to vehicles where the steering rack leak is originating from the right (passenger) side **and** is the OEM steering rack assembly.

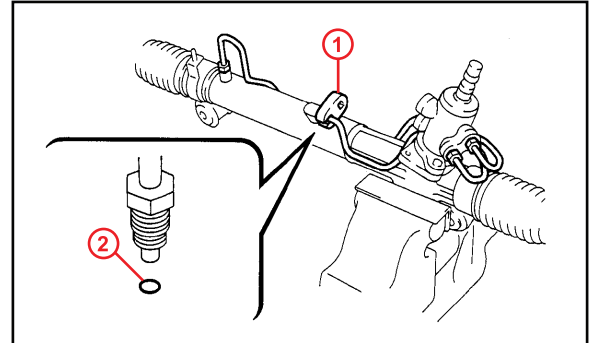
Figure 1.

1. Prepare the steering rack by steering the rack to the left-hand lock (clockwise).
2. Remove the steering left turn pressure tube.
 - A. Remove the tube clamp from the turn pressure tubes.
 - B. Using a 12 mm Union Nut Wrench (or equivalent), disconnect the left turn pressure tube.
 - C. Remove the 2 O-rings from the left turn pressure tube and discard.

1	Union Nut Wrench, 12 mm (or equivalent)
2	O-ring

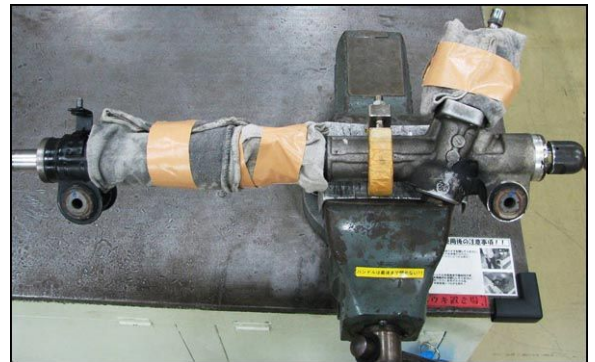
Figure 2.

3. Remove the steering right turn pressure tube.
 - A. Disconnect the right turn pressure tube using the procedure above.
 - B. Remove the 2 O-rings from the right turn pressure tube and discard.

Wrap the steering rack in cloth or shop rags to capture any excess power steering oil that will leak during the repair.

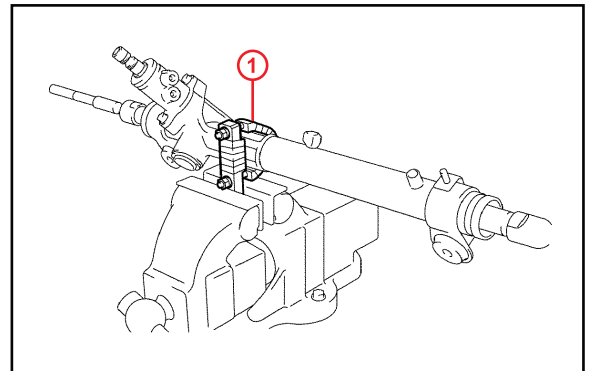
Figure 3.

4. Using the Rack & Pinion Holding Tool, secure the steering link assembly to prevent damaging the steering link assembly.

Wrap the SST with tape before use, in order to prevent damaging the steering link assembly.

1	Rack & Pinion Holding Tool
----------	---------------------------------------

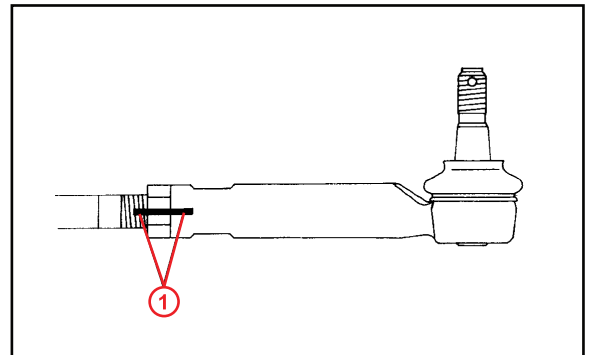
Figure 4.

5. Put matchmarks on the tie rod assembly and the rack end.

1	Matchmarks
----------	-------------------

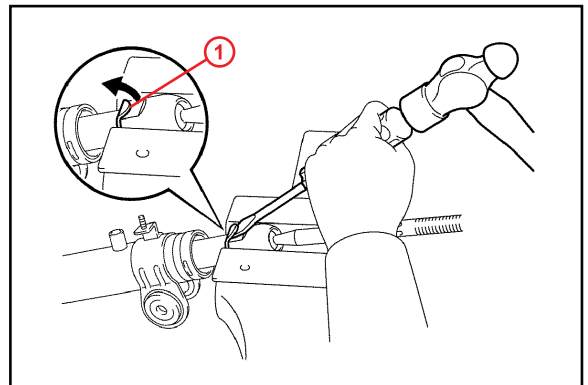
- A. Using soft jaws, clamp the steering rack end as shown in Figure 5.

This step is necessary to avoid transmitting impact to the steering rack gear and steering pinion gear which may cause damage.

1 Claw Washer

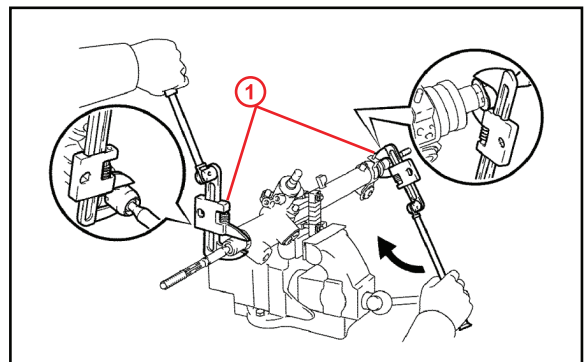
Figure 6.

- B. Using a screwdriver and a hammer, unstake the claw washer.

- C. Using the Variable Open Wrench, remove the right-hand rack end and the claw washer.
SST: 09922-10010-01, Variable Open Wrench

1 Variable Open Wrench

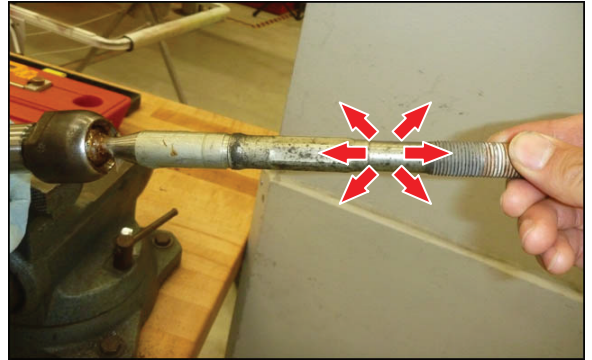
Figure 7.

14. Inspect the left-hand and right-hand tie rod ends for excessive wear and play. Push and pull the tie rod to confirm condition. Replace as necessary.

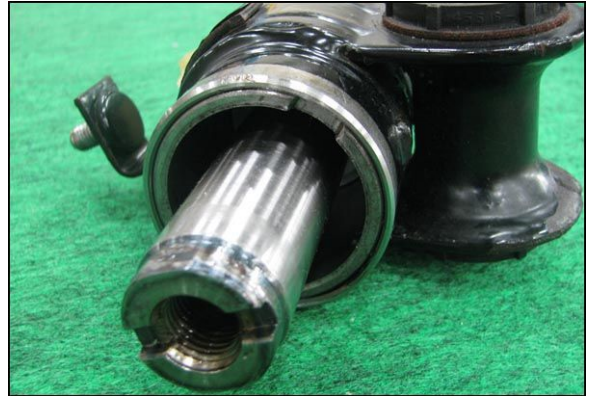
Figure 8.

15. Thoroughly clean the steering rack assembly.

Be sure to clean the inside of the rack assembly to prevent foreign material from damaging the rack surface (for example, when boot has torn and allowed debris to collect around the inside of the rack).

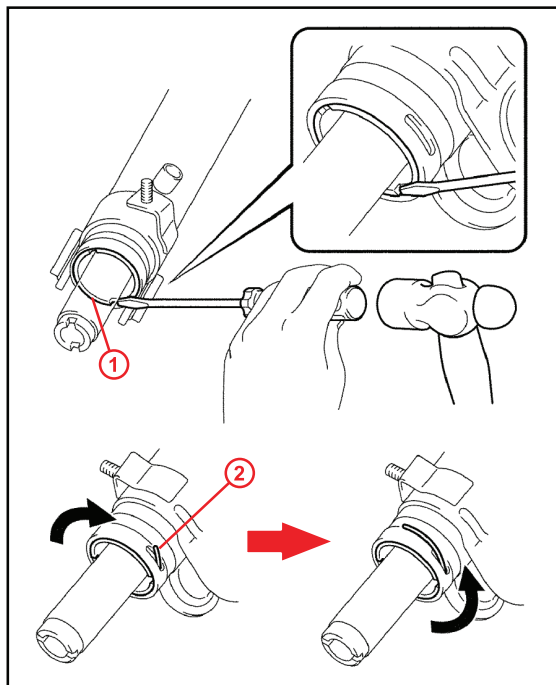
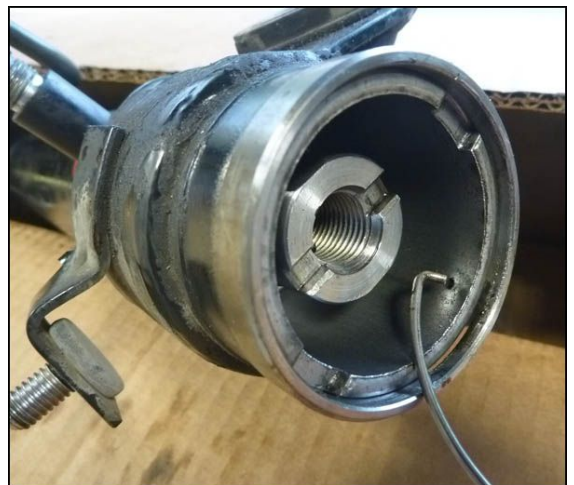
Figure 9.

- A. Using a screwdriver and a hammer, turn the cylinder end stopper clockwise until the wire end is visible through the service hole.
- B. Using a screwdriver and a hammer, turn the cylinder end stopper counterclockwise, and remove the wire and the cylinder end stopper.

Use the hooked wire end or a 90 degree angle hooked pick to pull the end stopper out.

1	Cylinder End Stopper
2	Wire

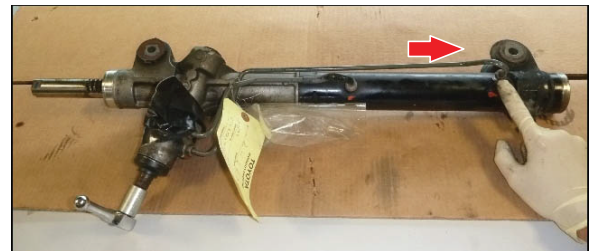
Figure 11.

Plug the port while simultaneously turning the input shaft counterclockwise.

The internal air pressure will cause the rack bushing to get pushed out.

Do NOT turn the input shaft clockwise. May cause damage to the center seal on the rack bar if it goes beyond its normal travel.

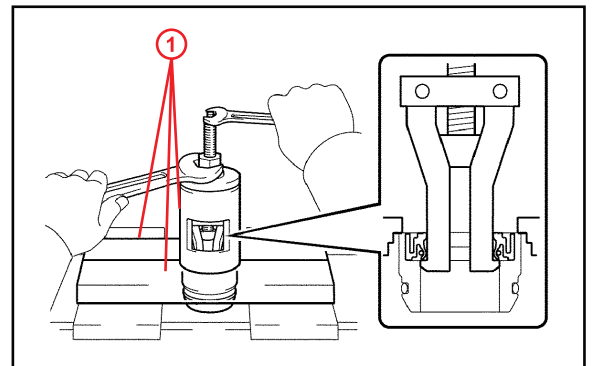
Figure 12.

- A. Using the SSTs listed below, remove the rack bushing oil seal from the rack bushing.

- B. Using a screwdriver or pick, remove the O-ring from the rack bushing.

1	Rear Axle Shaft Bearing Remover (or equivalent), Puller
----------	--

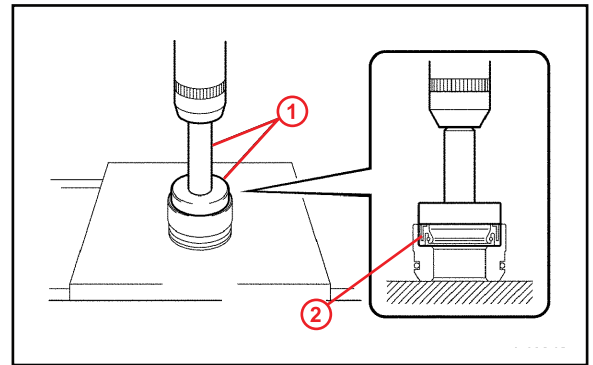
Figure 13.

20. Install the power steering rack bushing seal.
 - A. Coat a new rack bushing oil seal lip and outside diameter with power steering oil.
 - B. Using the SSTs listed below and a press, install the rack bushing oil seal to the rack bushing.

SST: 09950-70010-02, Handle Set (09951-07100-01, Handle Assembly 100 - 4.25")
 - C. Coat a new O-ring with power steering oil and install it to the rack bushing.

1	Replacer 40, Handle Assembly 100 - 4.25"
2	Oil Seal

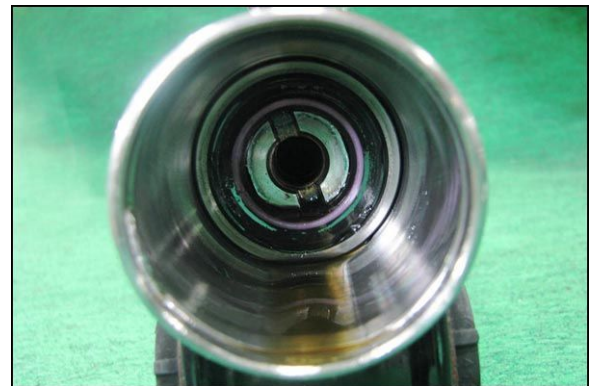
Figure 14.

21. Inspect and clean the inside of the rack housing.

Look down inside the rack housing to confirm it is clean before reinstalling the rack bushing.

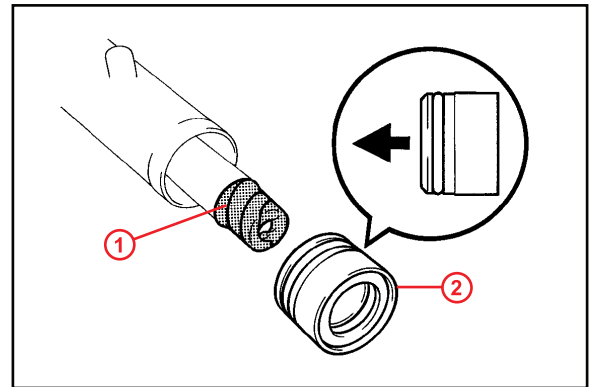
Figure 15.

22. Install the power steering rack bushing to the rack housing.
 - A. Wrap vinyl tape around the end of the steering rack in order to prevent damaging the rack bushing oil seal.
 - B. Coat the rack bushing oil seal lip, vinyl tape, and the O-ring with power steering oil.
 - C. Install the rack bushing to the rack housing.

1	Vinyl Tape
2	Rack Bushing

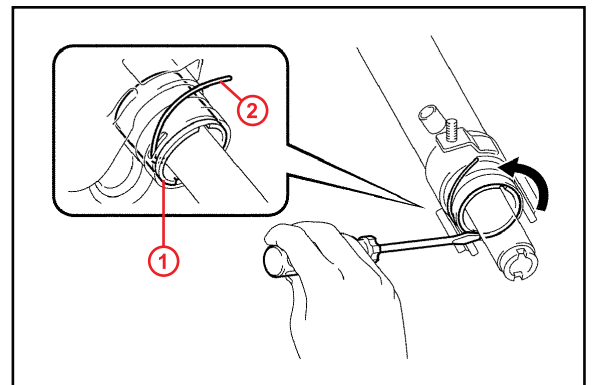
Figure 16.

23. Install the cylinder end stopper.
 - A. Align the installation hole for the wire of the cylinder end stopper with the slot of the rack housing.
 - B. Install a new wire into the cylinder end stopper.
 - C. Using a screwdriver, turn the cylinder end stopper counterclockwise by $450^{\circ} \pm 50^{\circ}$.

1	Cylinder End Stopper
2	Wire

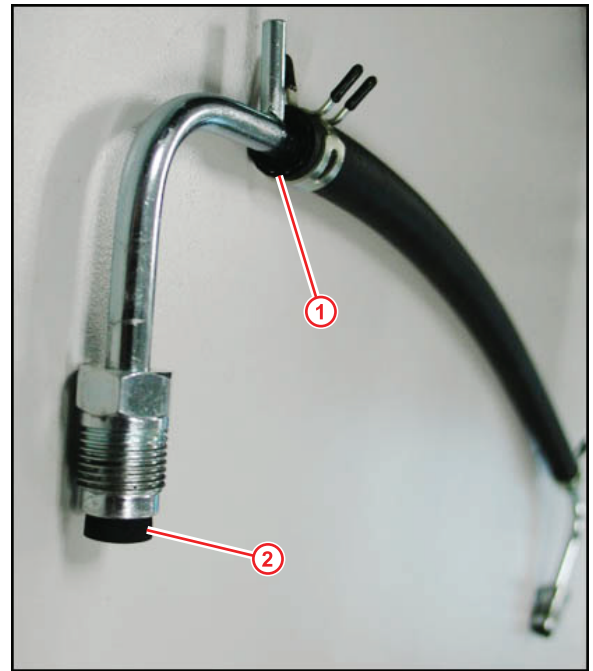
Figure 17. Vacuum Pressure Tester Seal

1. Remove the old O-ring and install 2 Vacuum Pressure Tester Seals to ensure proper sealing during testing.

1	Vacuum Pressure Tester
2	Tester Seal

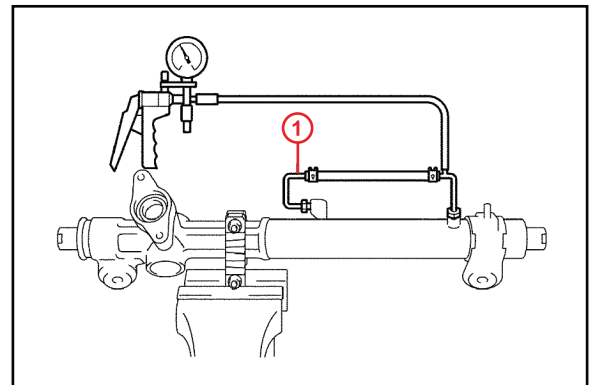
Figure 18.

2. Install the SSTs to the rack housing.
SST: 09631-12071, Steering Rack Oil Seal Test Tool
SST: 09633-00010-01, Tester Seal (2)

NOTE
Be sure not to over-torque the SST as it can crush the opening of the seal shut and cause inaccurate reading.

1	Steering Rack Oil Seal Test Tool, Tester Seal
---	---

3. Apply a vacuum of 53 kPa for about 30 seconds.
Vacuum Pressure: 53 kPa (400 mmHg, 15.75 in.Hg)

4. Check that there is no change in the vacuum. If there is a change in the vacuum, check the installation of the oil seals.
5. Remove the 2 seals when SST is removed from the steering rack housing.

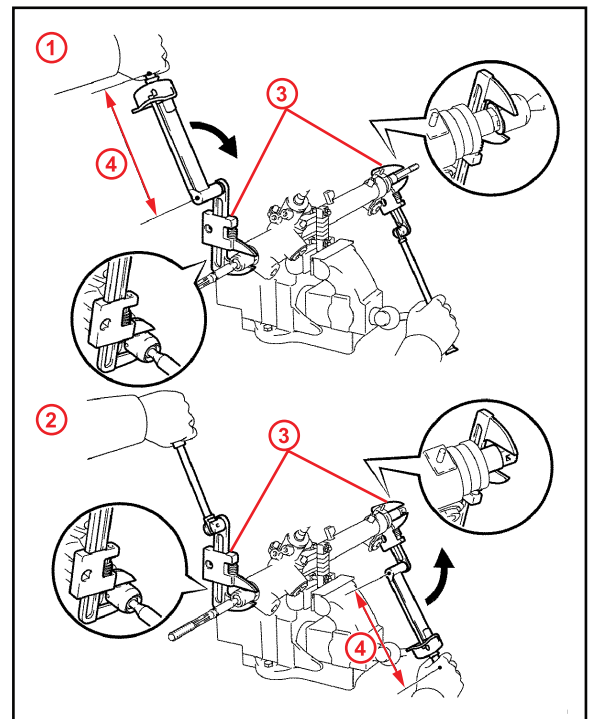
Figure 19.

- B. Using the Variable Open Wrench SST, install the rack end sub-assembly.

SST: 09922-10010, Variable Open Wrench
Torque: 50 N*m (505 kgf*cm, 37 ft*lbf)

Use the Variable Open Wrench following the direction shown in the illustration. Failure to follow this procedure will result in the tie rod not being tightened to the proper torque.

- Using the Variable Open Wrench, hold the rack and install the rack end sub-assembly.
- Use a torque wrench with a fulcrum length of 345 mm (13.58 in.).

1	LH
2	RH
3	Variable Open Wrench
4	Fulcrum Length

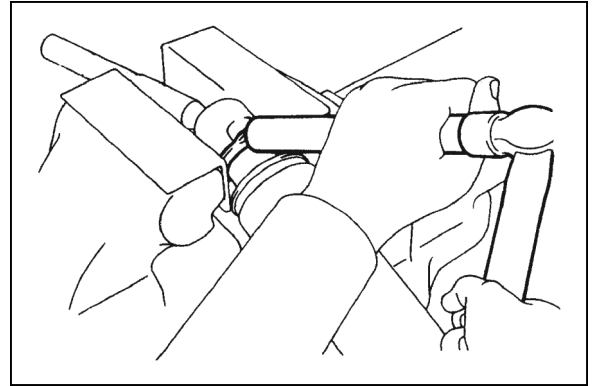
Figure 20.

2. Use a brass bar and a hammer to stake the claw washer.

Clamp the tie rod as shown to help avoid any impact to the steering rack.

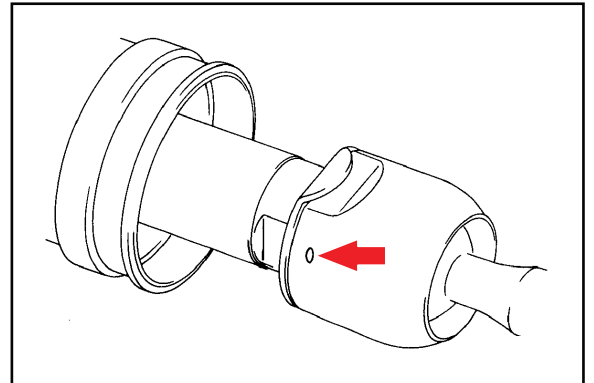
Figure 21.

3. Inspect the power steering rack end. Ensure that the holes of the rack ends are NOT clogged with grease.

If the hole is clogged, the pressure inside the boot will change after it is assembled and steering wheel is turned.

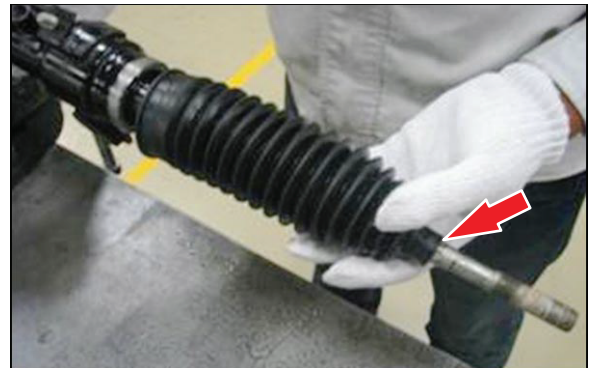
Figure 22.

4. Install the steering rack boot.
 - A. Apply a small coat of silicone grease to the inside clamping surface of the small end of the boot as shown.
 - B. Install the steering rack boot.
 - C. Install the steering rack boot clip using pliers.

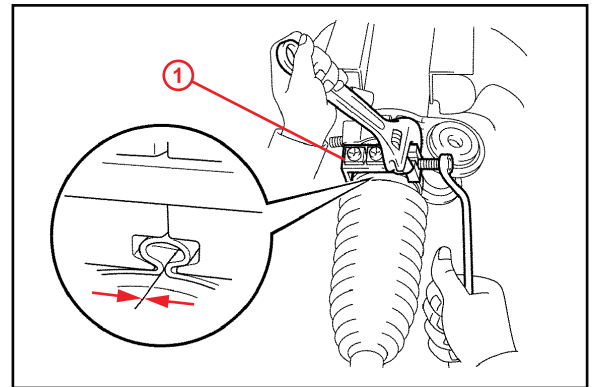
Figure 23.

Using the SST, tighten the rack boot clamp as shown in the illustration.

Clearance: 3.0 mm (0.18 in.) or less

1	Drive Shaft Boot Clamping Tool
----------	---------------------------------------

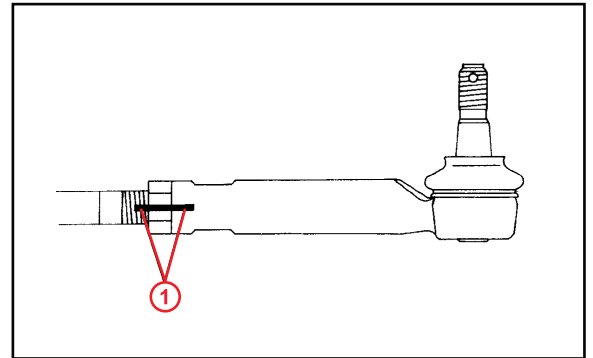
Figure 24.

Screw the lock nut and tie rod assembly on the rack end until the matchmarks are aligned.

Torque: 74 N*m (750 kgf*cm, 54 ft*lbf)

1	Matchmarks
----------	-------------------

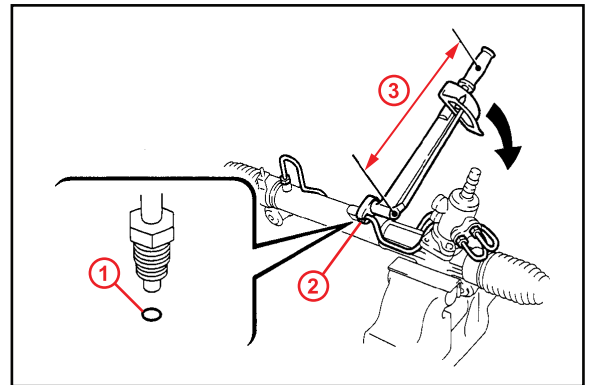
Figure 25.

9. Install the steering left turn pressure tube.
 - A. Coat 2 NEW O-rings with power steering oil and install them to the left turn pressure tube.
 - B. Using a 12 mm union nut wrench (or equivalent), install the left turn pressure tube to the steering link assembly.

Torque: 12 N*m (122 kgf*cm, 9 ft*lbf)

Use a torque wrench with a fulcrum length of 250 mm (9.84 in.).

1	O-ring
2	Union Nut Wrench, 12 mm (or equivalent)
3	Fulcrum Length
