2014 Tundra Vehicles With Steel Bumper Ultrasonic Parking Sensor Installation

Park Assist False Activation on Vehicle with Steel Bumpers

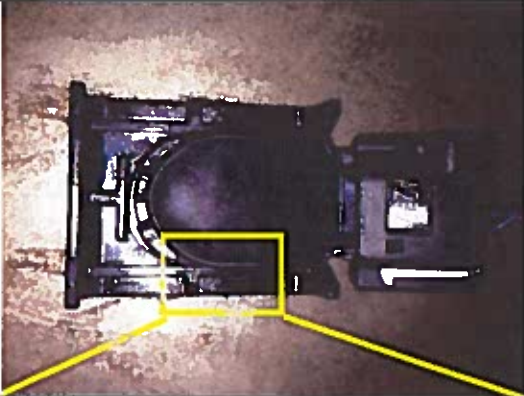
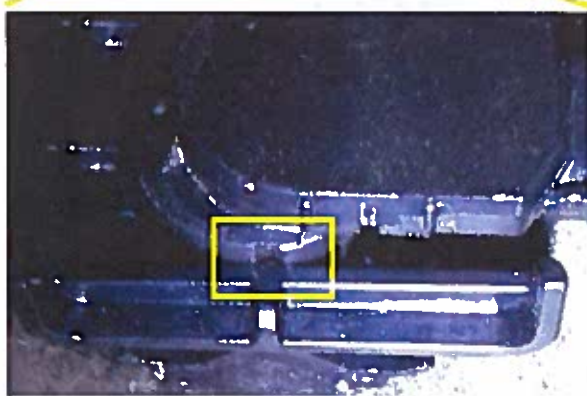
OK

Sensor retainer is installed straight. Retainer locking tab is seated all the way onto the sensor.

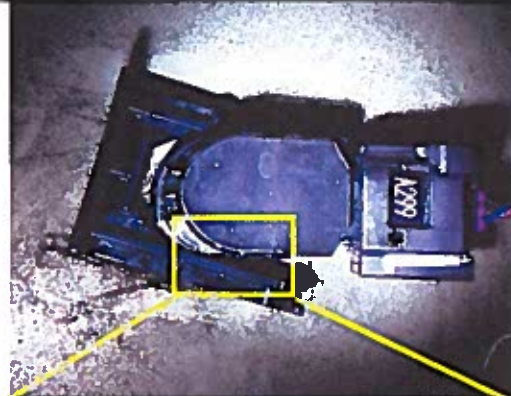
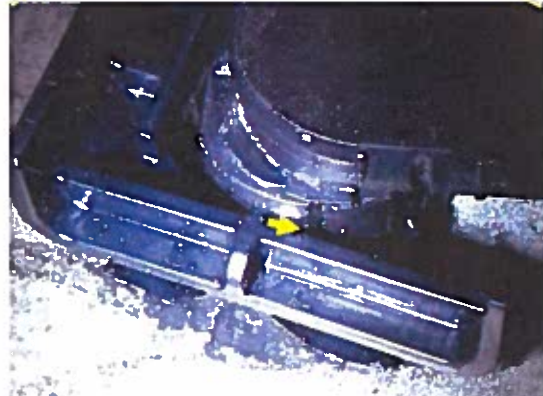
NG

Sensor retainer is not installed straight. Retainer locking tab is not seated all the way onto the sensor.

- **Do not reuse the ultrasonic sensor retainer** on vehicles that have a false activation concern
- When reinstalling an ultrasonic sensor into the steel bumper, pay special attention to step 2 sub section (a) in the repair manual document for sensor installation.
