## Odor from the air conditioning

Topic number	LI83.30-P-059119
Version	1
Design group	83.30 Air conditioning
Date	05-28-2014
Validity	Model series 166
Reason for change	
Reason for block

Odor from the air condition at series 166

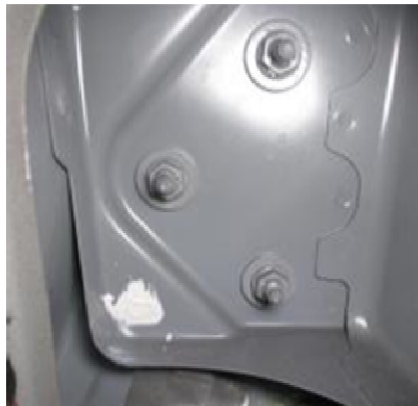
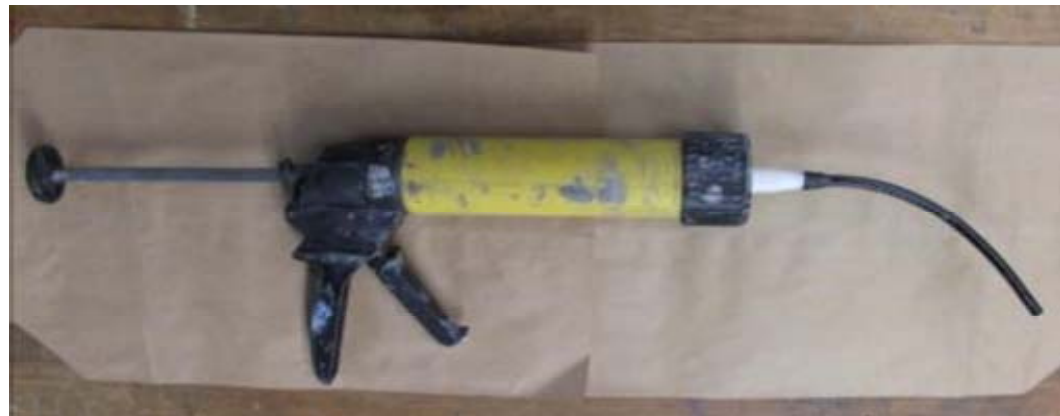
# Close hole (9) with sealing A 005 989 6320

Lead hose through the hole (9) to the skin paneling side panel. Pull out the hole slowly and apply sealing material until the cavity between the panels is completely filled.

- Seal off bodyshell holes (9, 10) with seam sealant as per "Repair instructions TIPS.pdf". To apply the seam sealant, fit the hose on the cartridge nozzle and pass it through the bodyshell hole (9, 10).

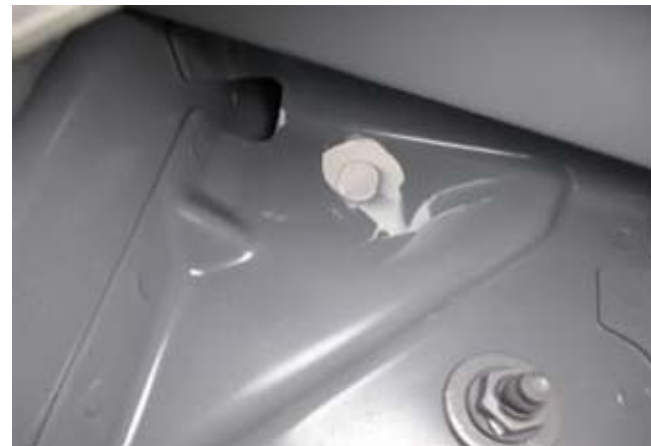
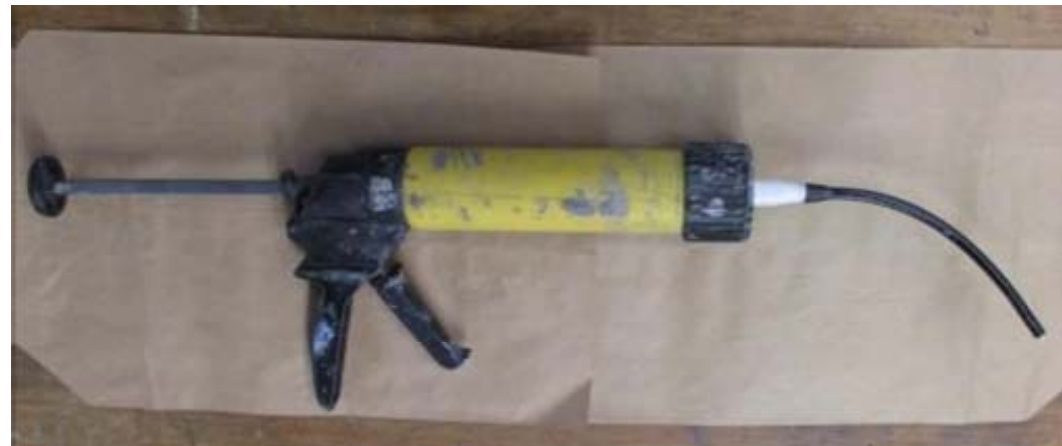
# Close hole (10) with sealing A 005 989 6320

Lead hose through the hole (10) to the skin paneling side panel. Pull out the hole slowly and apply sealing material until the cavity between the panels is completely filled.
