Squeaking noises from top of B-pillar when raising and lowering front door side window

Topic number	LI67.30-P-059214
Version	1
Design group	67.30 Side windows
Date	06-16-2014
Validity	Model series 166 up to VIN end no. A 417029
Reason for change	
Reason for block

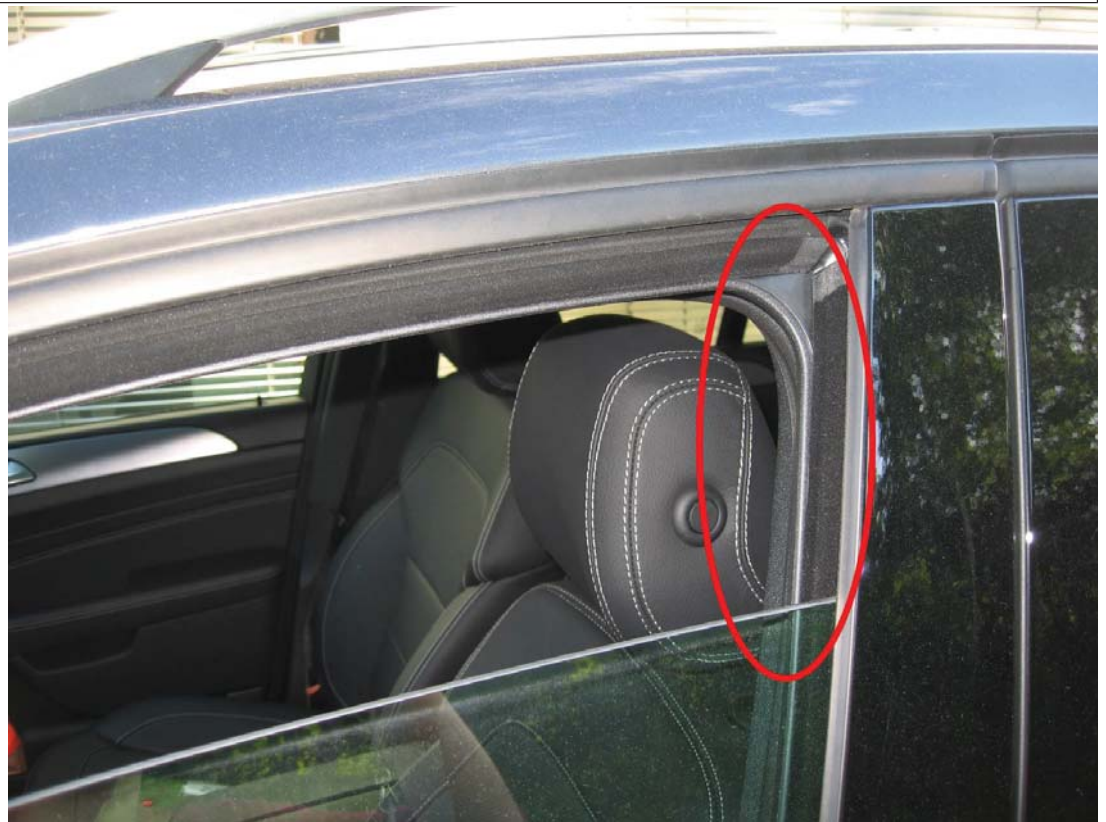
Bild 1.jpg:

Squeaking noises from top of the B-pillar when raising and lowering the front door side window, see Figure 1.

Attachments	
File	Description
Bild 1.jpg	Area causing the noise

During assembly the side window was pulled too tightly against the window guide rail at the top in the area of the B-pillar.

This produces a high pressure on the bottom lip of the window guide rail which causes squeaking noises when the window is raised.

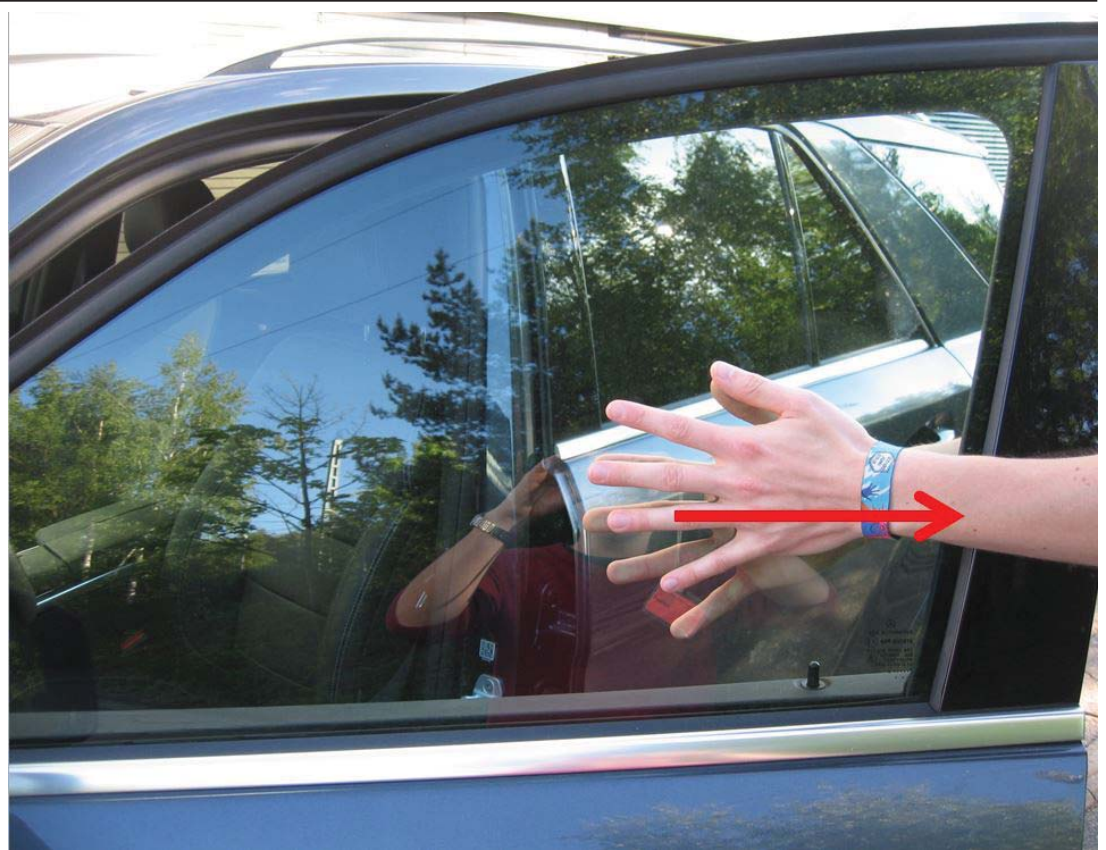
Bild 2.jpg:

Attachments	
File	Description
Bild 2.jpg	Pulling window horizontally against B-pillar

Readjust side window.

- Remove door lining
- Move side window to assembly position
- Loosen bolts until the side window can be moved
- Pull side window horizontally against B-pillar, holding the side window at the bottom, see Figure 2.
- Tighten bolts
- Install door lining
