Service Bulletin

Subject: Information on Active Noise Cancellation (ANC) Microphone Change and Identification Guide

Models: 2010-2014 Chevrolet Equinox
2010-2014 GMC Terrain
Equipped with Noise Control Active Interior (RPO VQN)

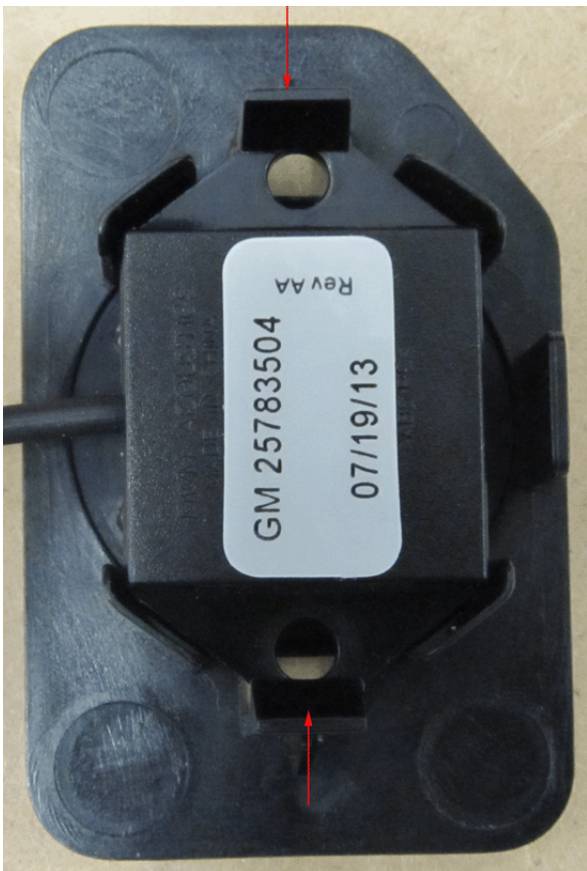
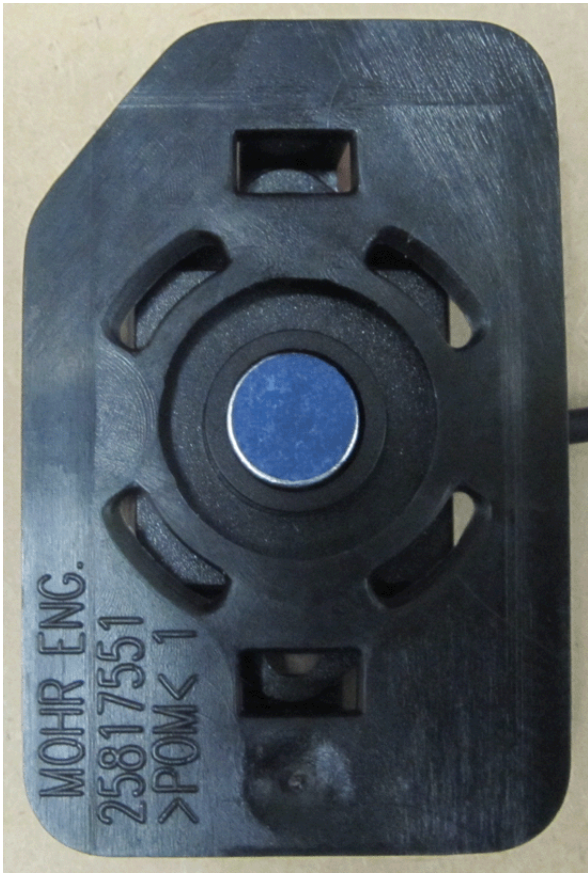
The old ANC microphone, P/N 25783504, has locking tabs with no mounting holes, as shown in the illustration above, which holds the microphone in place on the insulator.

The two designs are not interchangeable. The two designs can be identified using the following pictorial guide below.

Important: If the wrong microphone is installed into the vehicle, the system will not work.

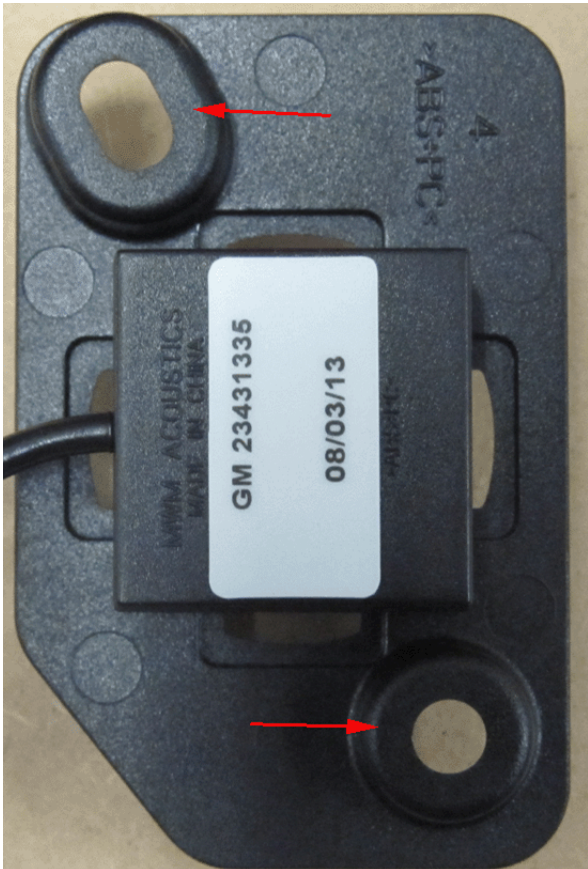
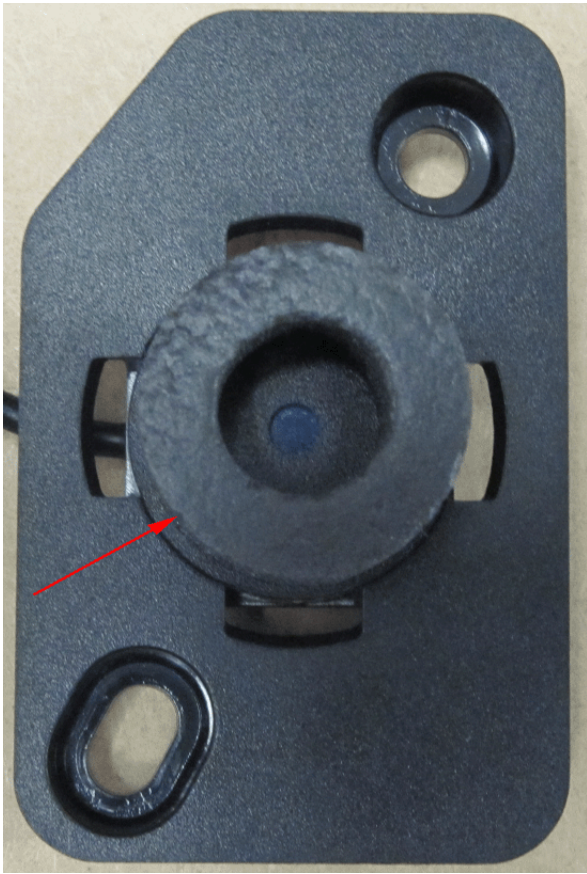
The new ANC microphone, P/N 23431335, uses screws and comes with a foam ring on the face of the microphone as shown in the illustrations above.
