Service Bulletin

PRELIMINARY INFORMATION

Subject: Groan, Squeak or Rubbing Type Noise When Turning Steering Wheel

Models: 2010-2014 Buick LaCrosse
2012-2014 Buick Verano
2012-2014 Buick Regal
2012-2014 Chevrolet Cruze, Volt
2013-2014 Chevrolet Malibu
2014 Chevrolet Impala

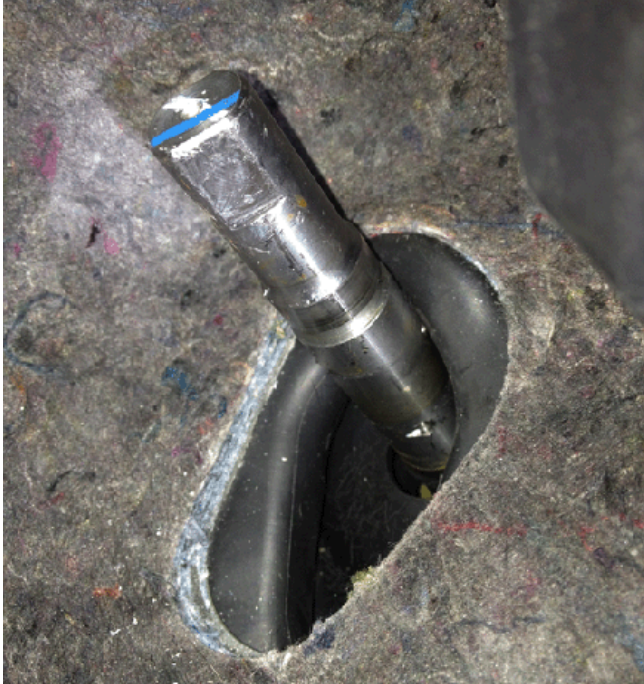
Condition/Concern (Impala)

Some customers may comment on a rubber squeak type noise when turning the steering wheel. This condition may be caused by the seal for the intermediate shaft, located at the front of dash, rubbing on the rotating intermediate steering shaft. Refer to the pictures above.

Technicians should inspect the steering column seal for proper installation by repositioning the inner intermediate steering shaft boot assembly to gain access. Inspect the seal at the front of the dash where the intermediate steering shaft passes through from the steering gear. Ensure that the seal is centered in the opening and around the intermediate steering shaft as shown above. If the seal is out of position, replace the steering column seal following the steps below.

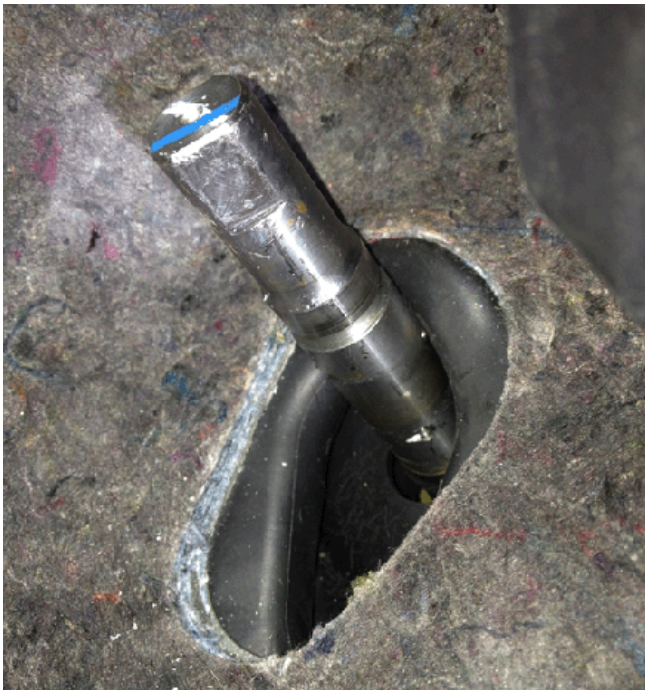
Condition/Concern (Malibu)

Some customers may comment on a rubber squeak type noise when turning the steering wheel. This condition may be caused by the seal for the intermediate shaft, located at the front of dash, rubbing on the rotating intermediate steering shaft. Refer to the pictures above.

The EPS wire harness bracket may also be contacting the steering column seal.

Technicians should inspect the steering column seal for proper installation by repositioning the inner intermediate steering shaft boot assembly to gain access. Inspect the seal at the front of the dash where the intermediate steering shaft passes through from the steering gear. Ensure that the seal is centered in the opening and around the intermediate steering shaft as shown above. If the seal is out of position, replace the steering column seal following the steps below.

Technicians should also inspect the EPS wire harness bracket if equipped and make sure that the bracket is not contacting the steering column seal. If contact is observed, manually adjust the EPS bracket to obtain an 8-12 mm (0.31-0.47 in) clearance from the steering column seal.
