Service Bulletin

PRELIMINARY INFORMATION

Subject: Missing Nut on Stud for 100 Amp Fuse

Models: 2014 Chevrolet Corvette

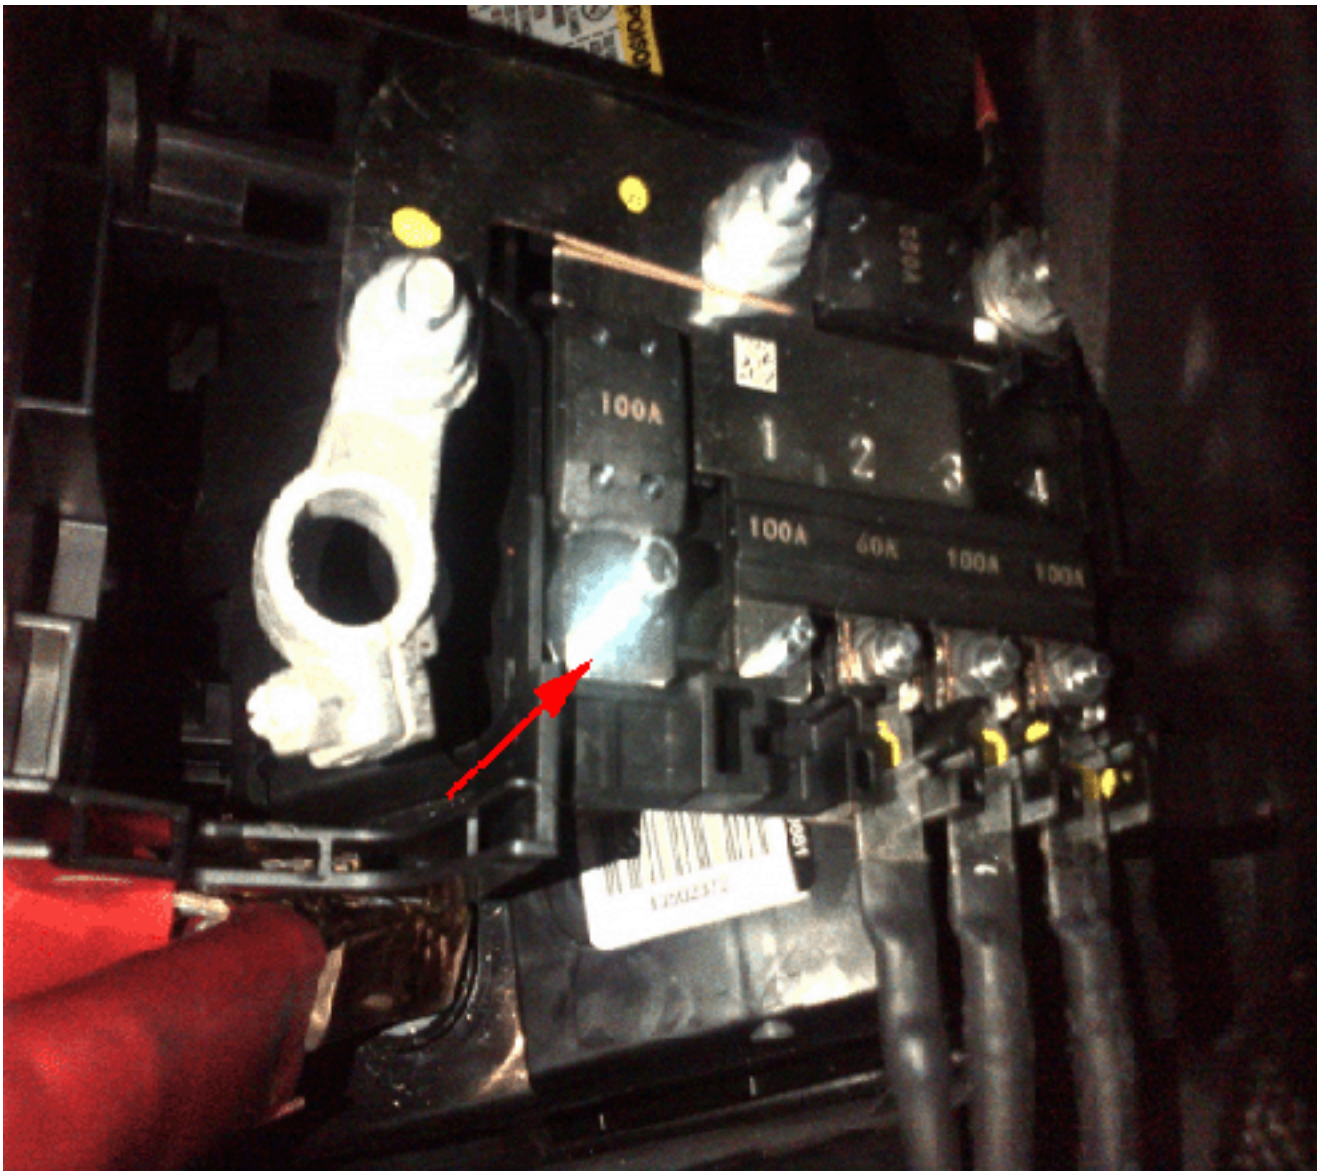
The purpose of the PI is to inform the customer and dealership personnel that the stud for the 100 amp fuse does not require a nut as shown in the illustration above. This fuse block is a common part and the Corvette does not use the 100 amp fuse.

Note: **DO NOT** order a nut for the 100 amp fuse.
