# **Service Bulletin**

Bulletin No.: 02-08-98-002E

Subject: Hem Flange Rust Repair

Models: 2014 and Prior GM Passenger Cars and Trucks

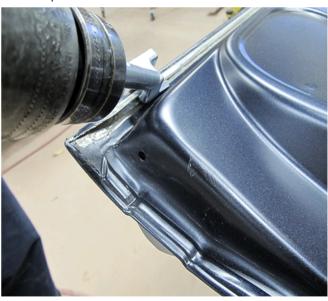
3706159

- 1. Remove the affected body panel from the vehicle and place on a clean non marring work surface.
- 2. Clean the hem flange area with wax and grease remover.
- 3. Inspect the area for rust perforation or "micro pin holes."

**Important:** If perforation is present, replace the affected panel.

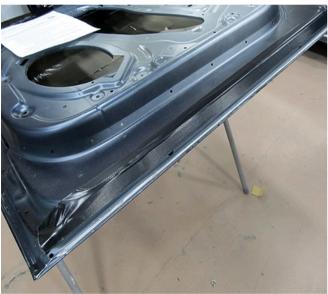
3706172

- 5. Protect the adjacent area with cloth protective (duct) tape.
- 6. Sand blast the rust area. Ensure all of the rust is removed leaving clean bare metal.

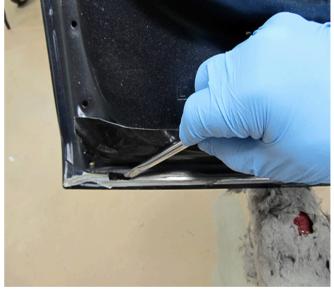
3706185

If sand blasting is not available, remove the rust using a 3-M Scotch-Brite™Clean and Strip Disc, Part # 07466, abrasive wheel.

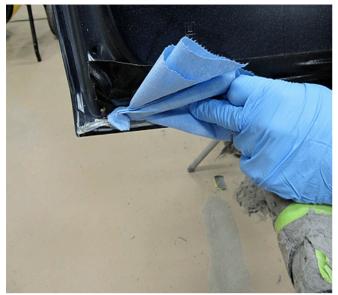
3706190

7. Using \*Lloyd's Pure Prep™ Metal Surface Preparation P/N 25418 (10 fluid ounce bottle) in a spray bottle, saturate the complete flange area with the pre-diluted solution and scrub the area well, rendering a foaming of the Pure Prep.™ This will greatly improve adhesion and corrosion resistance in the repair areas.

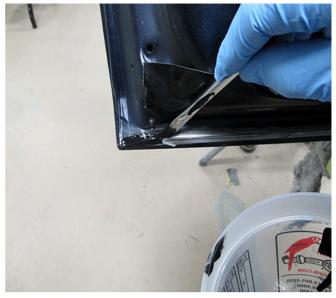
3706205

- Using a water dampened clean towel, remove any residue and dry the affected area. Dry the repair area completely using an air hose to blow dry the frame
- Check the repair area for phosphate treatment by wiping it to see if any corrosion residue can be picked up. Correctly treated areas will not have any residue on the surface.

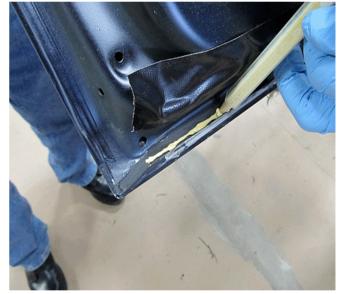
3706214

- Apply a light coat of \*Lloyds Kryptonite Metal Treatment P/N 36502 with a small brush as shown. This first coat should flash in approximately 3-5 minutes.
- 11. Apply a second coat of Lloyds Kryptonite.

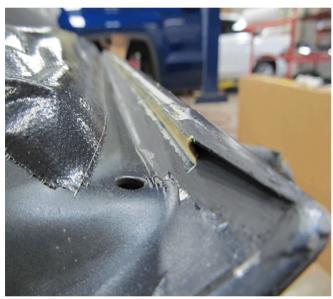
3706234

12. Using a small tip opening, apply a small bead of seam sealer such as \*LORD Fusor® 806HD (beige) = 10.5 oz (310.5 mL) or the equivalent to the open joint area.

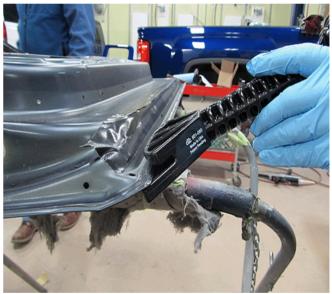
3706573

14. Close the hem flange using the flange closing tool.

Make an initial pass with the tool parallel to the door outer panel.

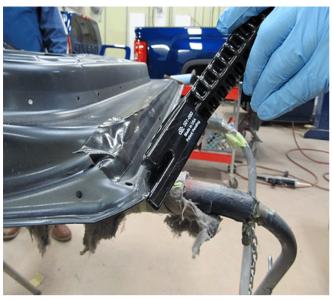
3706594

Make a second pass with the tool at a 40° angle towards the inner panel to close the flange completely.

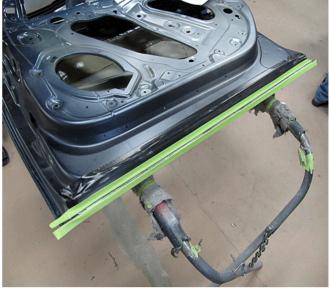
3706625

15. Mask the area as shown to create a 10 mm (0.40 in) wide sealer area.

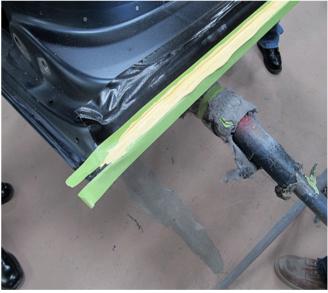
3706635

16. Apply a bead of \*LORD Fusor® 806HD (beige) = 10.5 oz (310.5 mL) or the equivalent, as shown to completely seal the hem flange.

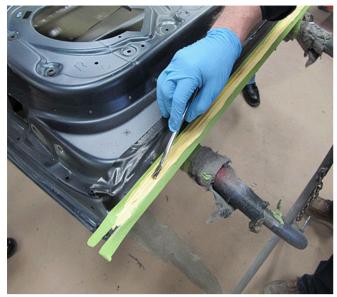
3706645

Use a small brush to finish the area, the sealer will self level to remove any brush marks.

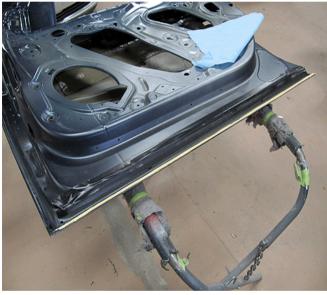
3706653

#### 17. Remove the masking tape.
