Service Bulletin

Subject: Illumination of Rings Around Volume, Menu, and Temperature Knobs of Center Stack

Models: 2014 Chevrolet Silverado 1500
2014 GMC Sierra 1500

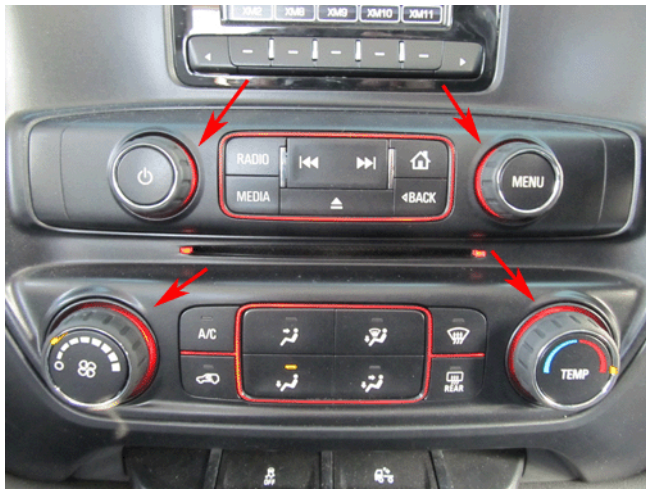
GMC Sierra

Some customers may comment that the Halo Rings around the four center stack knobs on their vehicle do not illuminate as shown in some of the marketing materials.

At the beginning of production for 2014, these rings were not illuminated. As a running change, these rings are now illuminated.

Explain to the customer their vehicle is operating normally.

Do not attempt to repair or replace any parts to alter the original vehicle design intent. You may wish to give the customer a copy of this bulletin.
