# Service Bulletin

Bulletin No.: P11290

**Subject:** Inside Rearview Mirror is Loose and/or Mirror Mounting Bracket Fell Off

**Models:** 2015 and Prior GM Passengers Car and Light Duty Trucks

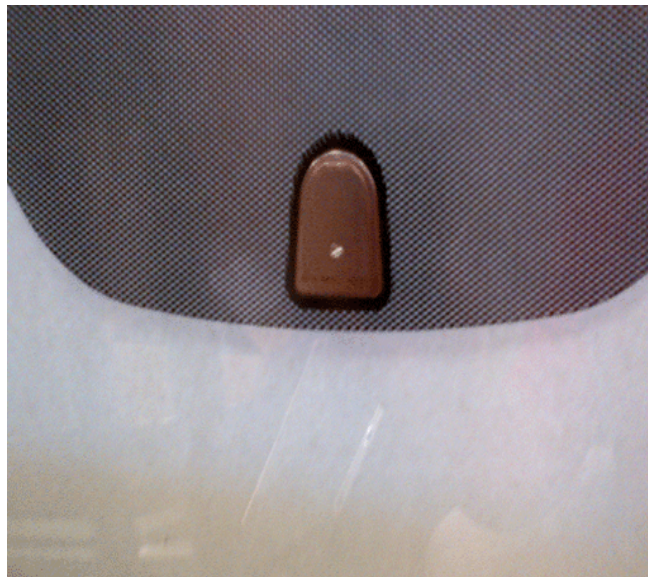
3963625

Some customers may comment that the inside rearview mirror is loose or the mirror mounting bracket fell off. This condition may be due to the adhesion from the mirror bracket to the windshield.

Replace the windshield glass assembly. The bracket comes installed on the new windshield glass assembly. Refer to Windshield Replacement in SI.

**Important:** DO NOT attempt to reinstall the bracket onto the windshield.
