Service Bulletin

Bulletin No.: PI0686C

Subject: Front Seat Lateral Movement, Clunk, Squeak, Click Noise or Shift While Cornering

Models: 2012-2015 Buick Regal
2012-2015 Buick Verano
2011-2015 Chevrolet Cruze
2013-2015 Chevrolet Malibu
2014-2015 Chevrolet Impala (VIN 1)
2014 Chevrolet SS

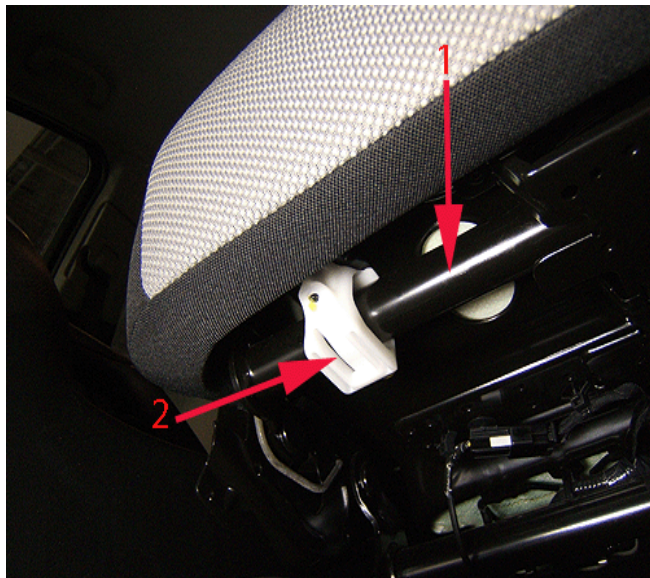
2773104

Note: Cruze shown, all others similar.

2. Locate the front crossbar as shown (1).
 - Identify the inboard guide block (2) on manually adjusted seats (closest to center console).
 - Identify the outboard guide block (2) on power adjusted seats (closest to door).

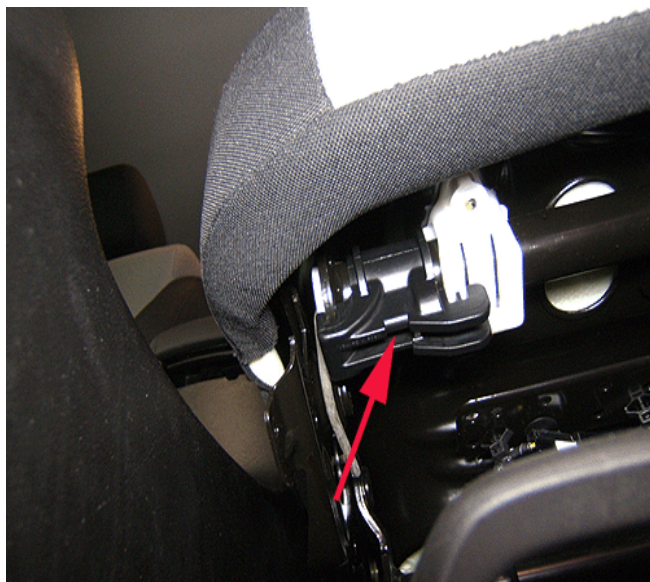
2773109

3. Install the clip as shown. Ensure the clip is fully seated around the crossbar and on the guide block.

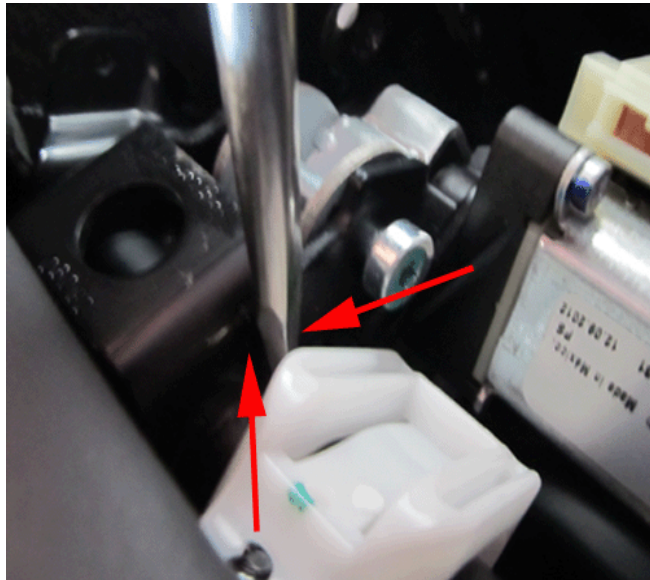
3932441

Note: You may need to move the crossbar using a flat head screwdriver to properly align the clip.

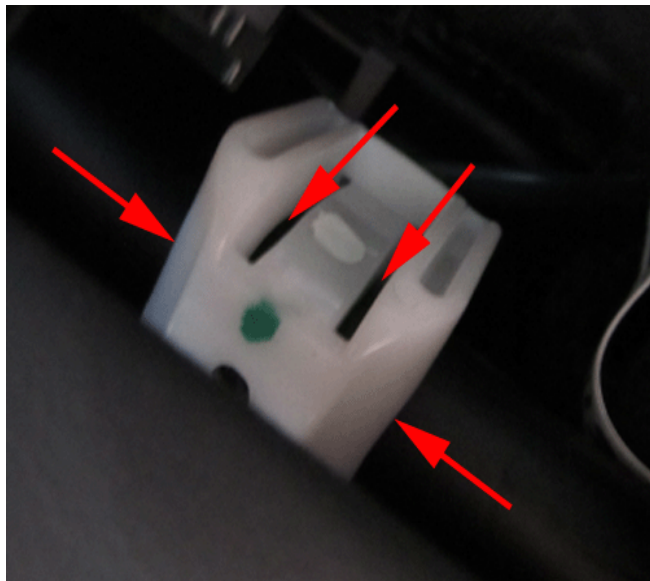
3931436

Note: Spray Super Lube, P/N 12346241 (in Canada, P/N 10953474), or equivalent to the areas on the white clip, as shown in the illustration above, to ensure that the noise is eliminated.

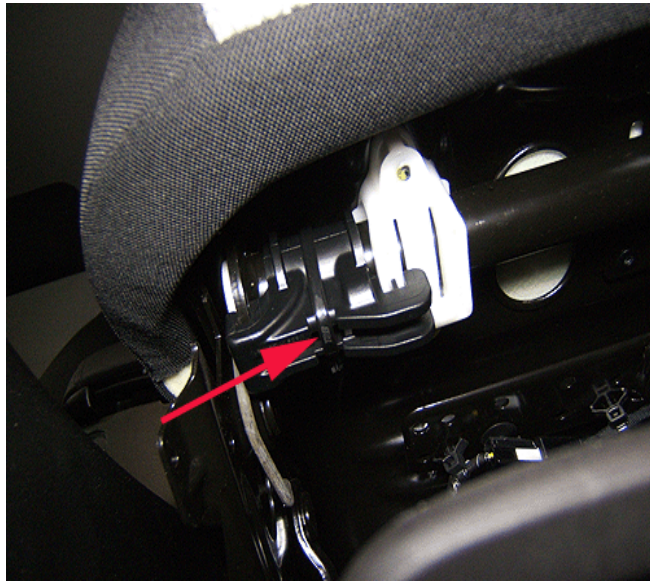
2773113

4. Install a nylon wire tie as shown. Trim the excess wire tie material.

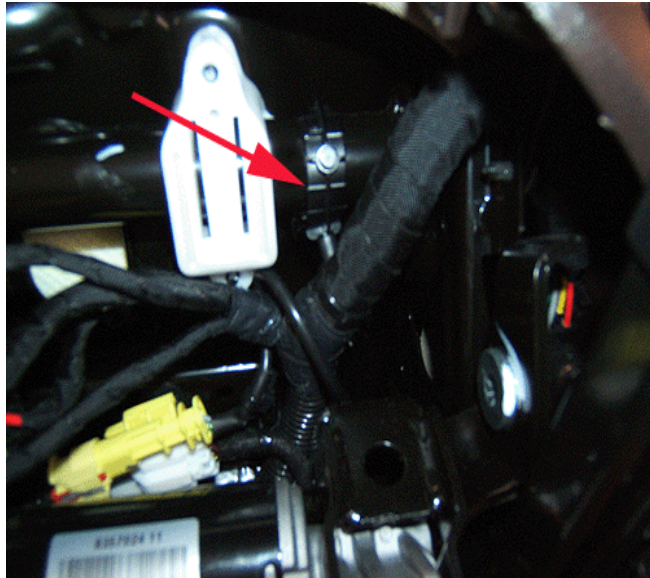
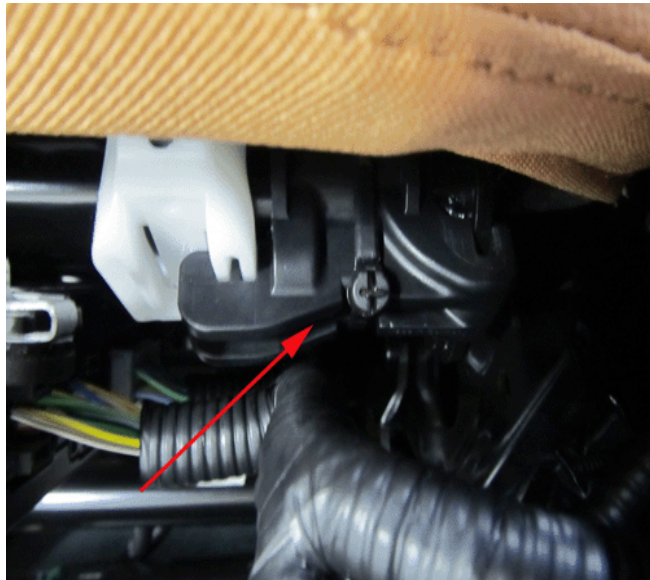
5. On vehicles equipped with power seats, there may be a wire harness attached to the crossbar where the clip is to be installed.
 - If there is a harness clipped to the seat crossbar, remove the harness and clip from the crossbar.
 - Cut the clip off of the harness.
 - Use a second wire tie to re-secure the harness to the new seat clip. Ensure the harness does not come into contact with the connector area of the first wire tie.
 - Ensure that the wire harness is still properly routed after this operation to avoid pinched/cut wires by the power seat mechanism.
