**NUMBER:** 08-075-14

Heated Mirror Feature Inoperable

This bulletin involves installing the correct HVAC control head, updating vehicle configuration and installing an overlay harness as necessary.

2014 (VF) ProMaster

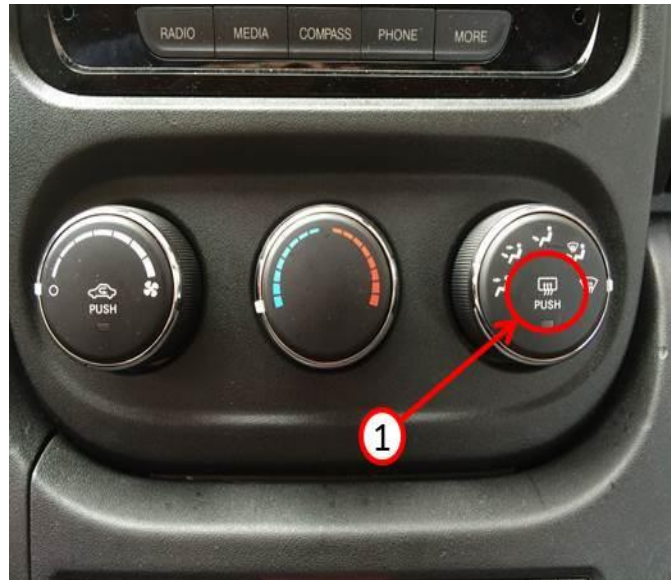
**Fig. 1 HVAC Control Head**

1 - Defrost Button

1. Does the HVAC control head contain the heat/defrost button (See Figure 1)?
  - a. If Yes>>> Proceed to Step 2.
  - b. If No>>> Proceed to Step 3.

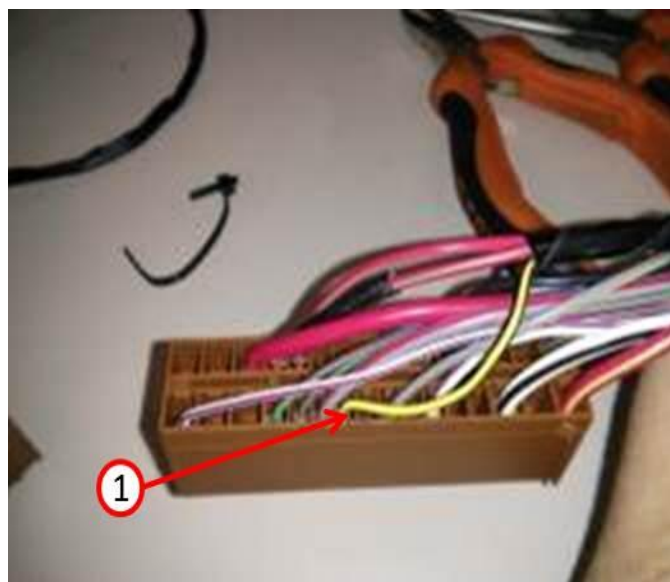
**Fig. 10 PDC Connector C1 Cavity 23**

- 1 - Cavity 23 YL/BK Circuit

12. Insert the YL/BK circuit terminal into cavity 23 of connector C1. Next, insert the untagged RD/GN circuit terminal into cavity 5. Finally, insert the tagged RD/GN circuit terminal into cavity 4 (See Figure 9, 10 & 11).

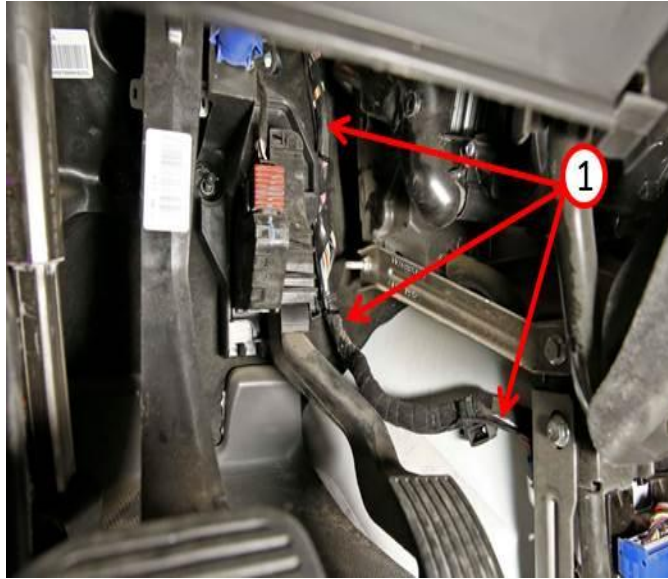
**Fig. 17 Overlay Harness Routing**

1 - Route harness along this path and secure using provided electrical tape

23. Route the remaining portion of the overlay harness around the pedal assembly bracket and secure to the existing harness using electrical tape (See Figure 17).

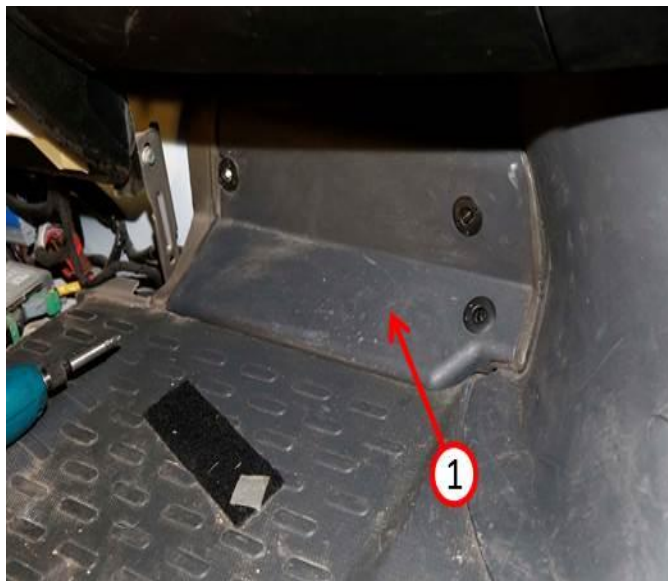
**Fig. 18 Toe Kick Panel**

1 - Toe Kick Panel

- 
24. Remove the screws securing the cup holder cover assembly and remove the cover.  
25. Remove the screws securing the lower dash toe-kick cover located on the passenger side of the vehicle. Remove the toe-kick cover (See Figure 18).
