NUMBER: 08-040-14

Police Vehicle A/C Inoperative

This bulletin involves relocating the A/C fuse within the front Power Distribution Center (PDC).

2011-2012 LD Charger

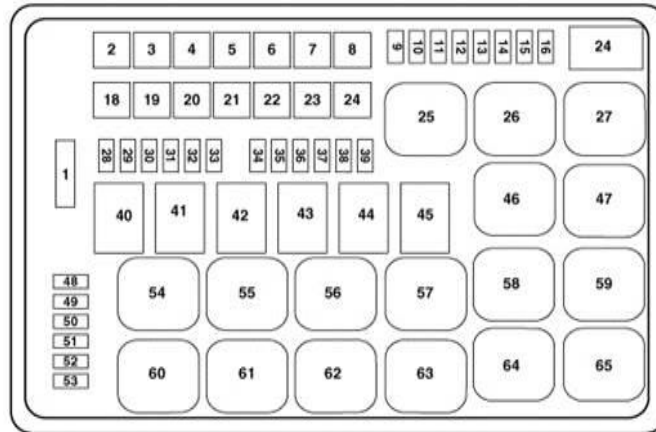
Fig. 1 Fuse Locations

Customer comments A/C is warm. On further inspection the technician will notice the A/C clutch fuse is loose in its cavity (#12) in the PDC. This will cause a poor connection and the fuse cavity to be distorted.

1. Refer to fuse location diagram for fuse cavity locations ([Fig. 1](#)).

2. Is there a 10 Amp fuse in cavity 12 of the PDC?
 - a. YES>>>Perform the repair procedure, proceed to next [Step #3](#).
 - b. NO>>> This Bulletin doesn't pertain, normal diagnostic needs to be performed.
3. Disconnect the battery.
4. Remove the main B+ battery feed from the front PDC.
5. Release the retaining tabs that secure the PDC to the mounting bracket.
6. Turn the PDC over to expose the bottom side of the PDC.
7. Remove the PDC bottom cover.
8. Remove and discard the white plastic terminal lock see ([Fig. 2](#)).

21. Install the front PDC to the mounting bracket.
22. Connect the B+ power feed to the front PDC.
23. Remove and discard the 10 amp fuse from cavity 12 of the PDC.
24. Install the new 10 amp fuse provided in the repair kit into cavity number 53 of the PDC, for location see (Fig. 1).
25. Reconnect the battery.

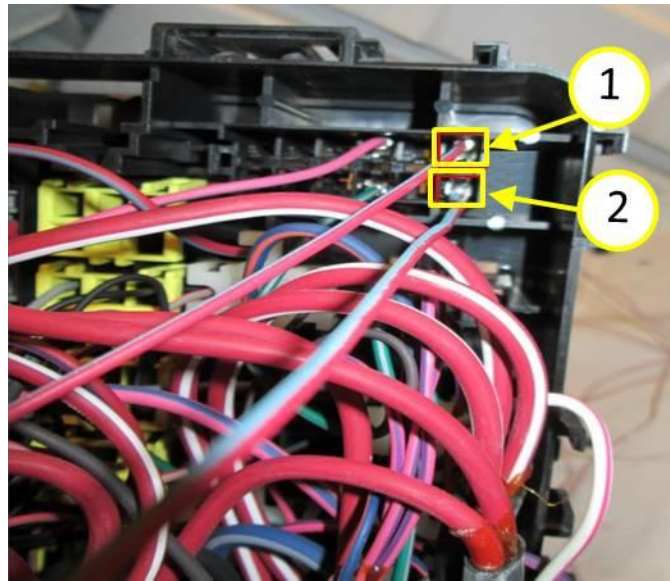
Fig. 3 New Circuit Location

- 1 - Cavity 53A
- 2 - Cavity 53B

9. Insert the terminal wire color RD/LB without eyelet end provided in the repair kit into cavity number 53B of the PDC
10. Insert the terminal with wire color RD/LB with eyelet end provided in the repair kit into cavity number 53A of the PDC (Fig. 3).

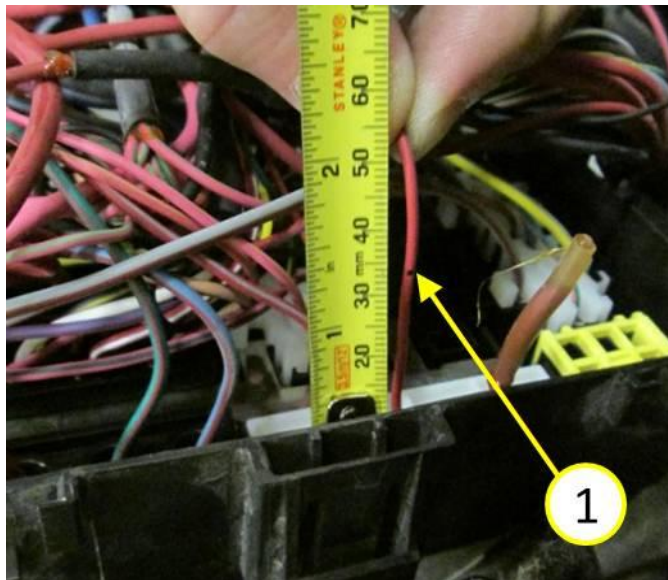
Fig. 5 Cut Wire From Cavity 12

1 - Location to cut wire

12. Locate the RD/LB wire located in cavity 12. Place a mark on the wire approximately 35mm (1.375 In.) up from the terminal, see (Fig. 5).

13. Cut the wire at the mark made in the previous step.

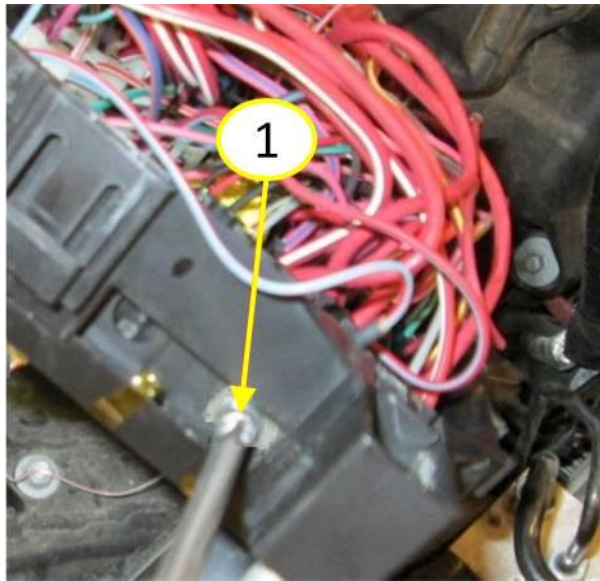
Fig. 7 Tighten Screw For Buss Bar

1 - Torque the screw to 2.9-3.9 Nm

-
18. Using the 5m screw provided in the repair kit, attach the wire installed in cavity number 53A with M5 eyelet to the buss nut. Torque the screw to 2.9-3.9 Nm, see (Fig. 7).

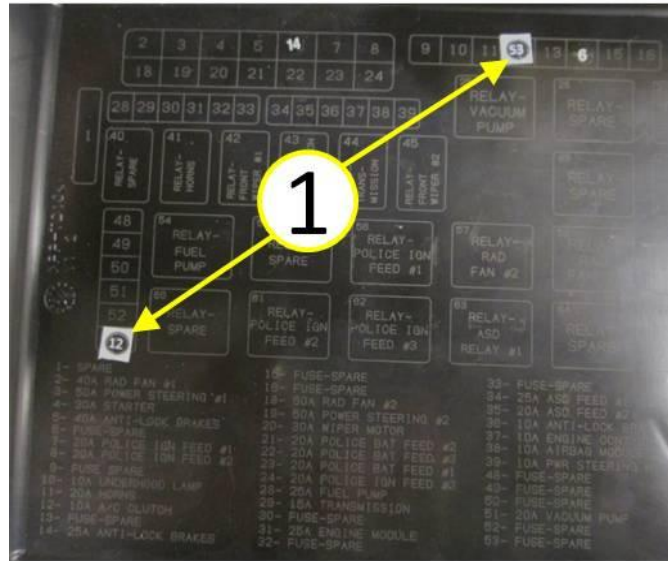
Fig. 8 New Fuse Label Location

1 - New fuse label

26. Install the new fuse location stickers provided in the repair kit, onto the fuse location diagram on the inside of the PDC cover.
