SI B51 19 13
Body Equipment

Service Action: Missing Front License Plate Bracket

F15

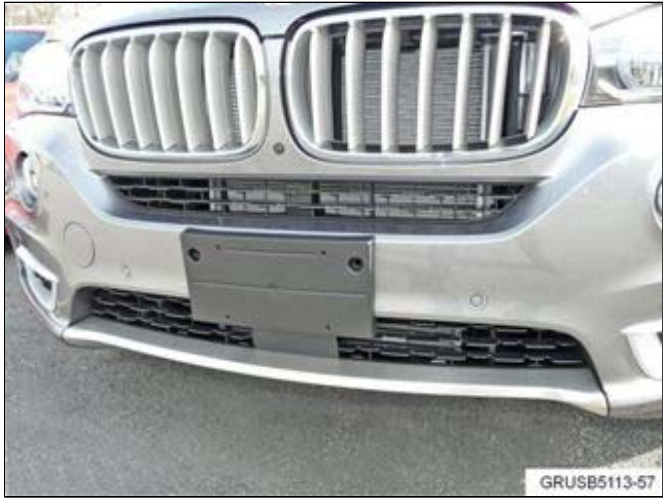
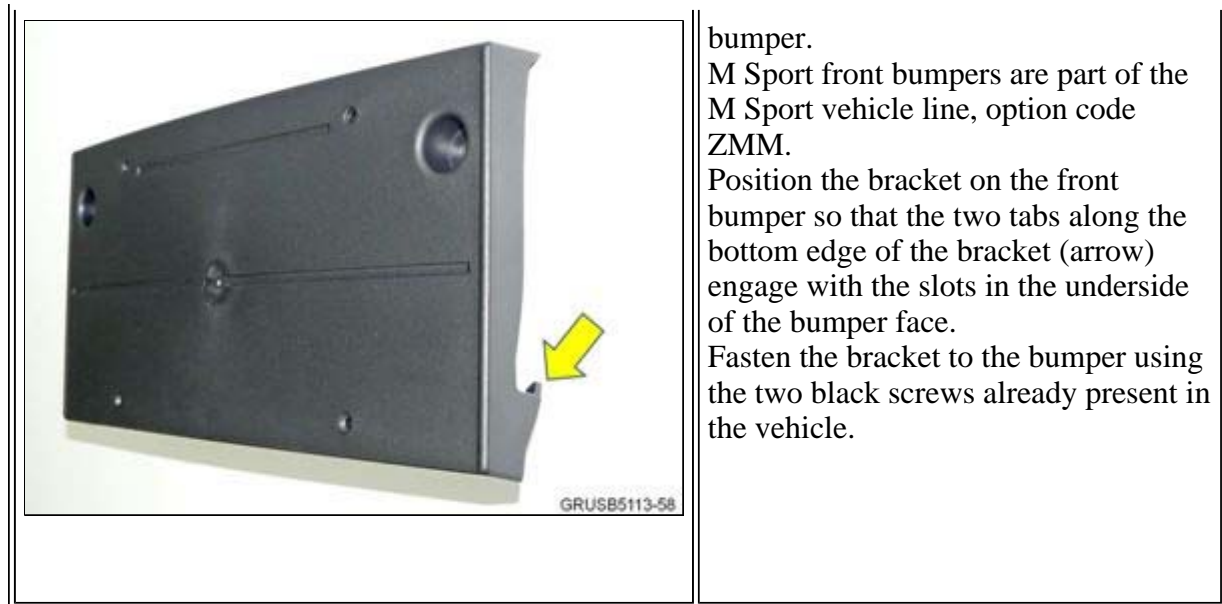
bumper.
M Sport front bumpers are part of the M Sport vehicle line, option code ZMM.
Position the bracket on the front bumper so that the two tabs along the bottom edge of the bracket (arrow) engage with the slots in the underside of the bumper face.
Fasten the bracket to the bumper using the two black screws already present in the vehicle.

<p>If the front license plate bracket has already been ordered and installed on an affected vehicle prior to the publication of this Service Bulletin, refer to the Warranty Information section to submit a warranty claim. In this situation, do not claim for the bracket. If the bracket is missing, proceed as follows.</p>
	<p>Order the appropriate bracket, depending on whether the vehicle has the standard bumper, or if equipped with the optional M Sport front</p>
